REVISION 0

# 2019 CONDITION ASSESSMENT OF THE MUNICIPAL WHARF

The Village of Tahsis retained McElhanney Ltd. (McElhanney) to complete a detailed condition assessment of the Municipal Wharf facility located in Tahsis, B.C. The scope of work included the following:

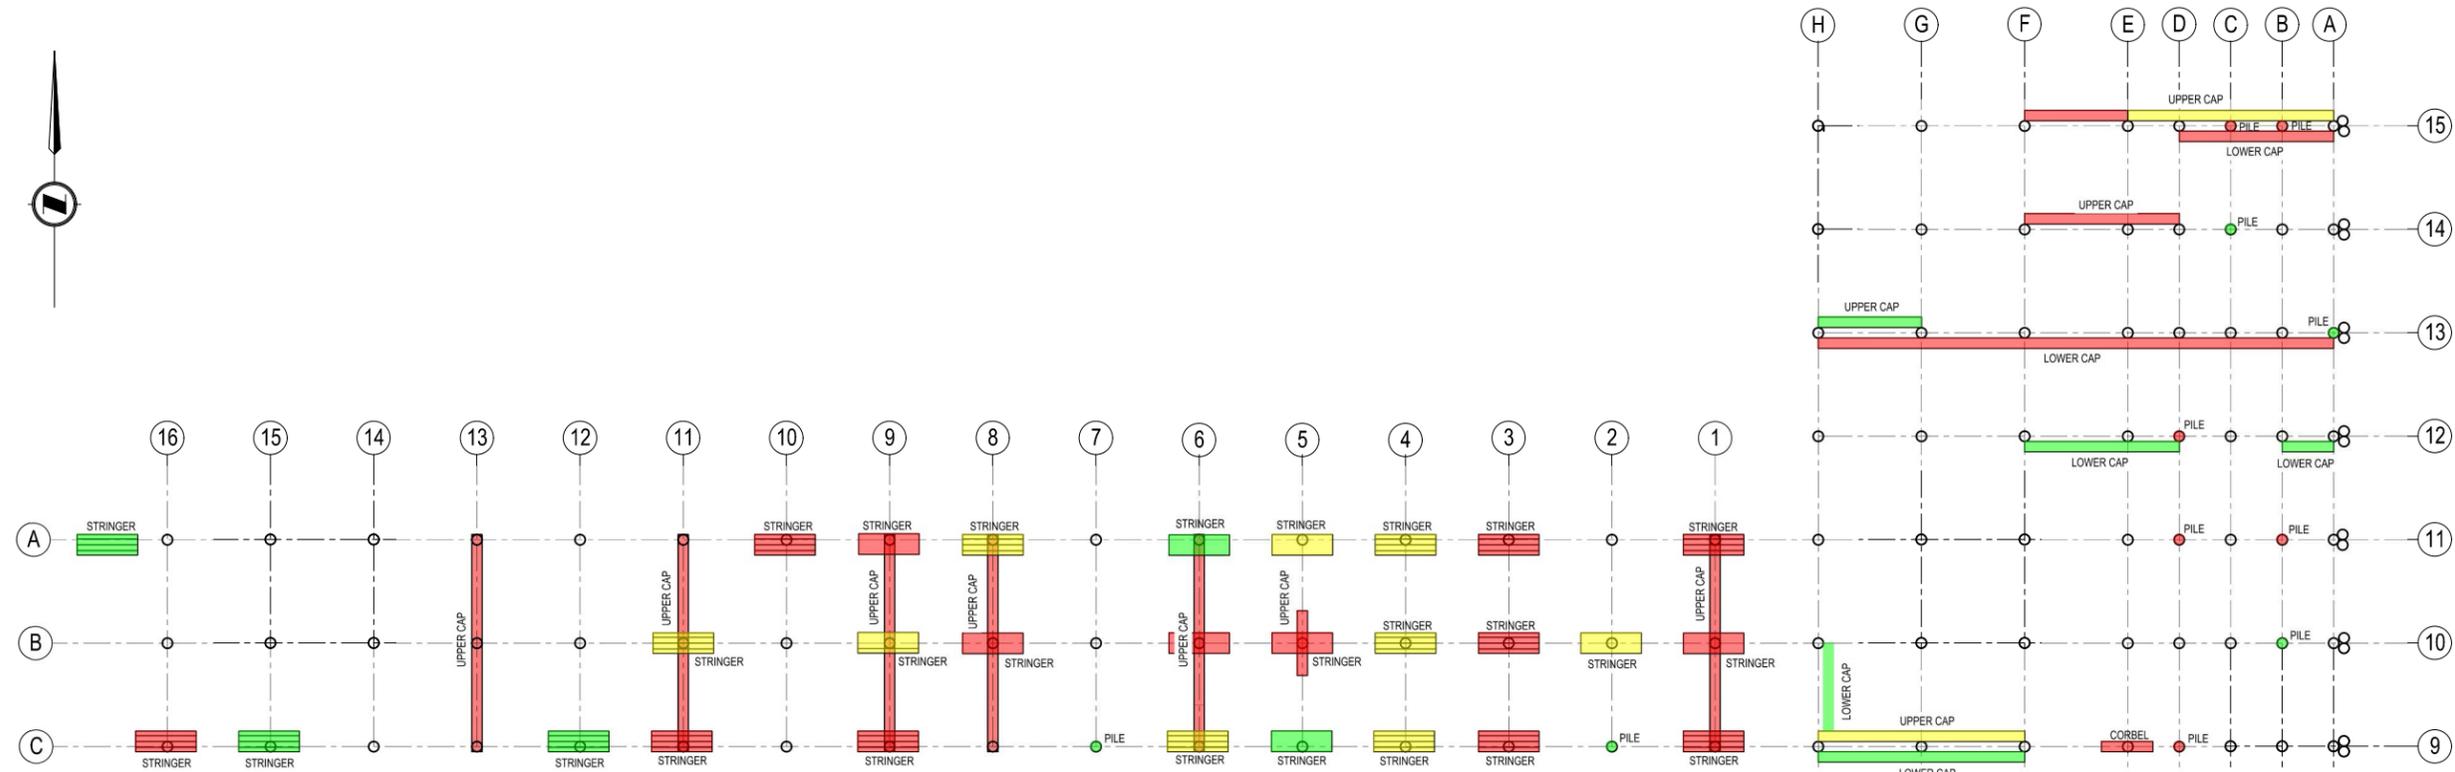
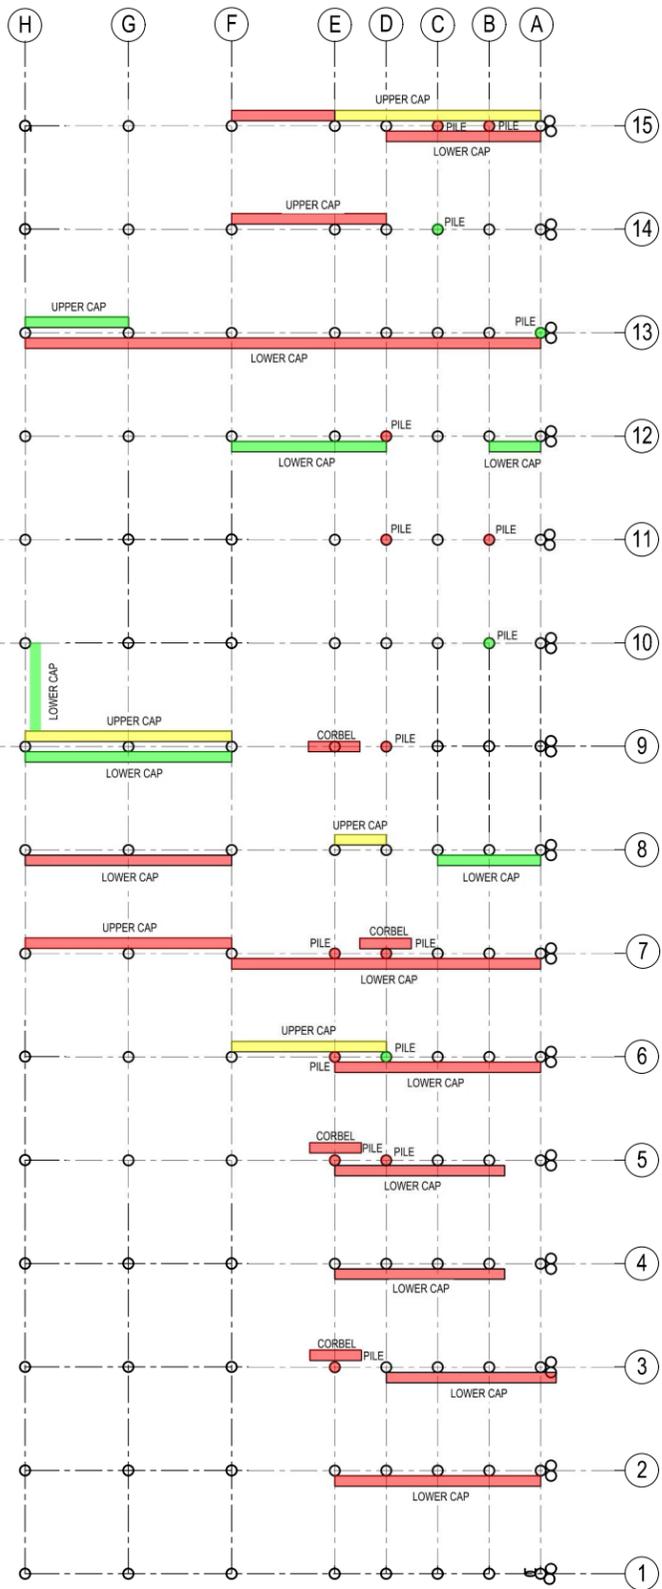
VILLAGE OF TAHSIS  
TAHSIS, BC  
VILLAGE WHARF  
TIMBER DAMAGE/ DETERIORATION  
DAMAGE PLAN

- Sheet 101 in Appendix 1 provides a location map of stringers identified with severe fungal decay.
- Approximately 60% of the location drilled during the timber coring inspection identified fungal decay with severity ranging from minor (less than 25%) to severe (greater than 50%)
- There is moderate fire damage to approximately 30% stringers from the historical fire occurring in 1971.

- Sheet 101 in Appendix 1 provides a location of pile caps identified with severe fungal decay.
- Approximately 50% of the pile cap locations drilled during the timber coring inspection identified fungal decay, typically severe.
- The stringers supporting the concrete panels and deck loads are located directly over the piles so the approach pile caps do not see significant bending moment loads. There is significant bearing and shear force loads.
- The internal fungal decay appears widespread and has progressed to consecutive pile bents. No locations were identified with evidence of structural overloading or crushing.

- Sheet 101 in Appendix 1 provides a location of pile caps identified with severe fungal decay.
- Bent Nos. 6 to 15 were drilled, and 8 / 10 of those bents had fungal decay present.
- The internal fungal decay appears widespread and has progressed to consecutive pile bents.
- There are multiple locations identified with pile cap structural failure at consecutive pile locations as a result of shear and bearing failure. Notably, this is evident at Bent Nos. 2 to 7, Piles A to E where there is widespread evidence of pile cap bearing / shear failure above the piles.

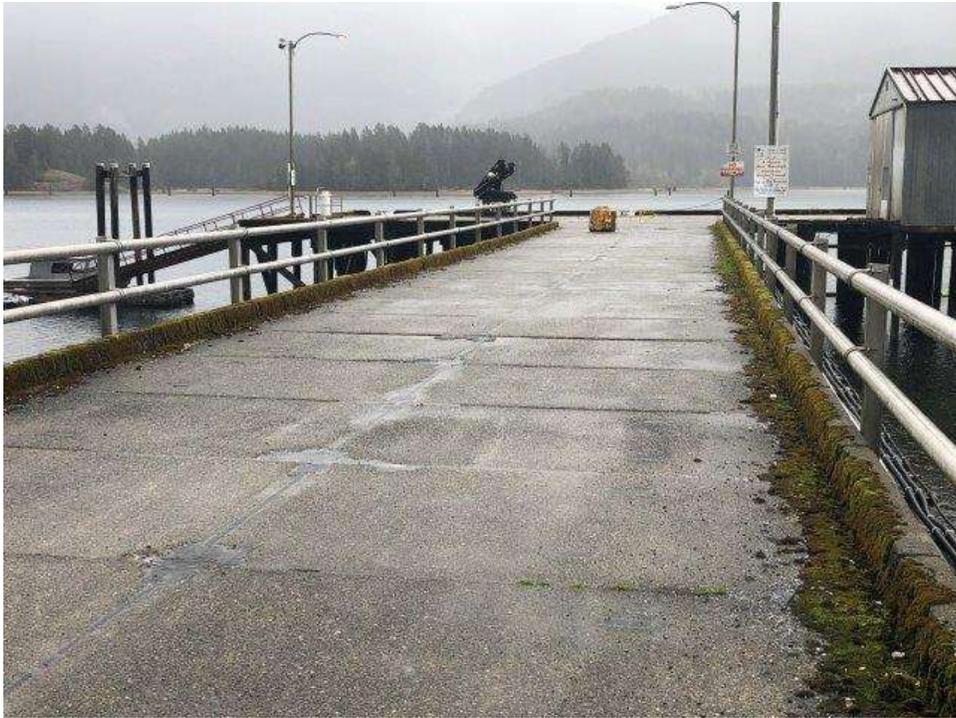
*Photo 9 – Approach Trestle Deck Panels*

- The concrete appears sound with no significant damage, structural cracking, spalling or delamination (Photo 9, Appendix B).
- There is minimal corrosion staining to indicate significant corrosion of the internal reinforcing steel.
- The deck panel joints are either significantly damaged or missing and there is significant water draining onto the stringers and pile caps resulting in significant fungal decay. See Sections 3.1.3 and 3.1.4.
- There is no evidence that the deck panels have significant movement and generally appear well secured to the pile caps.

*Significant repairs are not recommended at this time, although continued monitoring should be carried out.*

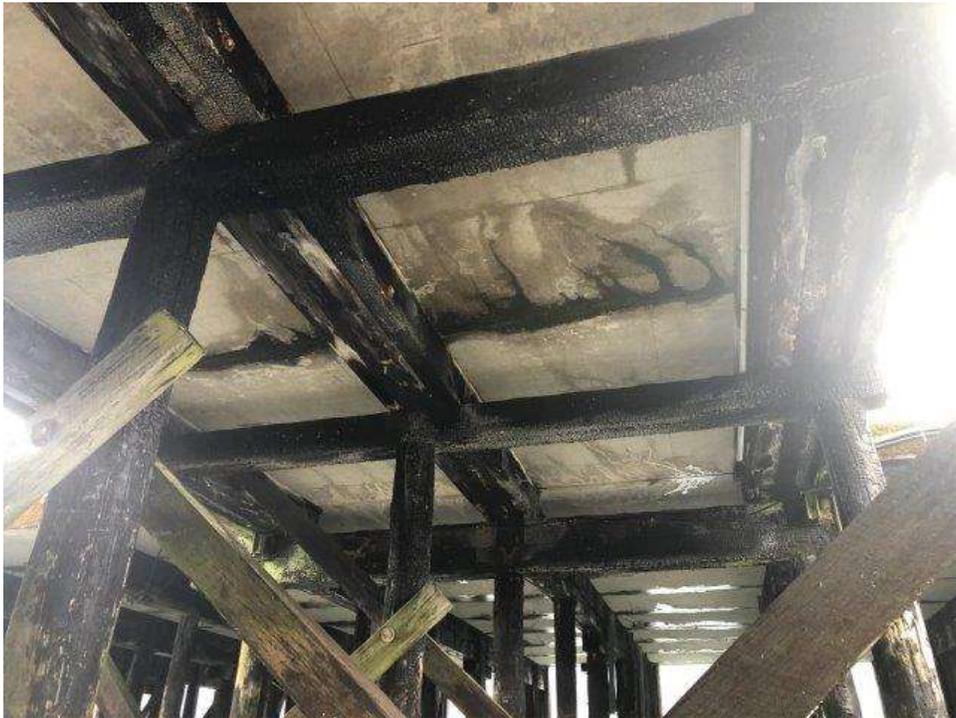
*Photo 10 - Approach Trestle Stringers and Pile Caps*

The approach stringers have widespread severe fungal decay and have generally reached the end of their service lives (Photos 10 and 11, Appendix B). Typical inspection findings are as follows:

*As part of the rehabilitation plan for the wharf, significant replacement or repairs to the stringers should be completed.*

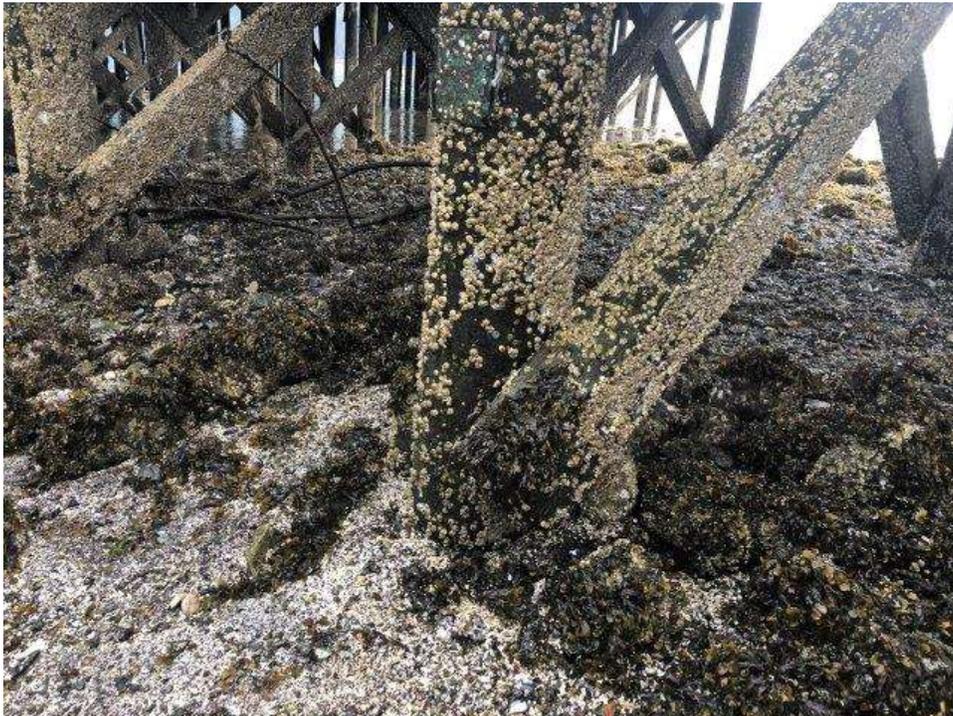
*Photo 12 - Approach Trestle Pile Cross-Bracing*

- There is minor fungal decay and marine borer attack at the lower bolted connections in the intertidal zone (Photo 12).
- The bracing appears generally well secured with no evidence of excessive movement or distress.

*Significant repairs are not recommended at this time, although continued monitoring should be carried out.*

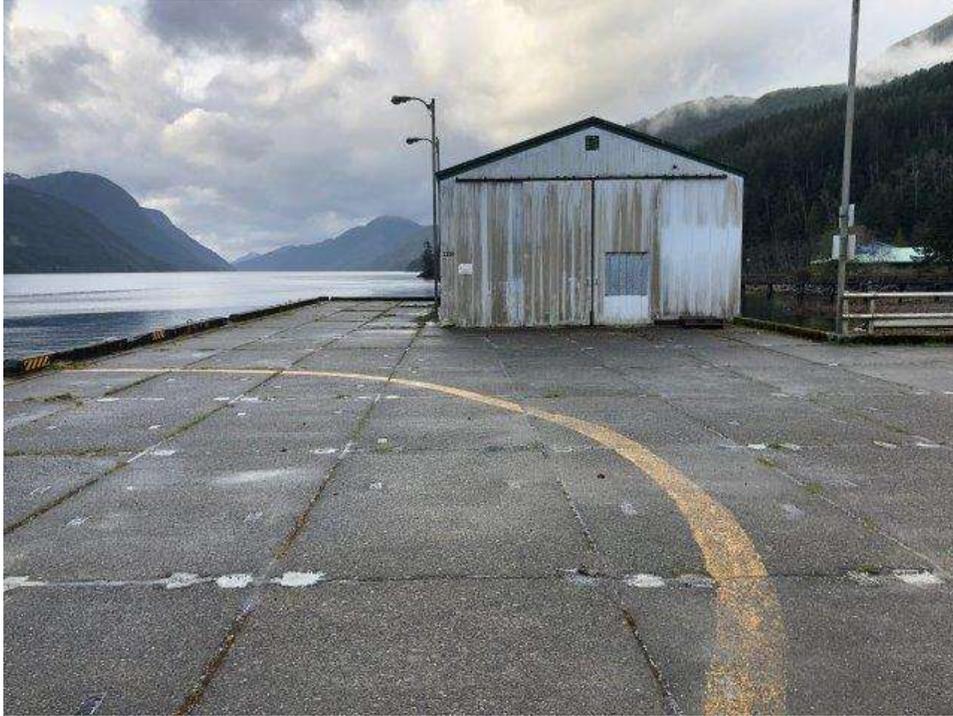
*Photo 13 – Wharfhead Topsides and Building Structure (Facing South)*

The wharfhead topsides are generally in a serviceable condition (Photo 13, Appendix B). Typical inspection findings are as follows:

*Installation of a timber handrail along the north, south, and west sides of the wharfhead is recommended. Alternatively, signage and “do-not-cross” delineation of the edge 2.0m could prevent pedestrian access from the unguarded wharf edge. Continued monitoring should be carried out.*

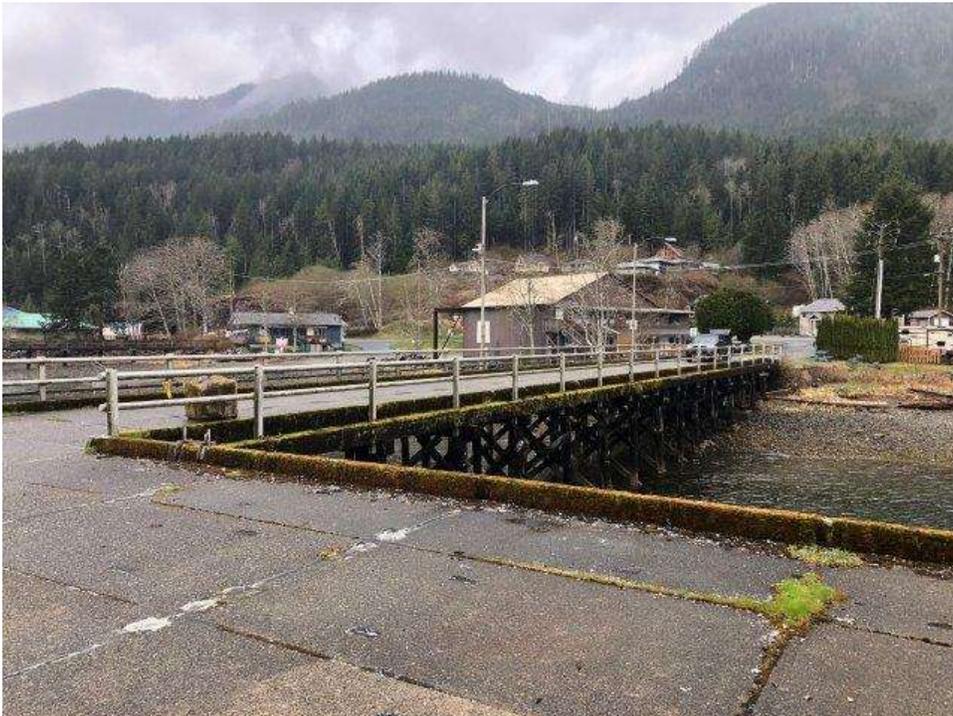
*Photo 14 - No Handrails Along West Face of Wharfhead*

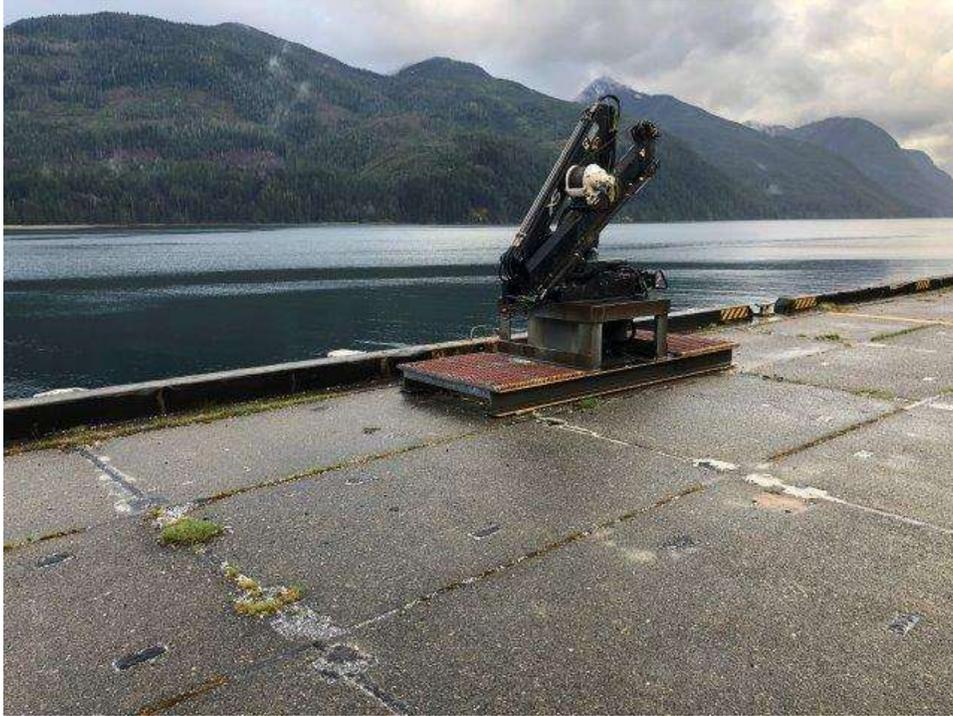
*Photo 15 – Hiab Crane Located Between Bent Nos. 12-13*

- The hiab crane located between Pile Nos. 12A and 13A appears to be in a serviceable condition (Photo 15, Appendix B). Although an inspection to the crane itself was not completed, the supporting deck and pile cap saddles appear well secured with no evidence of distress or significant movement. *The pier cap at Bent Nos. 13 was identified with severe fungal decay and limiting the use of the hiab crane is recommended.*

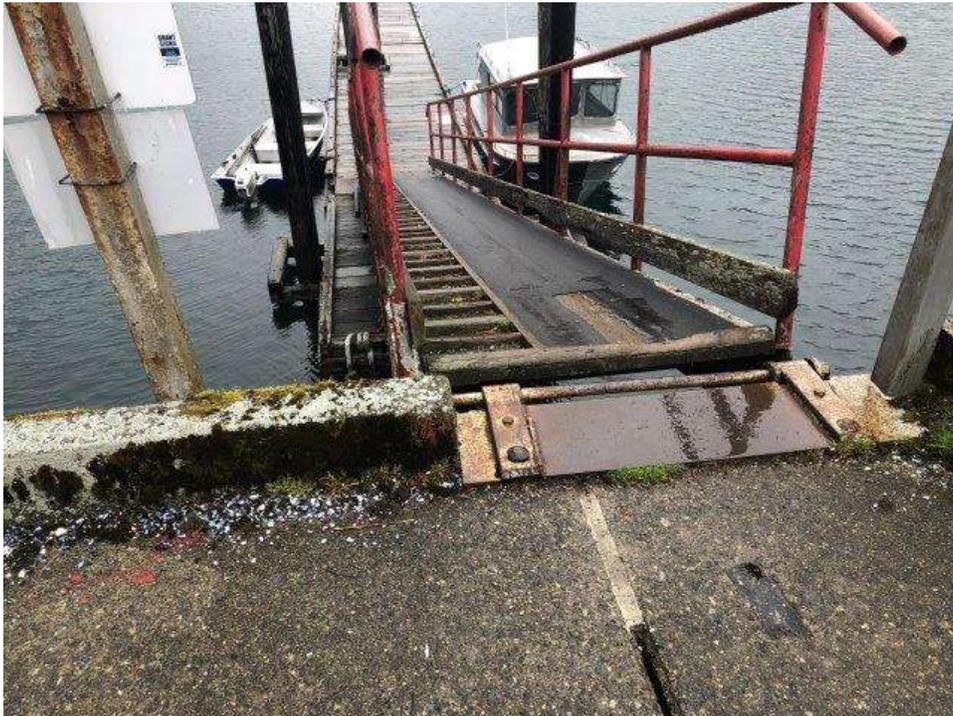
*Photo 16 – Upper Gangway Connection to Wharf*

- The upper gangway connection to the wharf has evidence of structural failure and rotation of the supporting plate due to the pile cap supporting the gangway connection having severe fungal decay (Photo 16 and 17). The gangway is connected to the wharf by hanging bars and a hinge pin supported by a steel plate bolted into the concrete panel on the top of the wharf. The hanging bars do not line up with the supporting plate at the inshore connection resulting in the hinge pin spanning approximately 150 mm. Additionally, with the gangway not sitting perpendicular to the wharf there is wearing on the hinge pin at the inshore side of the connection.

The gangway providing access to the floating dock is in moderate to severe condition. As previous discussed in Section 4.2.1, the connection from the wharf to the gangway consists of hanger plates with a hinge pin. As the hanger plates are misaligned, the hinge pin is now spanning with significant deflection and evidence of structural overloading.

*McElhanney strongly recommends to load restrict the gangway ramp to a maximum of 500 lbs. This load restriction would consist of 1-2 occupants on the gangway at a time. No assembly or groups of people on the gangway is permitted. Load restriction signs should be clearly marked at both ends of the gangway.*

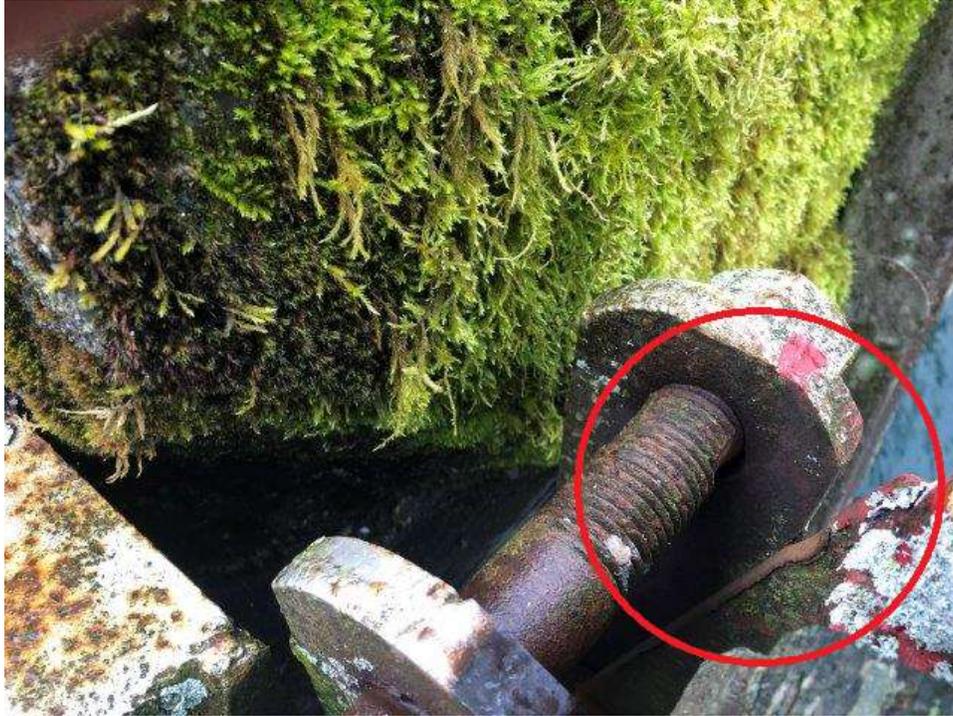
- The hinge pin of the gangway was found to be the critical element of the hinge system since the hinge pin acts as a cantilever span at the inshore connection.

*Photo 17 - West Hinge With Wearing / Abrasion of the Hinge Pin*

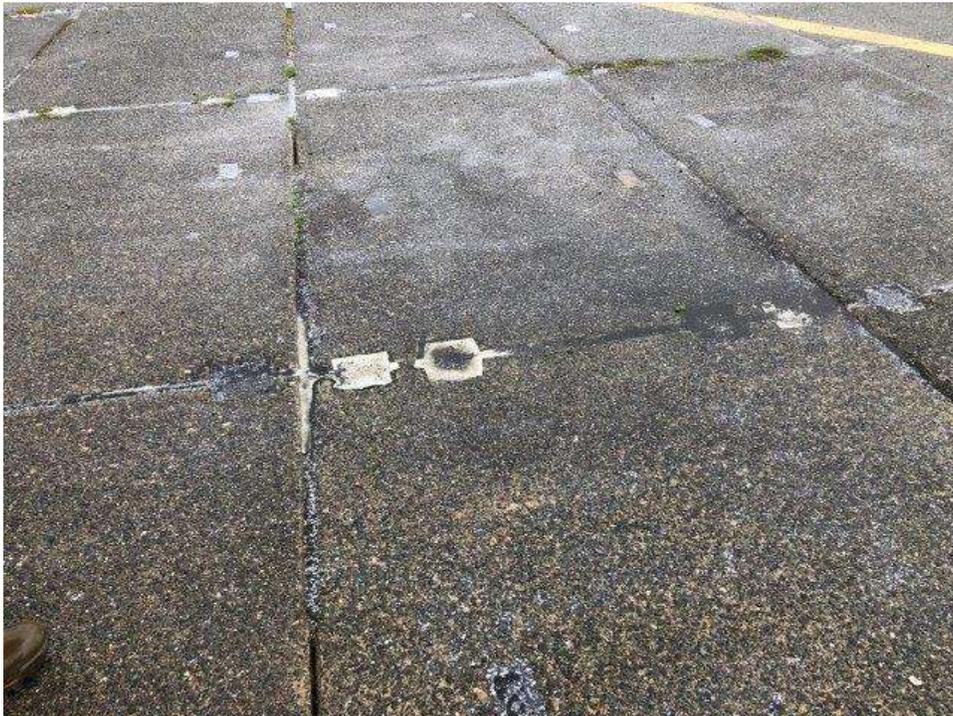
- The concrete appears sound with no widespread significant damage, structural cracking, spalling or delamination (Photo 18, Appendix B). There is some minor spalling adjacent to drain holes and electrical utility holes (Appendix 19, Appendix B).
- There is minimal corrosion staining which could indicate significant corrosion of the internal reinforcing steel.
- The deck panel joints are either significantly damaged or missing and there is significant water draining onto the pile caps resulting in significant fungal decay. See Sections 3.1.4

- There is no evidence that the deck panels have significant movement and generally appear well secured to the pile caps. In several locations, the pile caps have failed and are severely crushed resulting in settlement of the deck panels above.

*Photo 18 – Wharfhead Deck Panels with Settlement Due to Failure of the Pile Caps*

*Significant repairs are not recommended at this time, although continued monitoring should be carried out.*

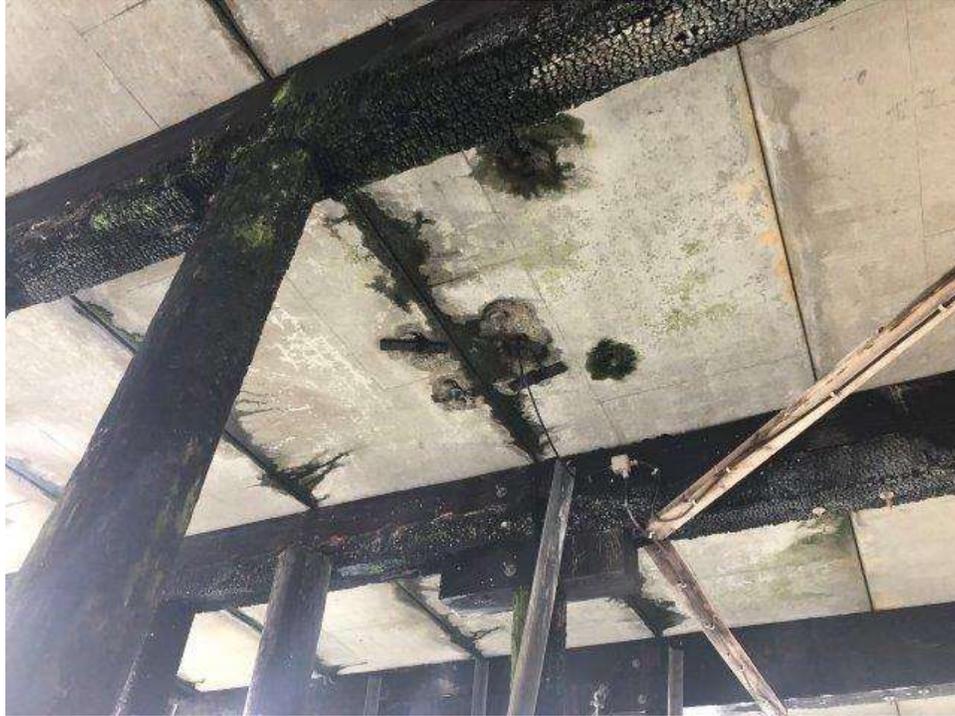
*Photo 19 – Wharhead Deck Panels With Spalling Adjacent to Drainage / Electrical Utility Holes*

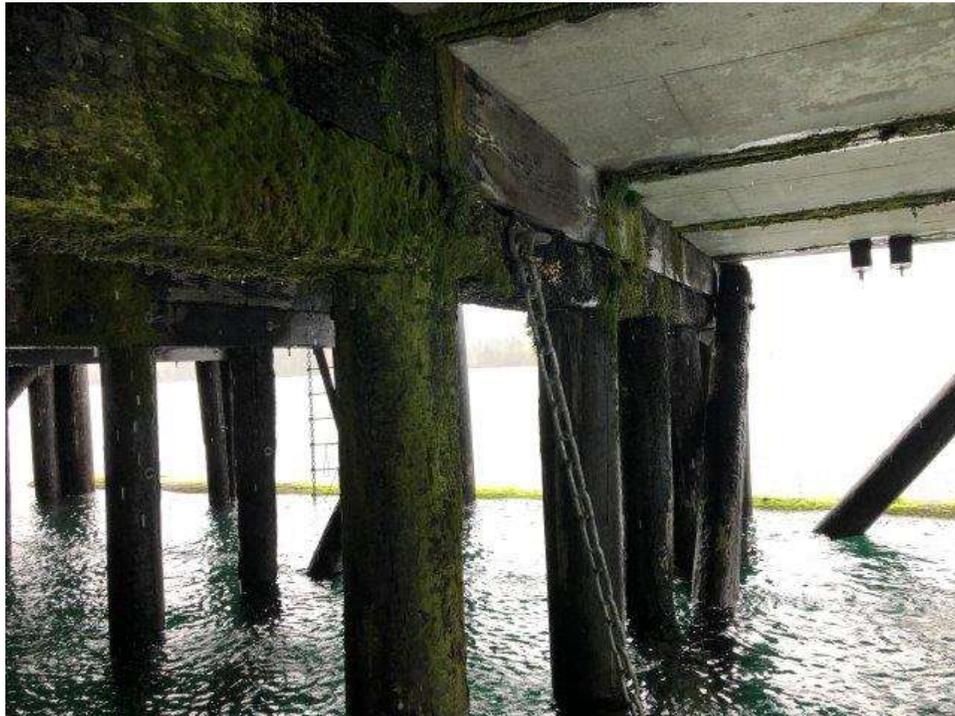
The wharfhead pile caps have widespread severe fungal decay and have generally reached the end of their service lives (Photos 20 to 25, Appendix B). Typical inspection findings are as follows:

*Photo 20 – Bent No. 2 Lower Pile Cap With Severe Fungal Decay*

*As part of the rehabilitation plan for the wharf, significant replacement or repairs to the pile caps should be completed. See Section 6 for further discussion.*

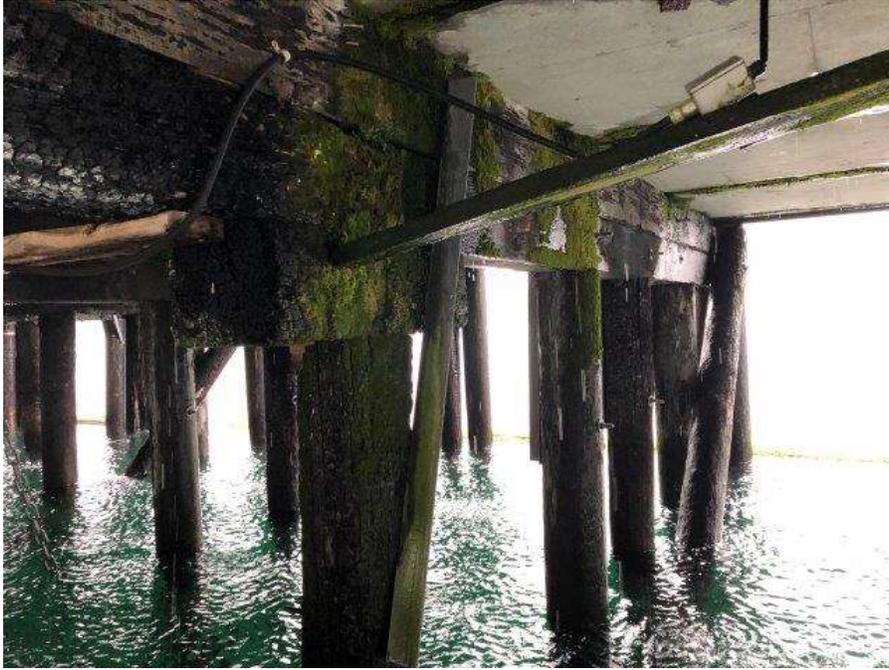
*Photo 21 – Bent No. 3 Lower Pile Cap With Severe Fungal dEcay*

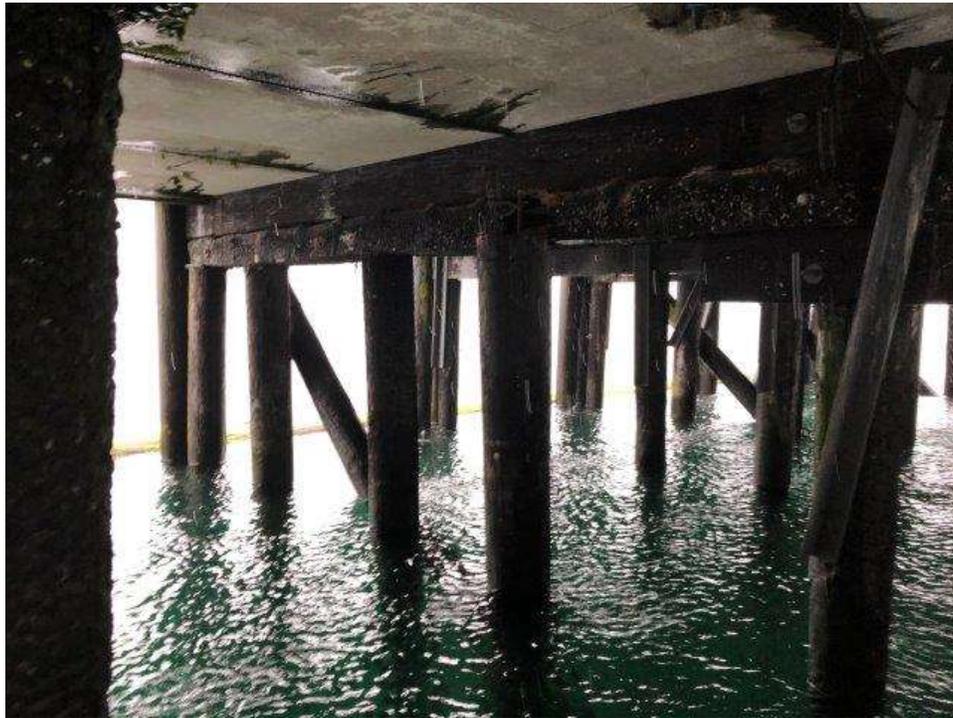
- There are a number of locations where the severe deterioration of the pile caps has resulted in the piles “punching” through the pile caps resulting in bearing loss.
- In a number of locations, there are pile straps and pile clamps added to the top of the piles to address misalignments and splitting.
- From the timber coring, 10 piles were identified with severe fungal decay at the top. This extent of fungal decay is typical for wharf structures approximately 50 years old and is attributed to water penetration at the drift pin connection.
- The batter piles appear well secured to the vertical piles with no obvious evidence of movement or elongation of the bolted connections.

*Photo 22 – Bent No. 5 Lower Pile Cap With Severe Fungal Decay. Note Pile D is not in bearing with cap.*

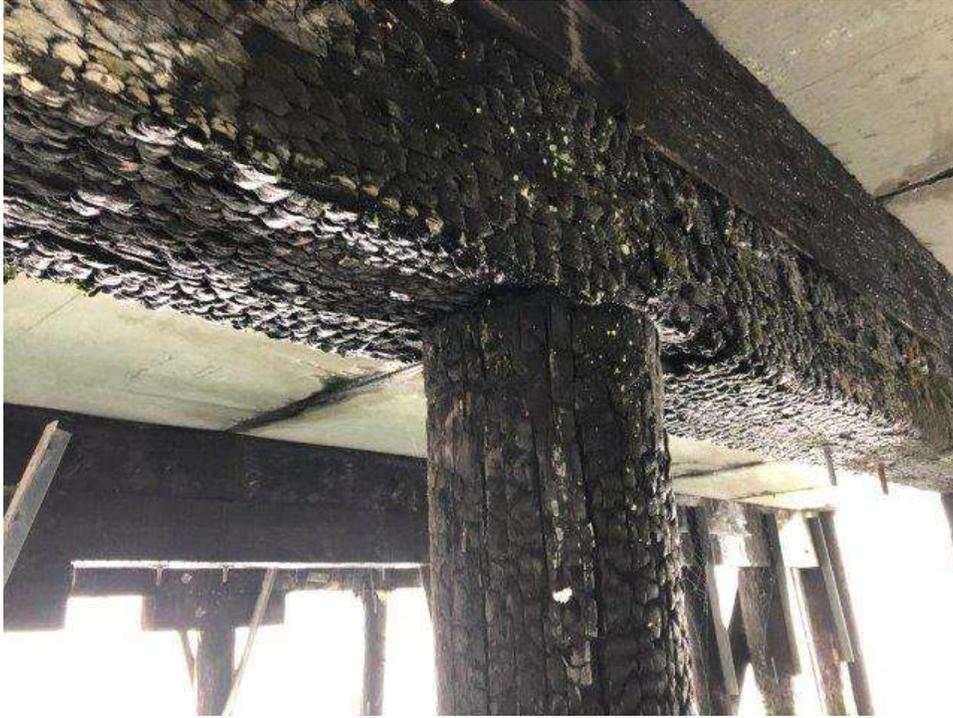
*Photo 23 – Typical View of Pile “Punching” Through Pile Cap from Pile Cap Severe Fungal Decay*

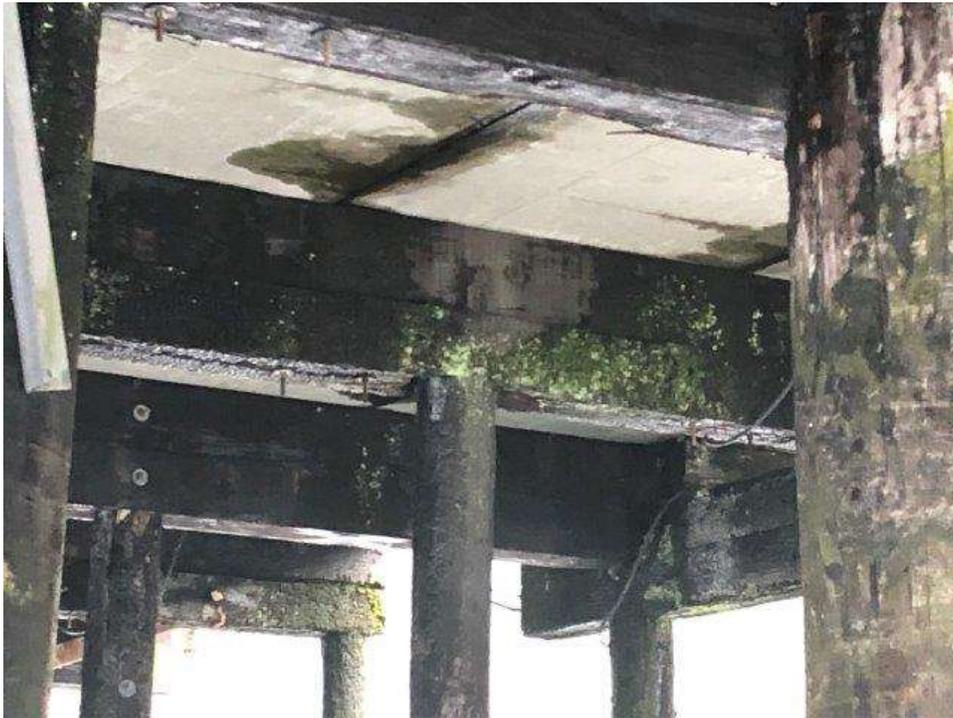
*Photo 24 - Pile Punching Through Pile Cap at Pile No. 6T*
