VILLAGE OF TAHSIS

Report to Council

Re: Hearing by Council to determine whether one or more buildings located at civic address 1400 S. Maquinna Drive should be declared a nuisance under Part 3, Division 12 of the *Community Charter* and whether to impose a remedial action on the property owner (the “**Hearing**”).

The follow observations were noted during exterior building inspection that was conducted on June 17, 2021, at 1400 South Maquinna Drive between the hours of 11:30 and 14:00hrs. The inspection was done by Strathcona Regional District Building Official Karl Neufeld and Strathcona Regional District Bylaw Compliance Officer Enzo Calla.

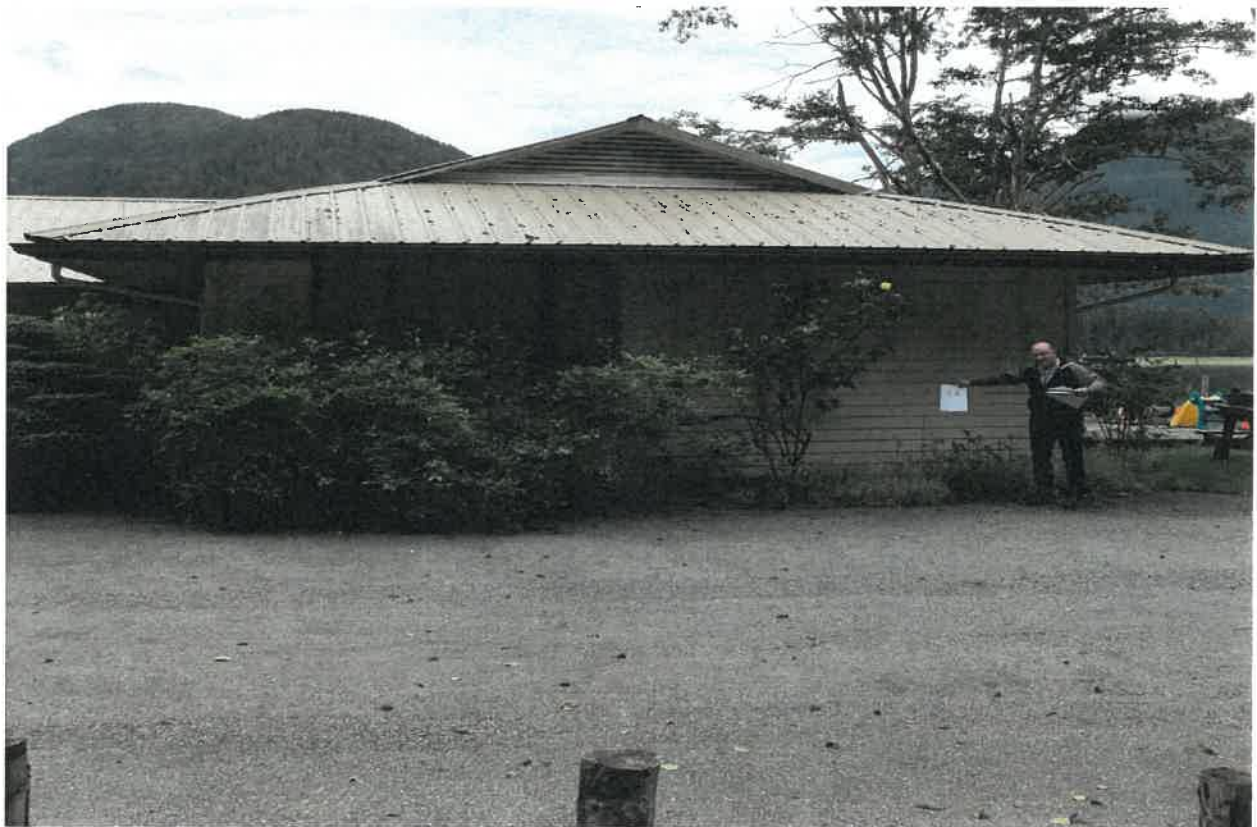
IMG_0270

Dry rot was identified at the downspout at the front entrance (image below is img_0270).

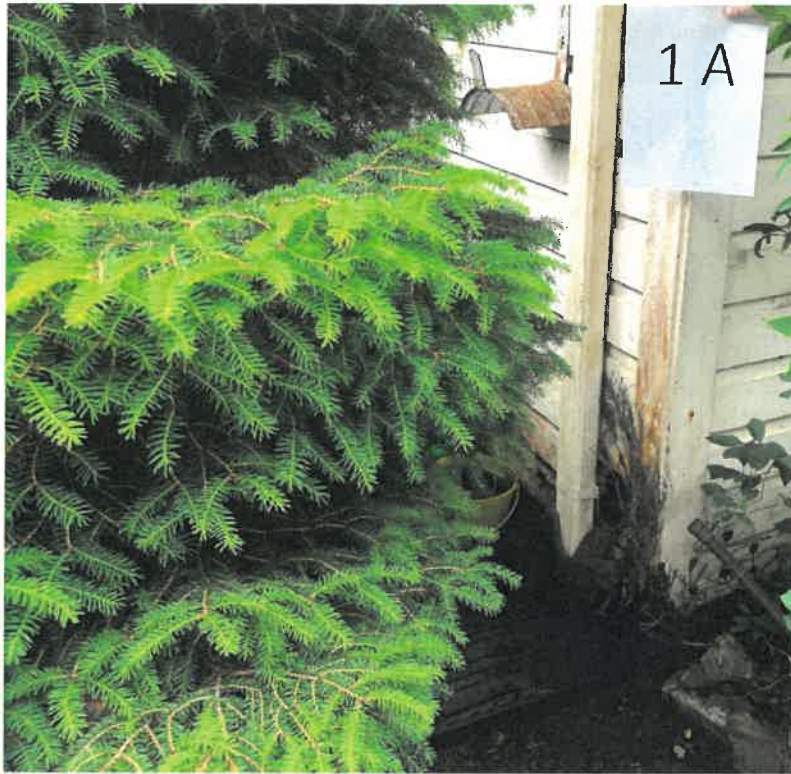
Note facial rotting on the corner at the bottom of the down spout. This will be on the left side of the wall as depicted in picture above.
IMG_0272

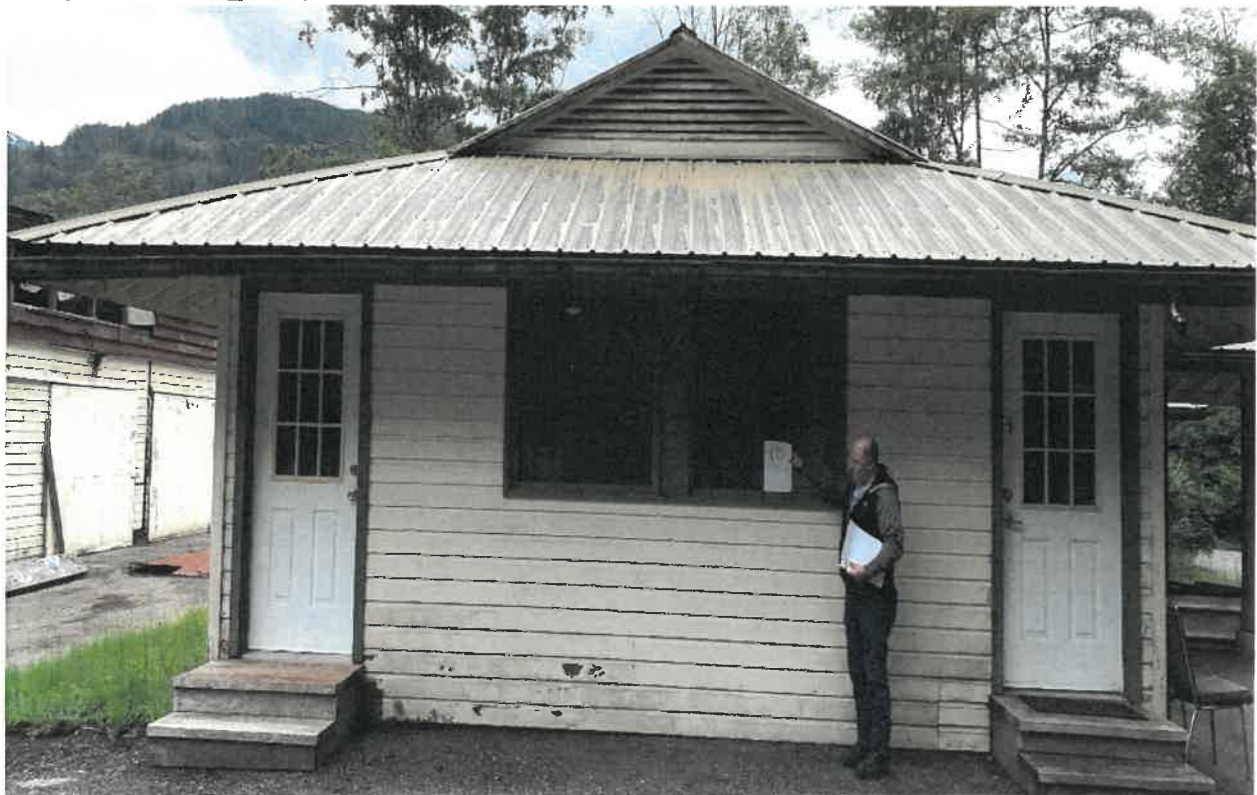
Facial rotting in the left corner by doorway that is located at the left-hand side of the building.
(Image below IMG_0274)

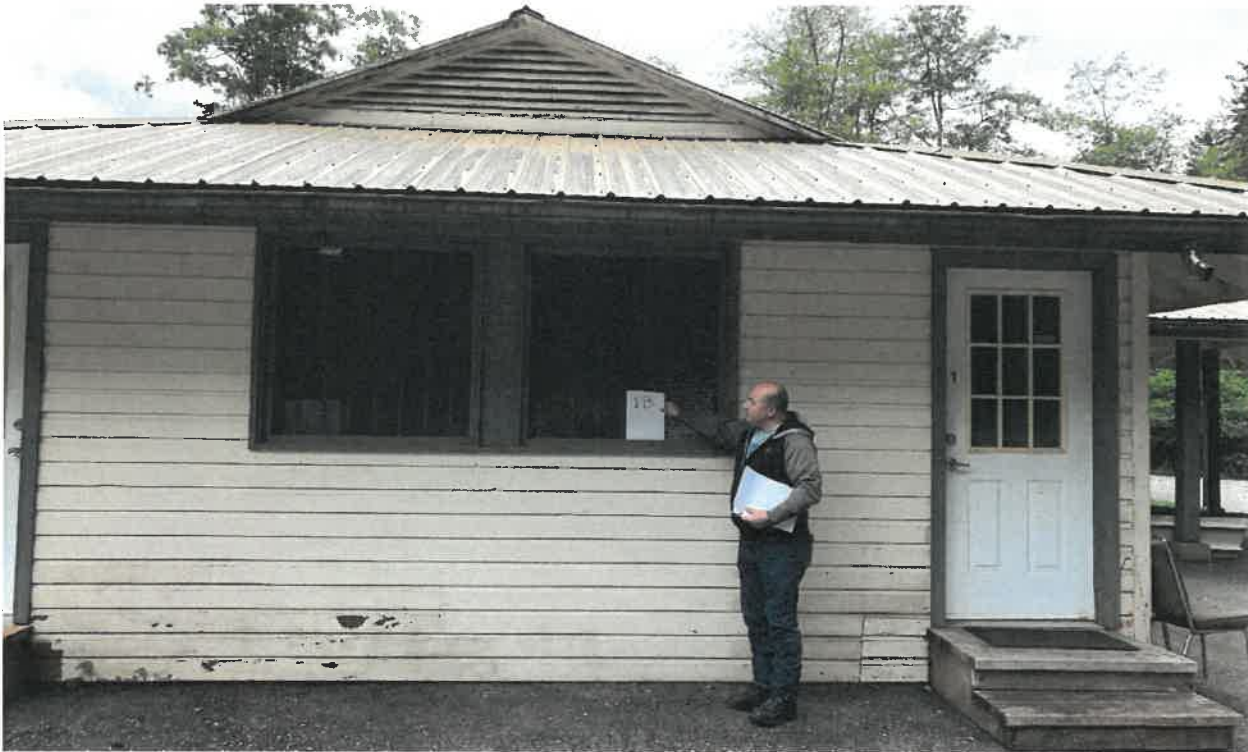
IMG_0273-above

Apart from paint that was peeling and wood replaced by door, nothing was observed on the B side of the structure.

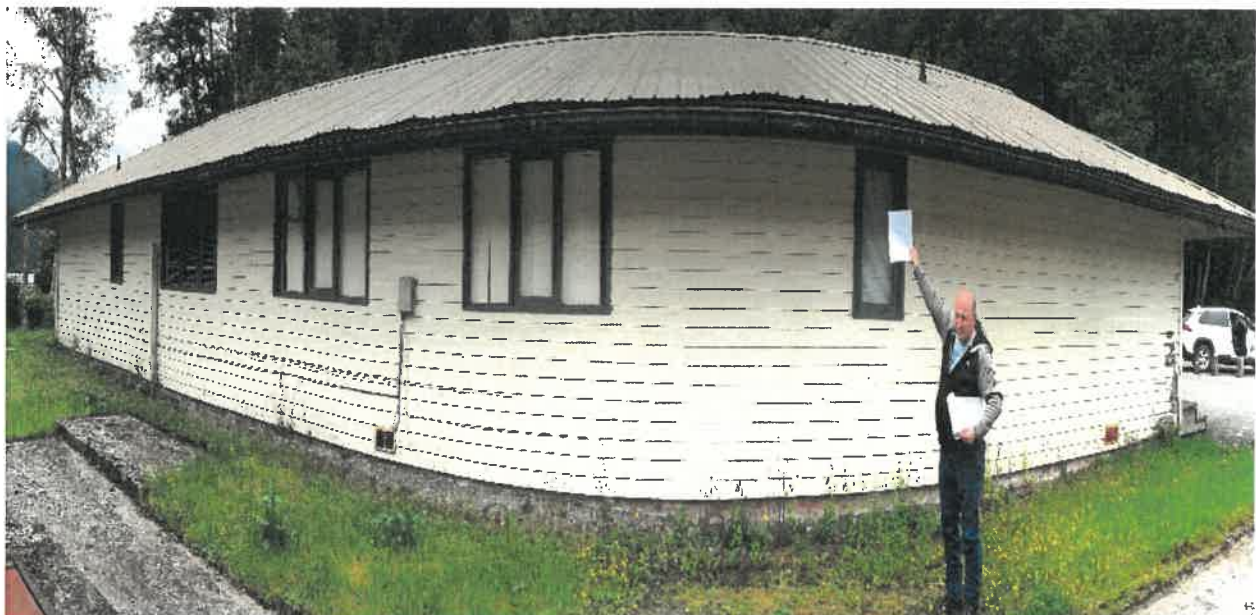
IMG_0276-below

Metal roof appeared to be lifting as it was due to the metal screws that lifting (it is unknown how long the roof has been in place). Please note, that this was a panoramic shot to include the entire side of the roof.

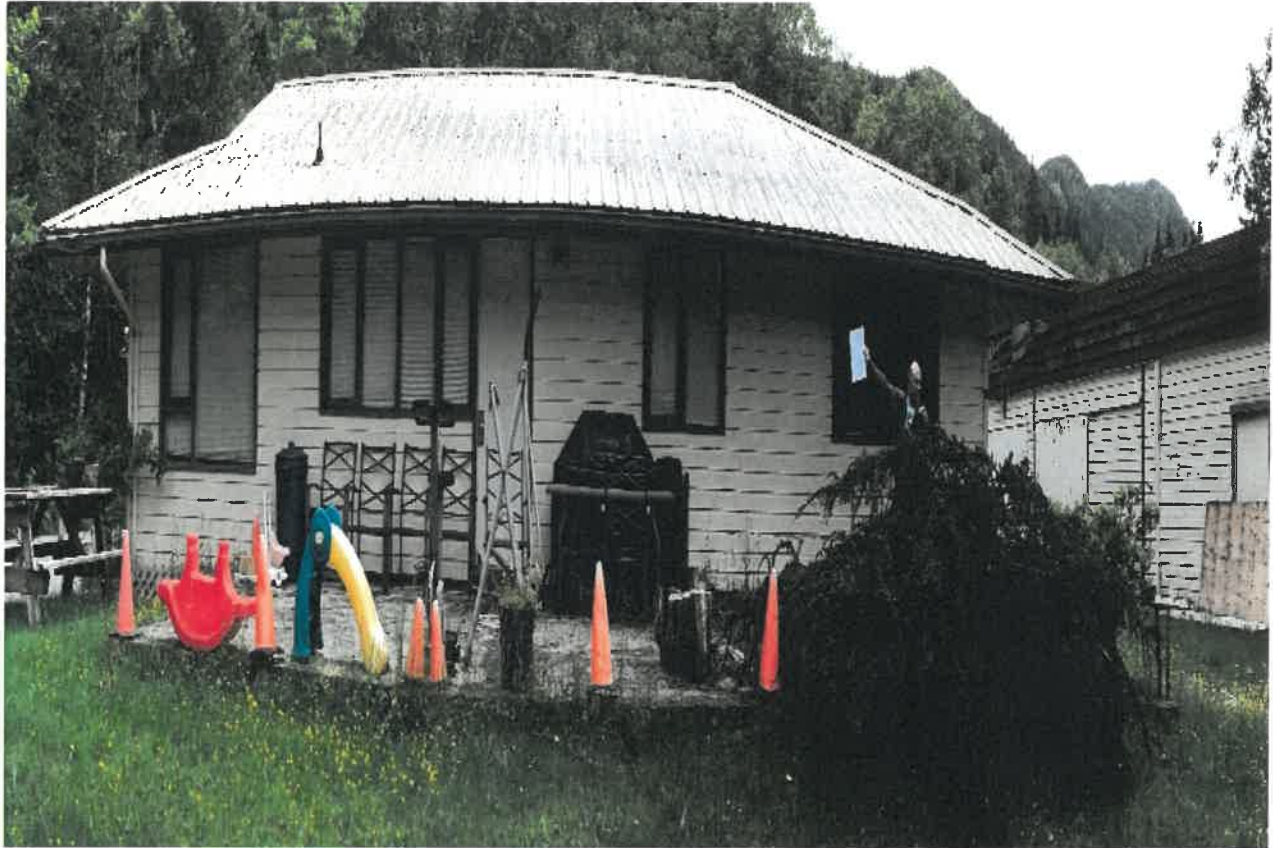
IMG_0278 - below

Note although this is the D side of building 1, captured a part of the C side of building 3 is in view of the portion of roof that has collapsed

Dry rot was in seen the lower corner on the C/D side

Siding was missing all along the side at ground level

Deterioration of the siding along the ground by the patio

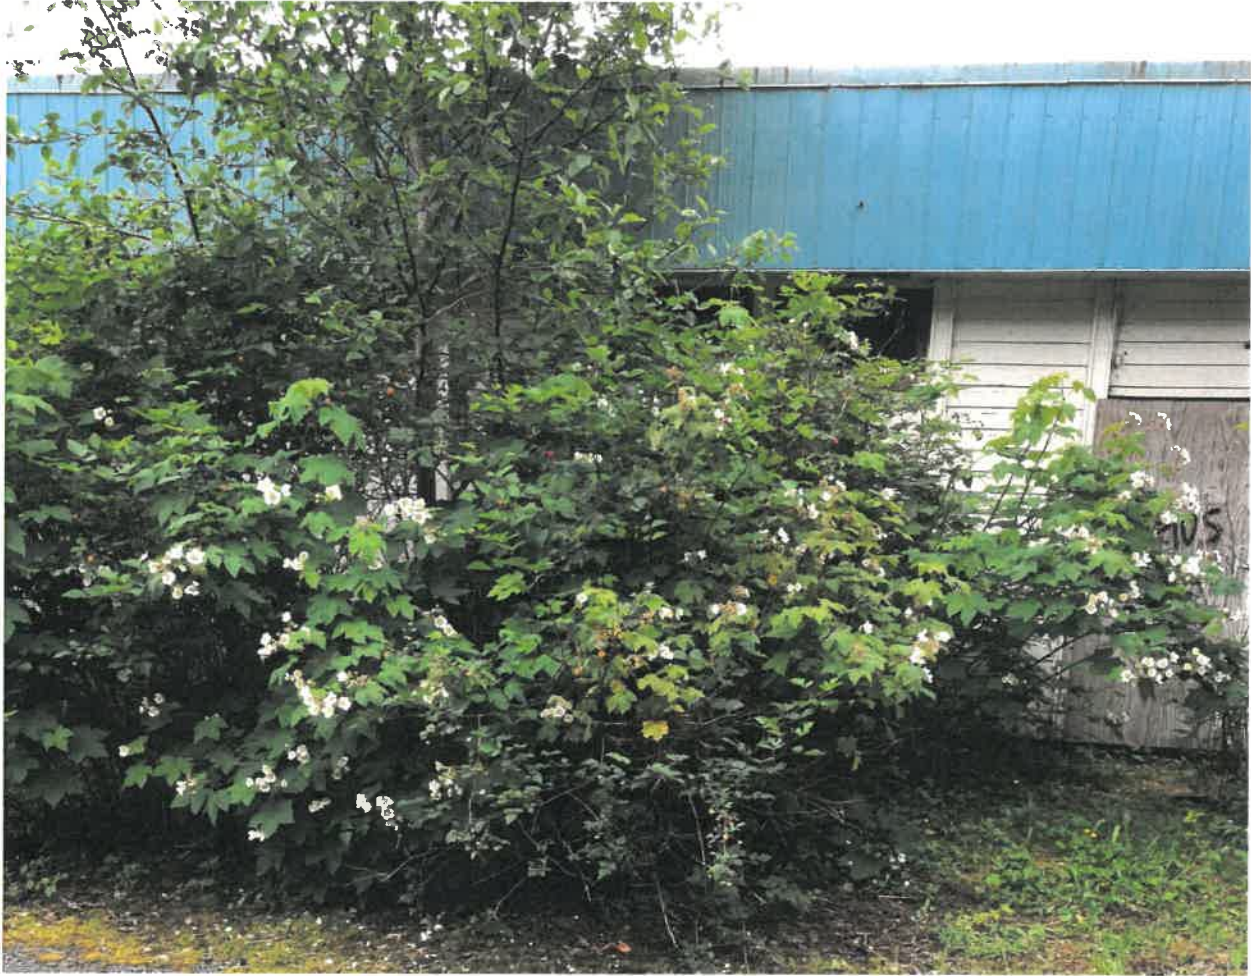
IMG_0279 - above

Doorway at the South end of the was inaccessible dur to overgrown vegetation. The base and foundation could not be observed. Doorways are covered with plywood.

Paint was found to be peeling and rot along the bottom of the wall along the length of this side of the building.

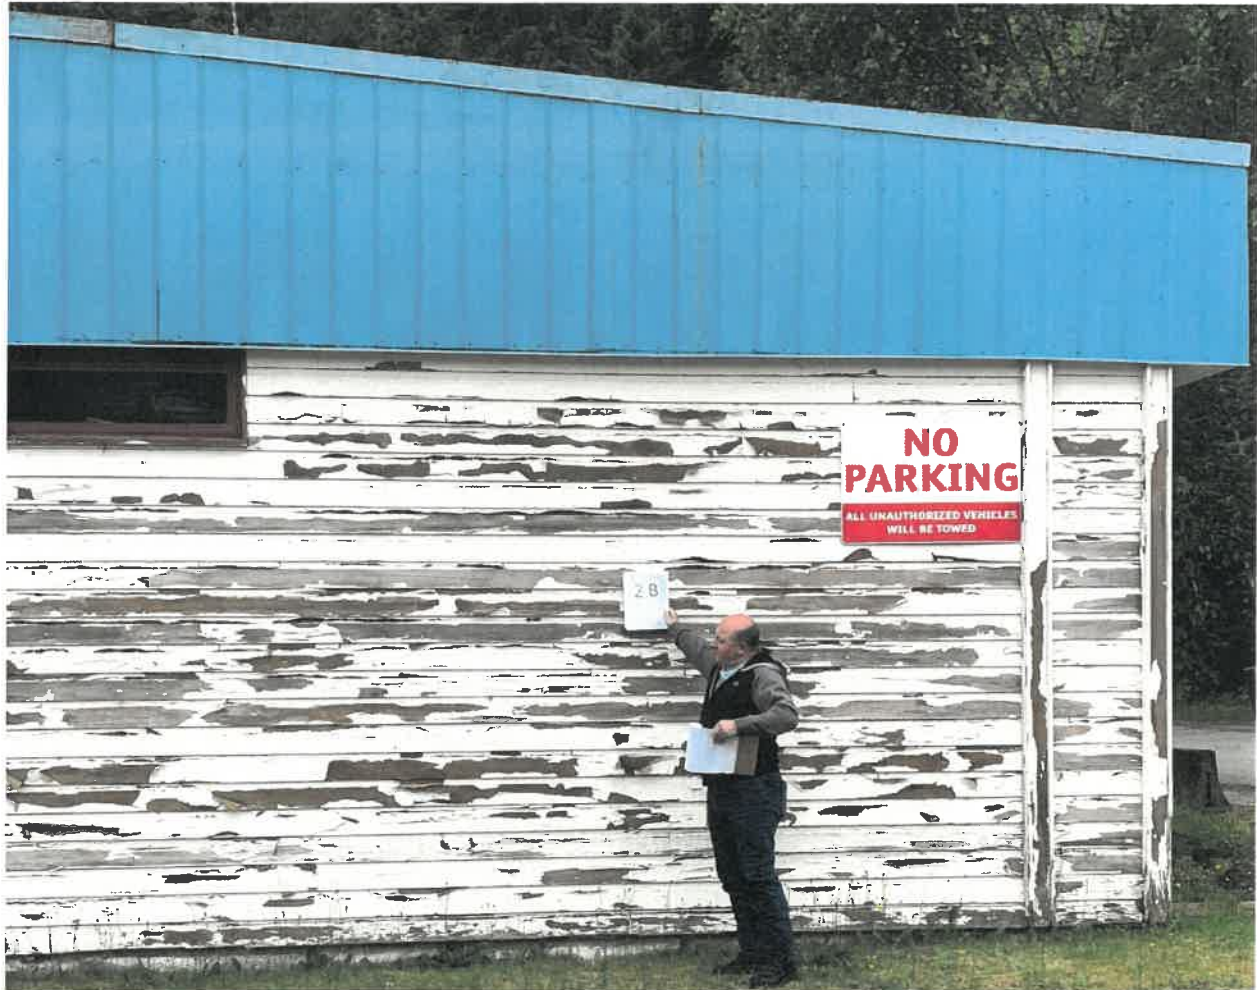
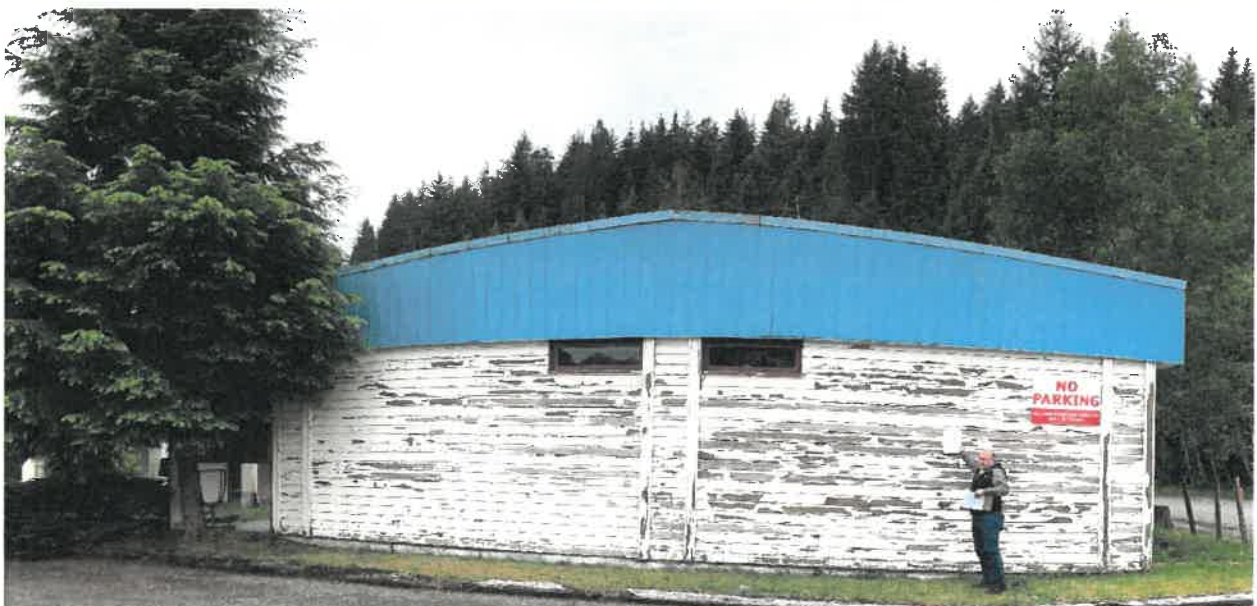
Note, paint is peeling and dry rot of the wood siding along the bottom of the wall (IMG_0280 & 0281)

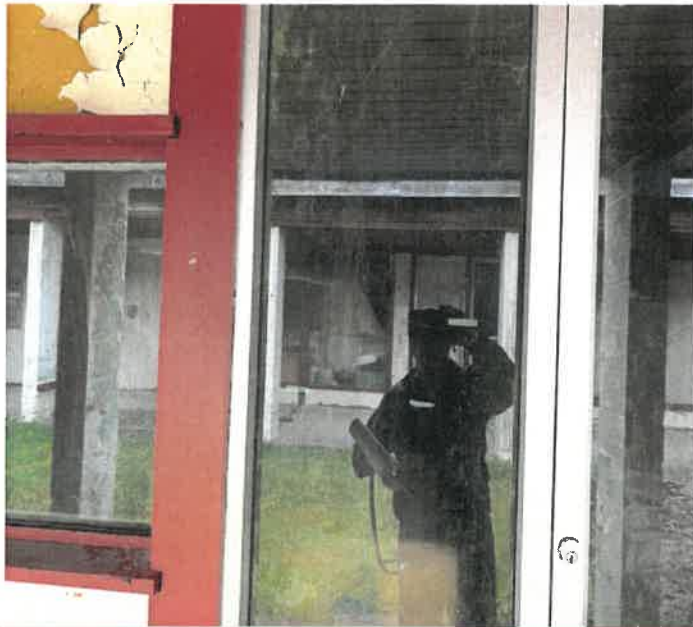
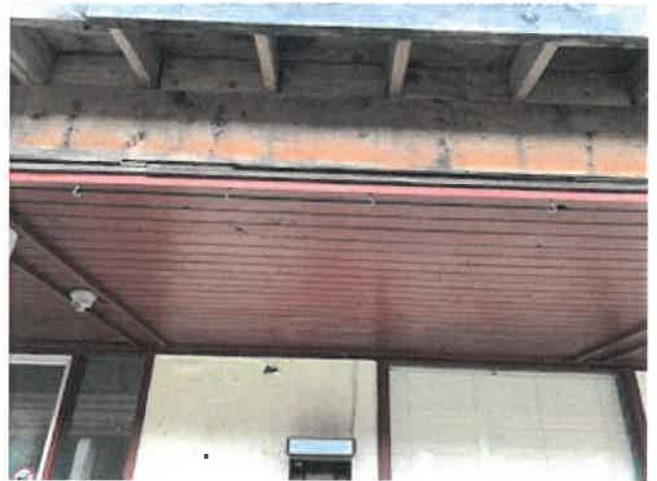
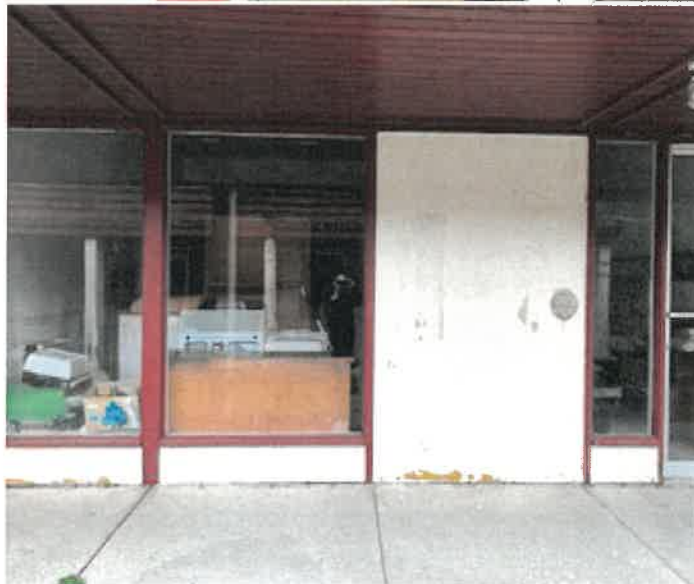
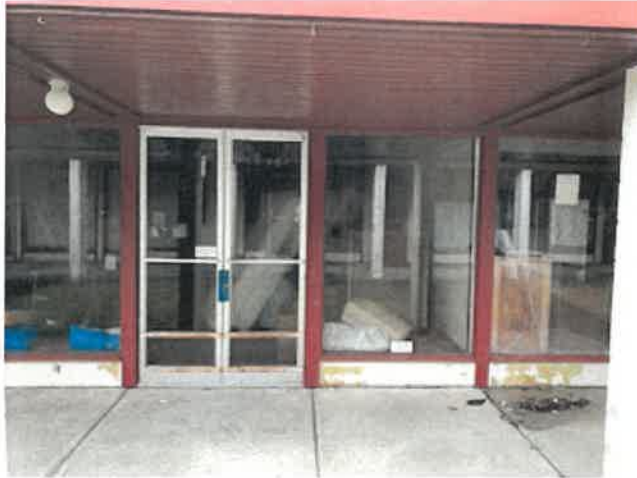
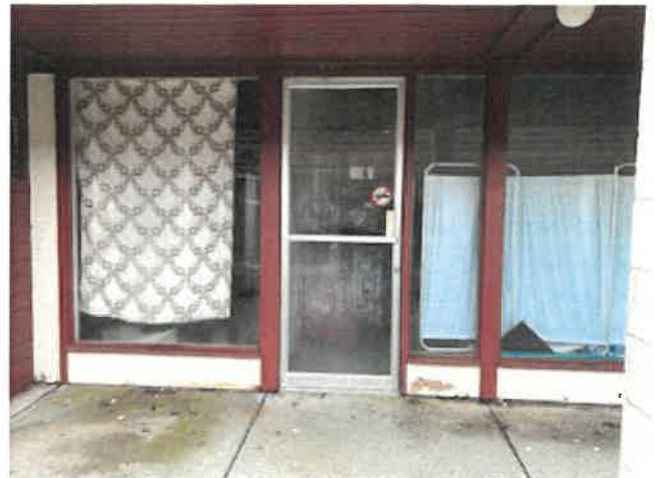
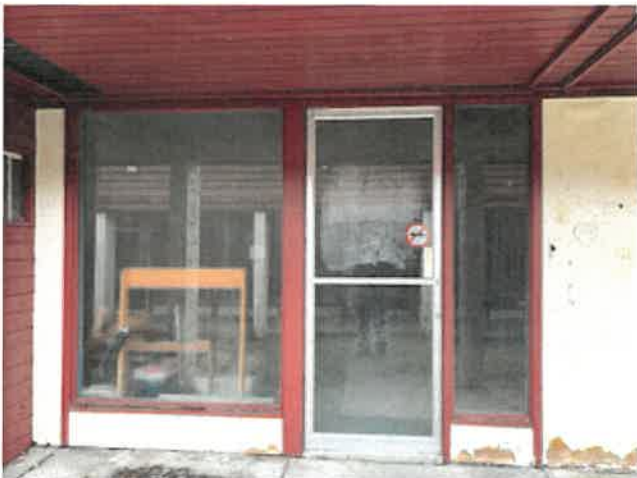
A short video that was taken encompass the length of the C side (which is include with this report on a memory stick). Of note the entire side is covered by an overhead cover which has spared direct contact from the element to some extent. While the cement support pillars appear to be intact, there is rot along the bottom edges of the store front windows that can be seen, roof shows significant signs of rot along the fascia and roof. Roof is believed to be asphalt with metal trim. Roof appears to be in poor shape, indications of leaking visible and may have compromised the structure (a structural engineer will required evaluate to confirm this assumption).

Also noted in the video, show signs of the drywall from the roof that has fallen along with mold that is staining the windows

Ceiling exposed in the interior of unit 4. Mold was visible on the interior from the exterior and musty odour noted while taking photos.

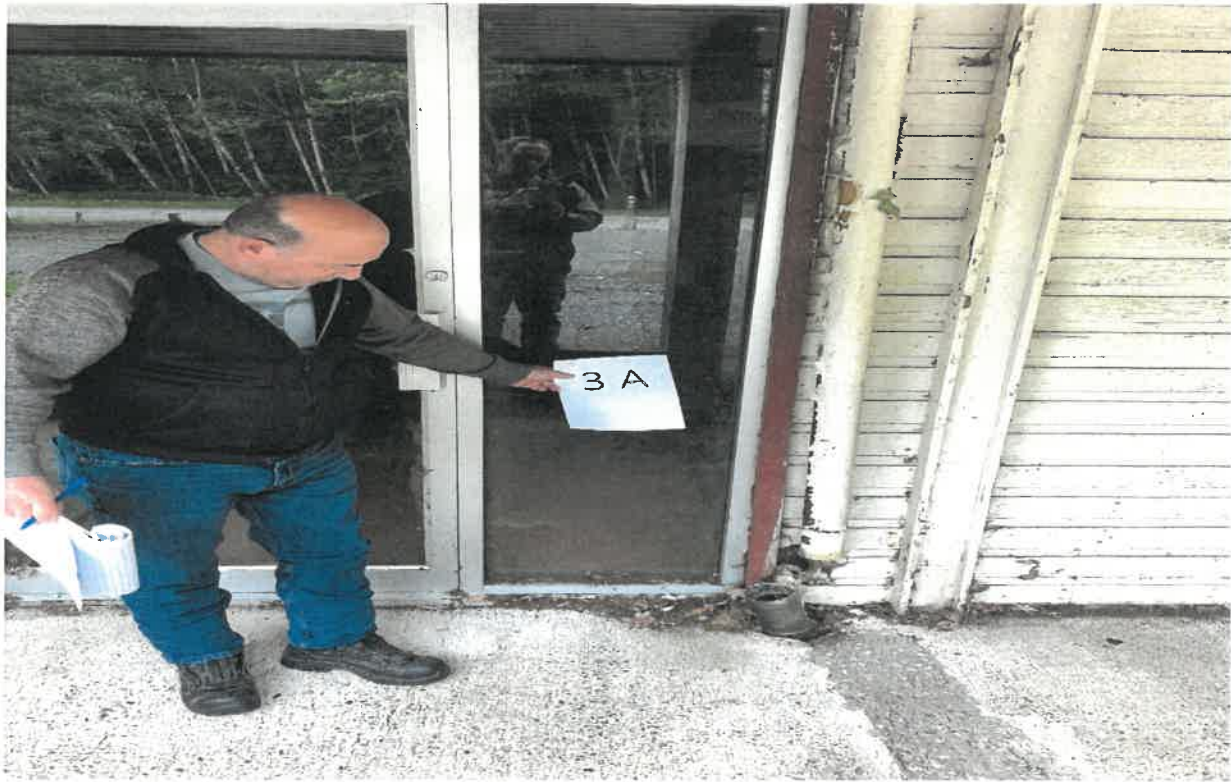
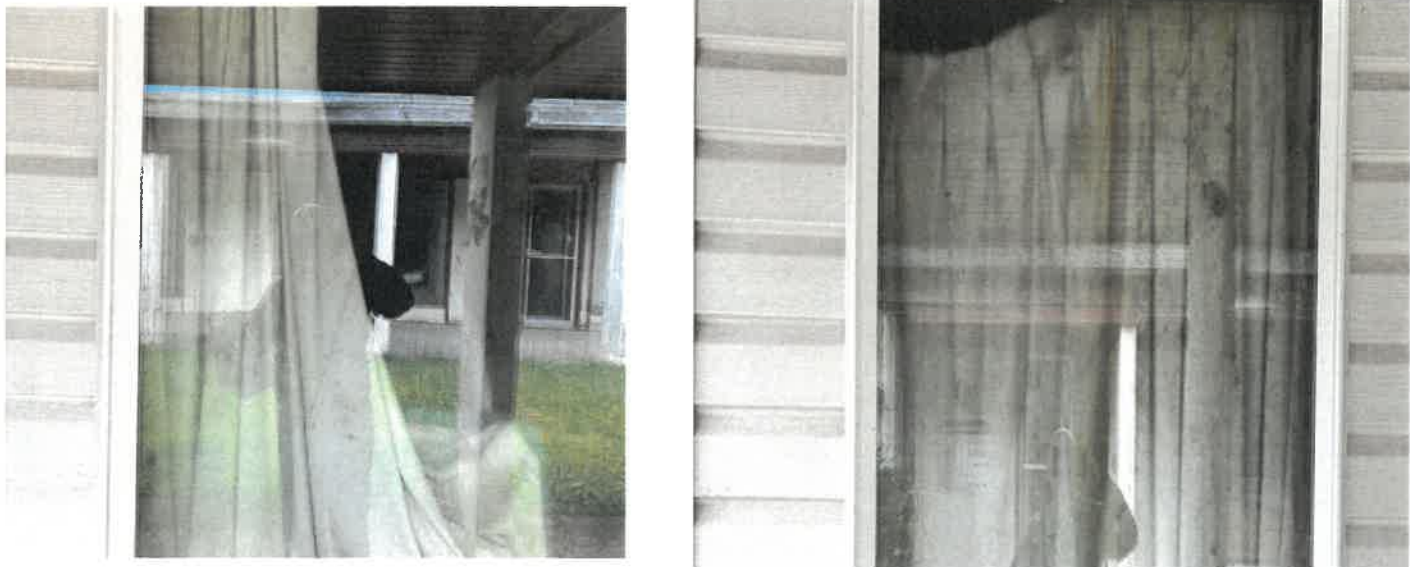
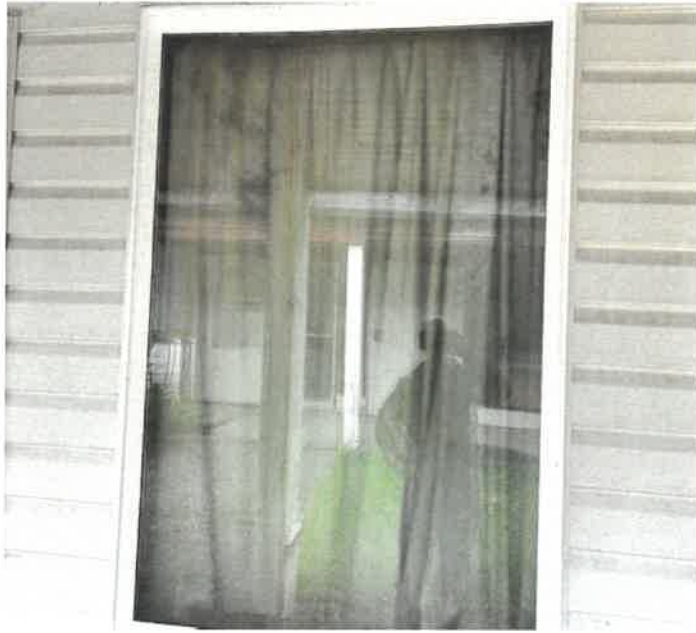
While the A side of the building is partially protected from the elements under the covered area and seem in relatively good condition at ground level at first glance. Closer look revealed that the plywood around the store front had numerous holes, rot along the wall in various areas peeling paint along with heavy

mold staining was observed on the interior curtains and windows. Vinyl siding by the A/B wall is in relatively good shape but could also be hiding further rot.

Above the flat roof that has protected the store front the roof section is open and exposed to the elements and is believed to be heavily rotted. Numerous penetrations were observed in the walls that were most likely for utilities (see video attached to report). The cover area flat roof appears to have leaks that has water to pass through, dampness underneath the covered area on concrete suggest this leaking.

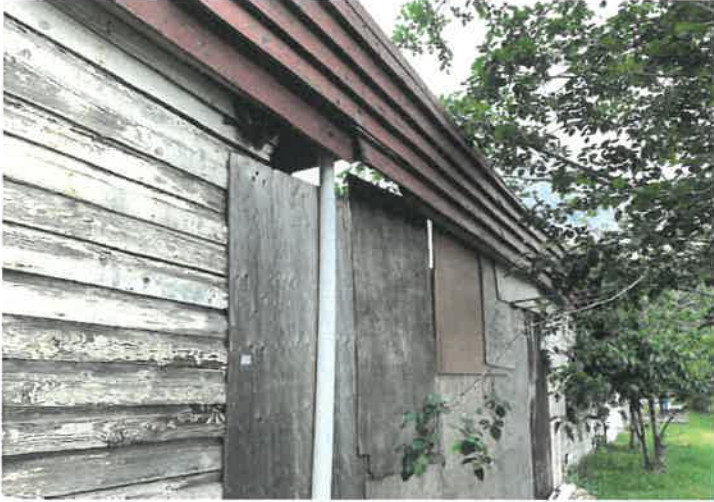
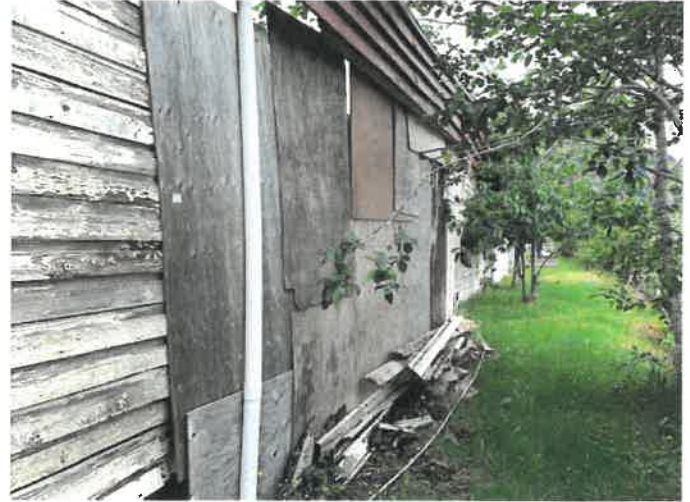
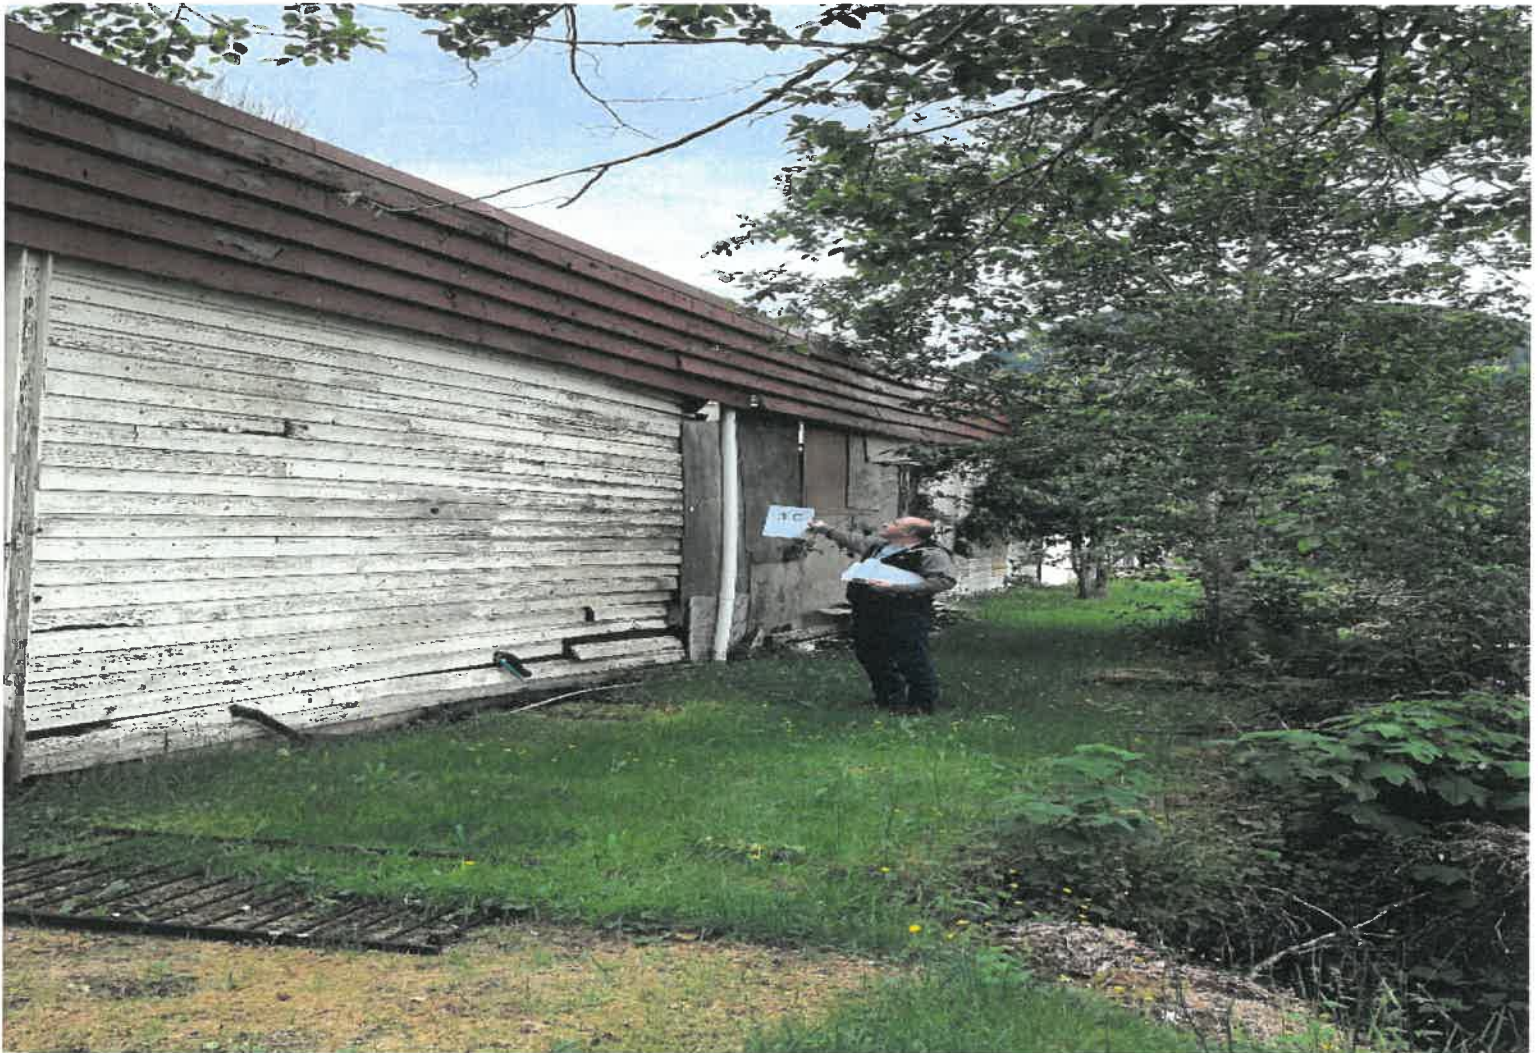
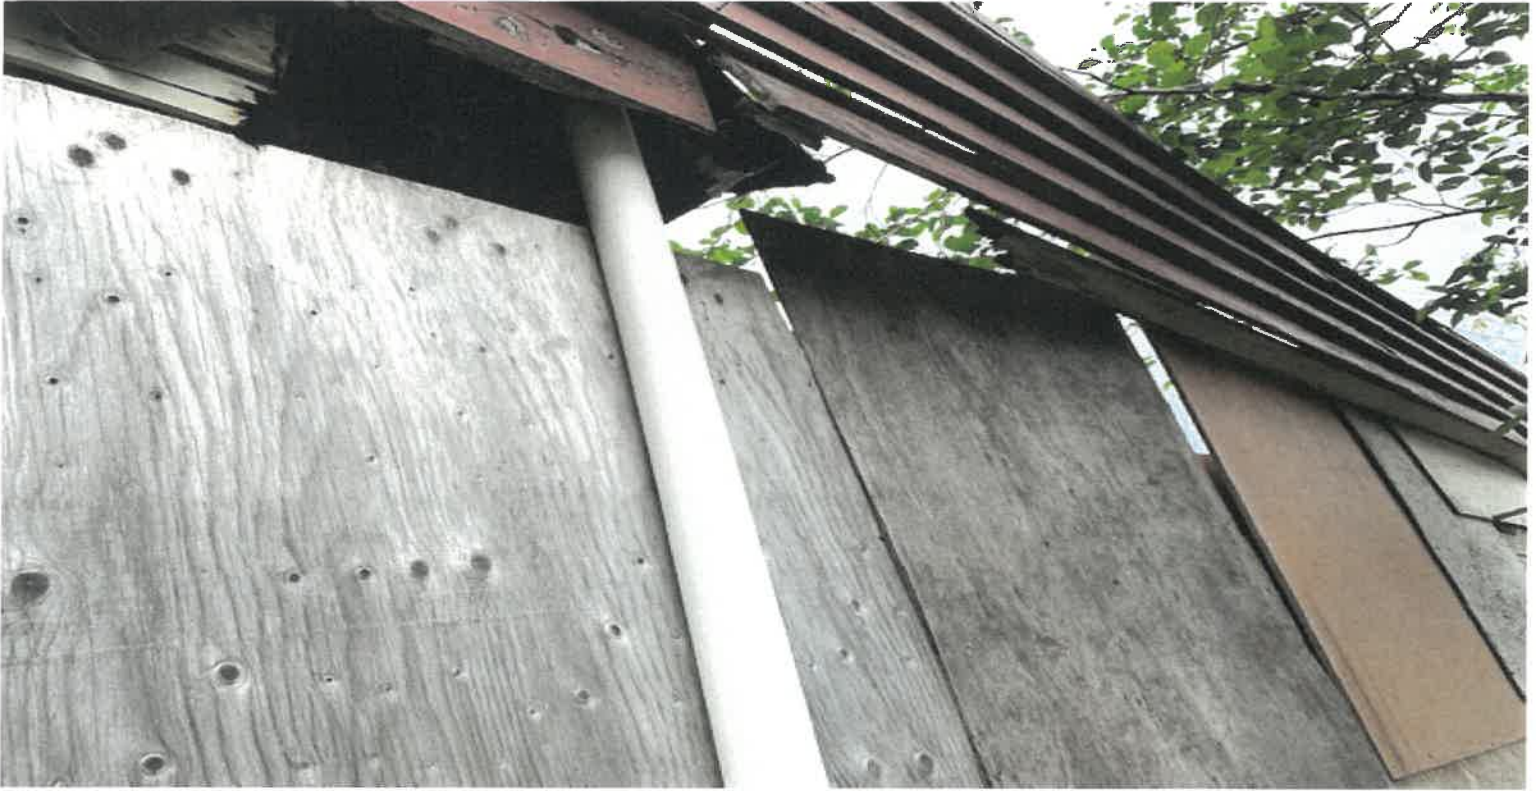
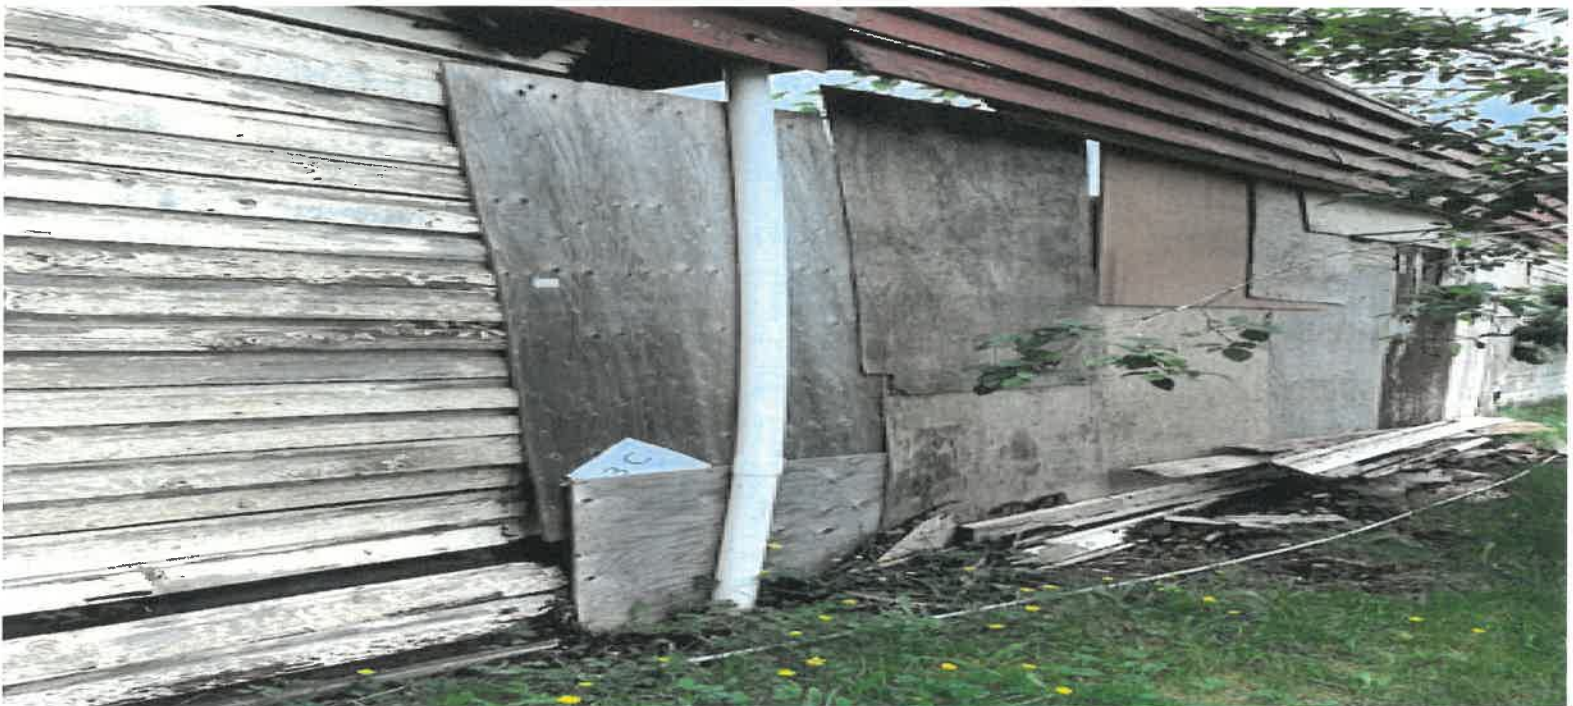
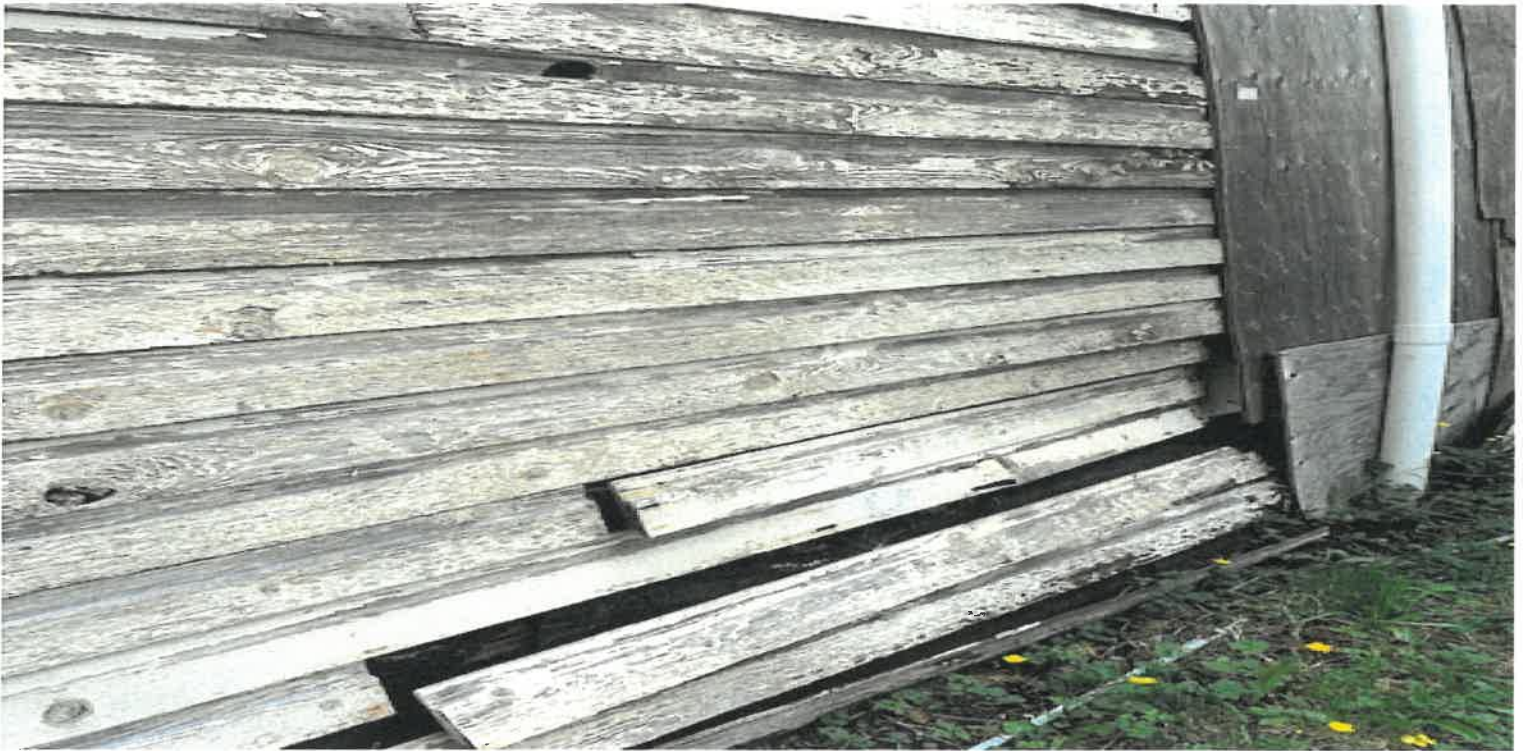
Access from the B side of the building was hampered by a fence that blocked the concrete walkway and overgrown vegetation. Review was then started from the D side of building walking towards the B side of the building. Right away it was noted that this wall is at the point of further collapse due to the siding pulling off and facial board boding outward, heavily rotted along the entire length. Note in the photos below towards the center of the building daylight can be seen in the interior of the building where the roof has collapsed. Currently wall is still standing, numerous sheets of plywood have been attached to the structure to try and re-enforce the wall. Structural Engineer should evaluate. Geotech Engineer should also be engaged to evaluate the location, due to the undermining of the foreshore and the location of the foundation in relation to the foreshore.

Video of this is available on the memory stick attached (img_293 and img_295). Video of roof collapse in the center section, rafters appear to be sliding into the center of structure. Of note in this (img_295) video a tree has grown in the interior of the structure above the roof line, the age of this tree would be a good indicator as to when the collapse occurred
