VILLAGE OF TAHSIS

Report to Council

Re: Hearing by Council to determine whether one or more buildings located at civic address 1400 S. Maquinna Drive should be declared a nuisance under Part 3, Division 12 of the *Community Charter* and whether to impose a remedial action on the property owner (the “**Hearing**”).

The follow observations were noted during exterior building inspection that was conducted on June 17, 2021, at 1400 South Maquinna Drive between the hours of 11:30 and 14:00hrs. The inspection was done by Strathcona Regional District Building Official Karl Neufeld and Strathcona Regional District Bylaw Compliance Officer Enzo Calla.

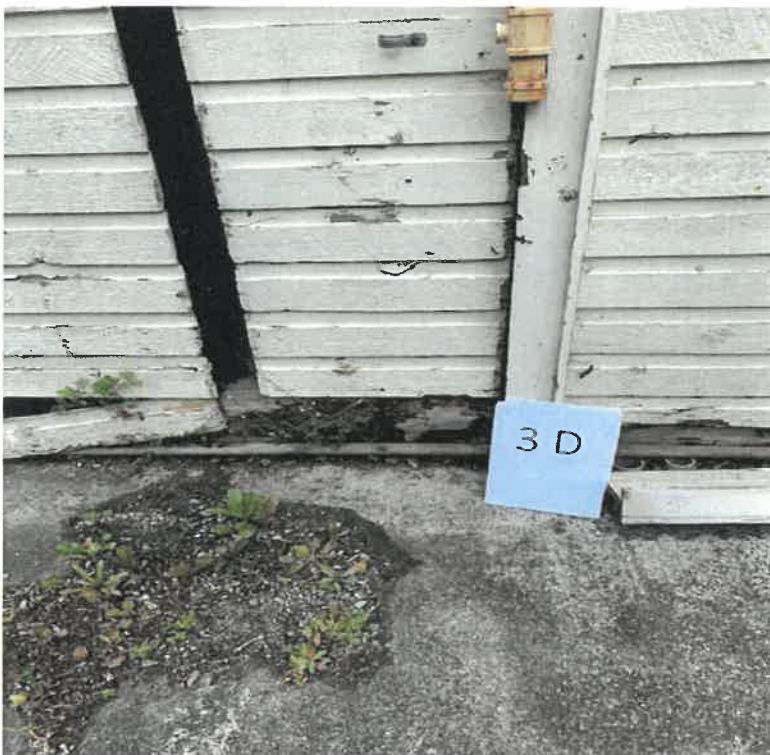
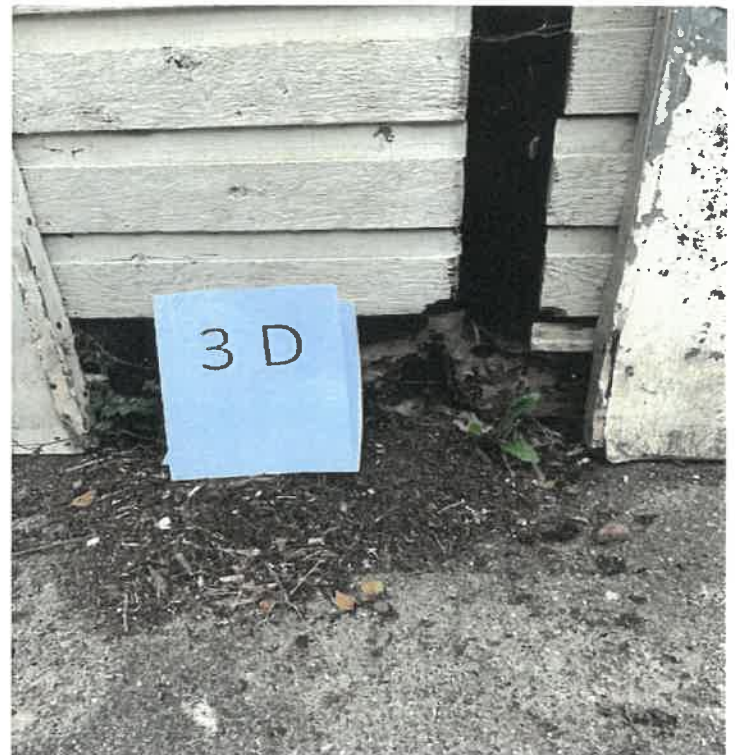
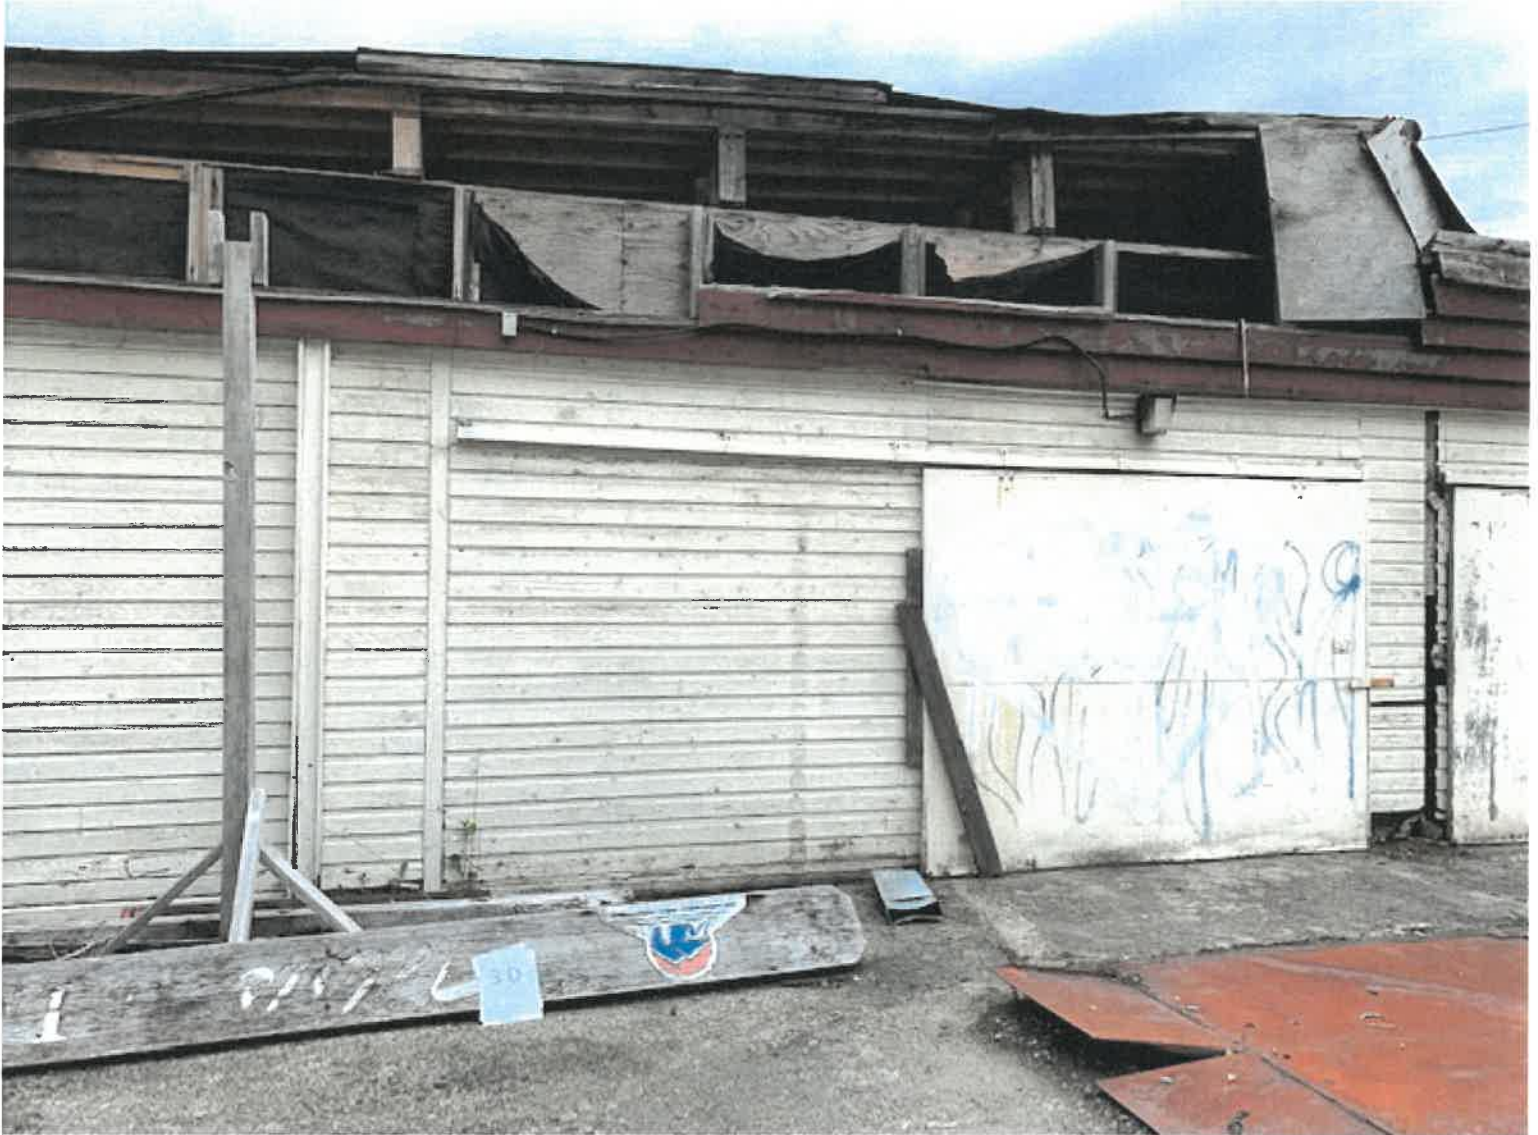
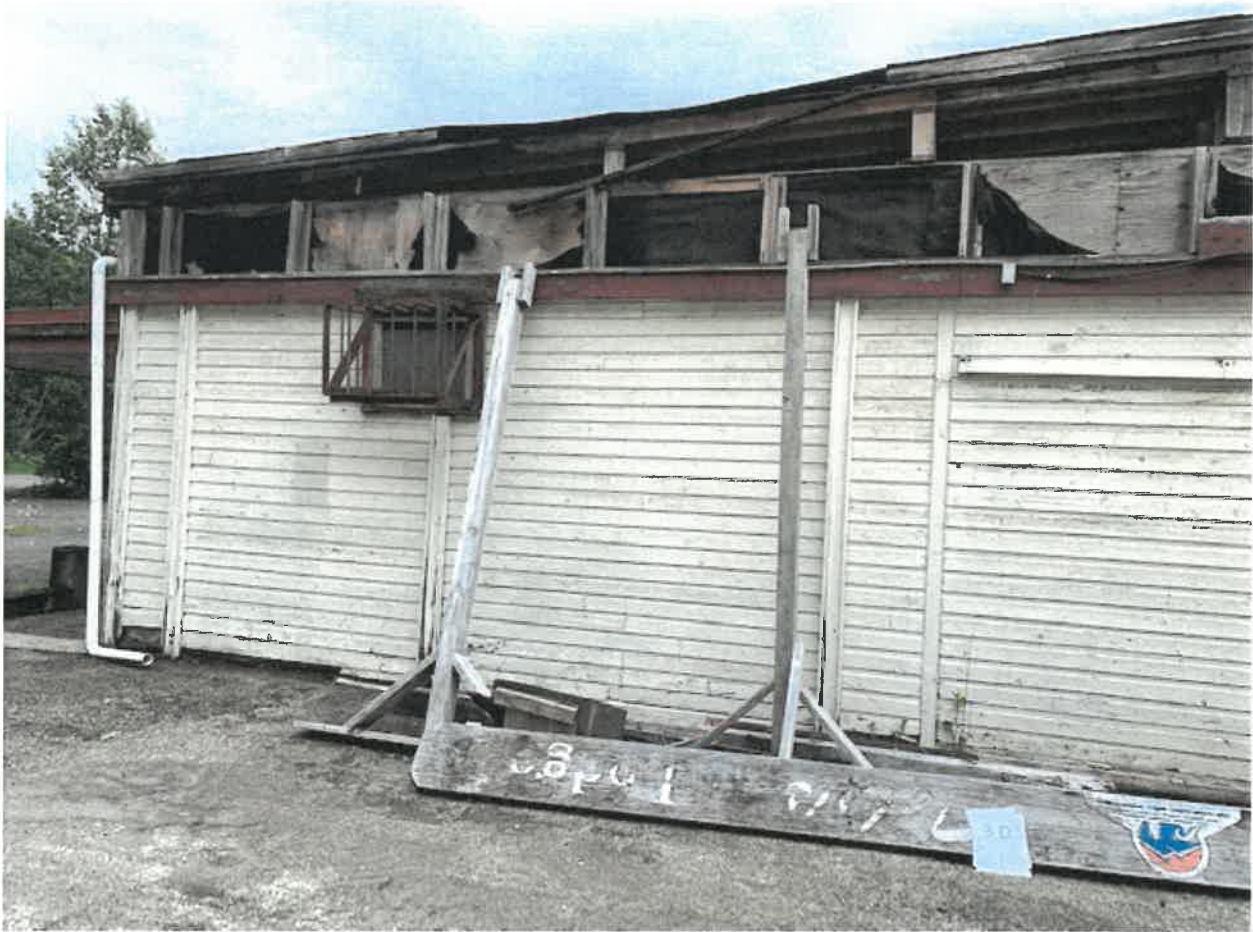
Starting With the C/D corner of wall D working towards the A side of the wall is in complete disrepair as is heavily rotted throughout. Judging by the bigger rotting timbers in the center section, this appears to

be a structural or load bearing (this will need to be confirmed by structural engineer as no building plans were available during inspection). Roof section, attic space open from one end to the other and is directly exposed to the elements. (video showing this is img_297 on attached memory stick).

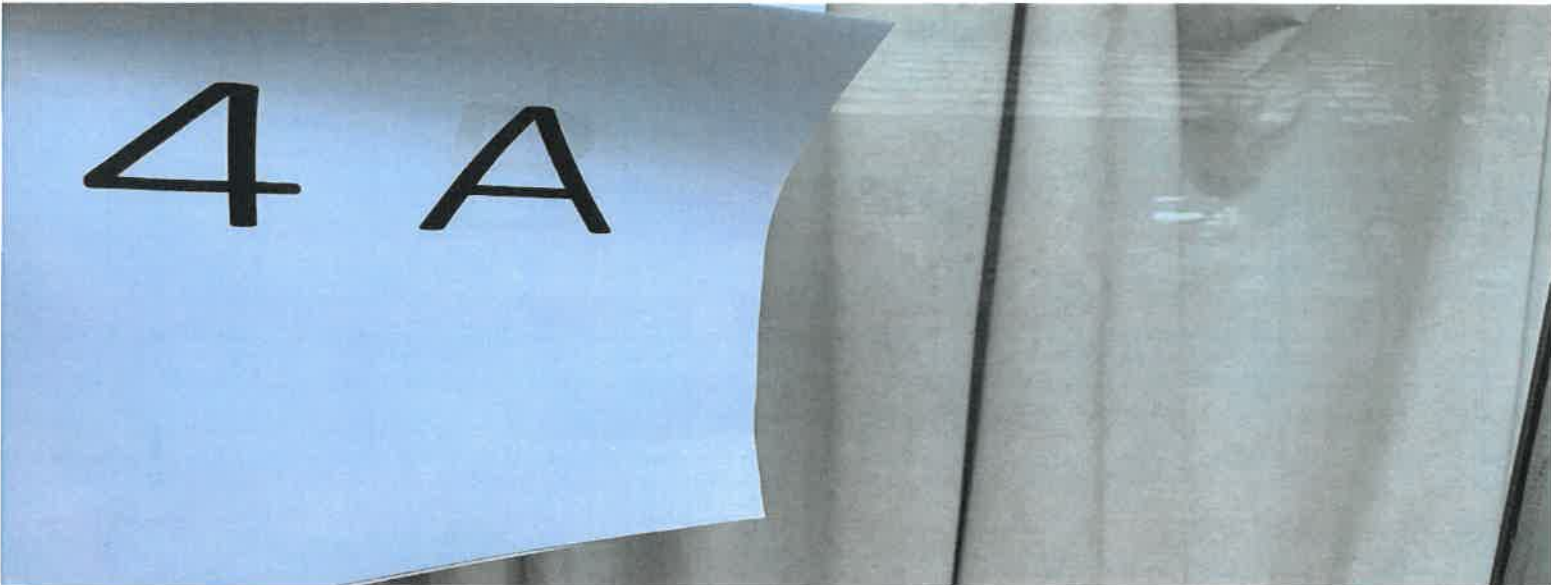
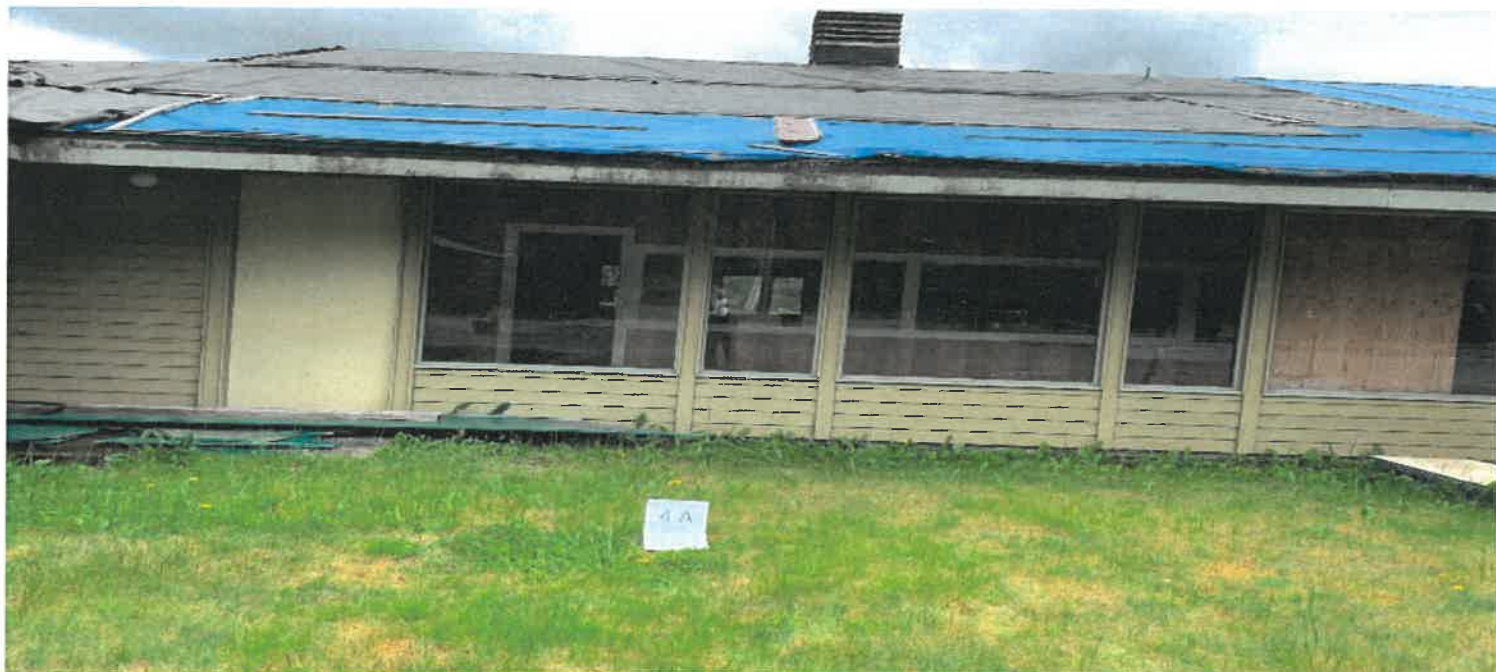
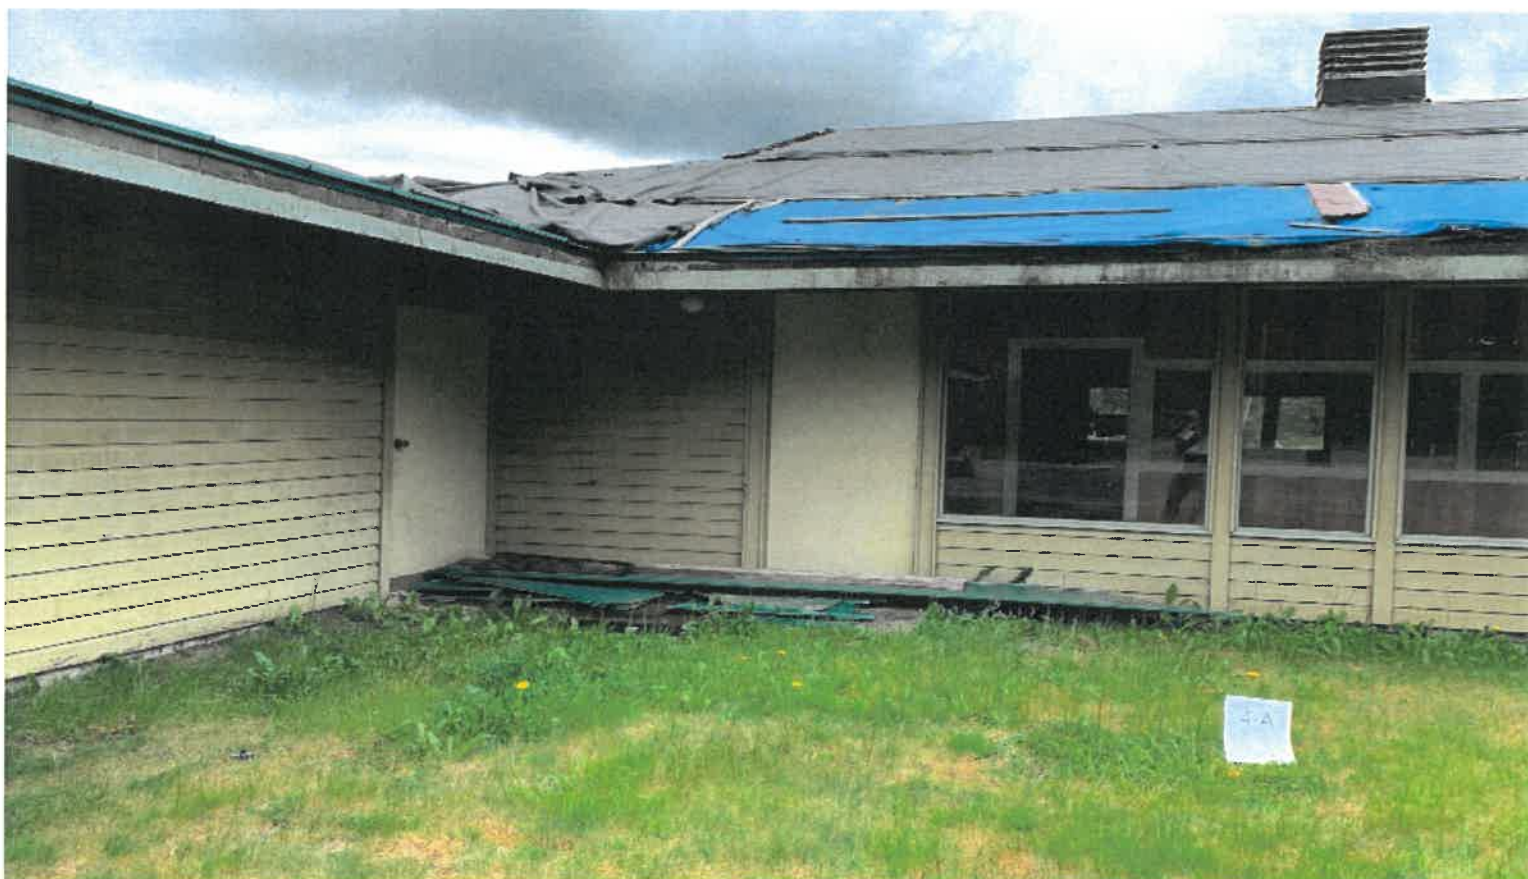
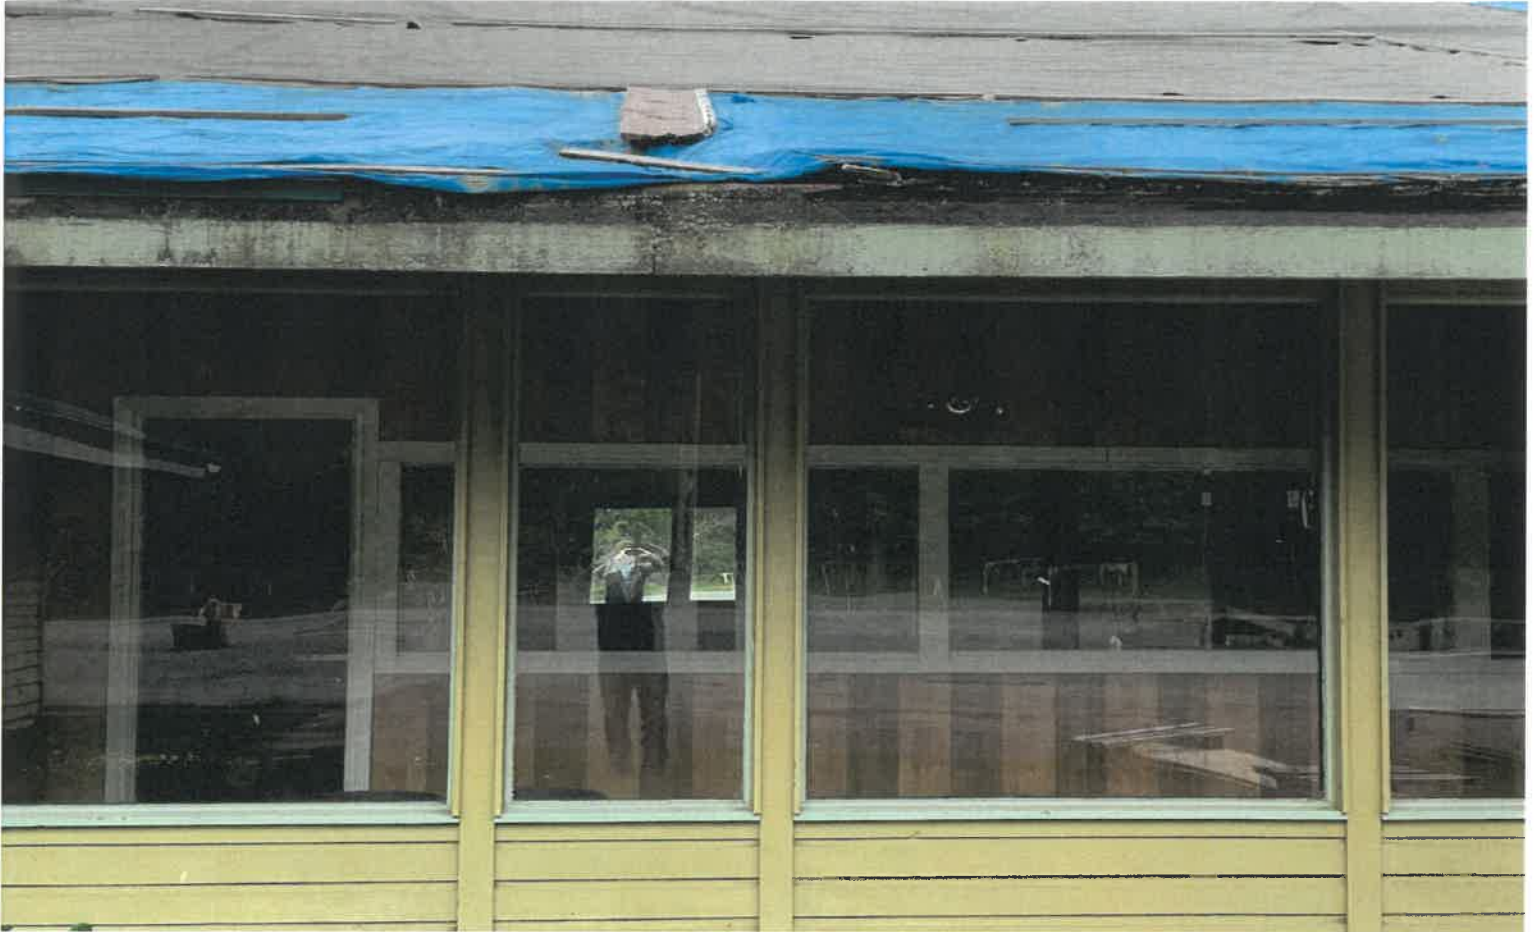
It is noted that the maintenance on this building appeared to be more current then was seen on building two and three.

Starting on the A side and looking down the length of the building. The hotel room section/wing of the

hotel is a two-story structure, with the center section of the roof above the lobby /restaurant area being covered with tarps. While the above image shows rot at the edge of the roof, it would be a speculation as to the condition of the rest of the roof. Overgrown vegetation curtains being drawn hampered ability

to see into the windows of the hotels rooms to assess interior, in the above photos in the interior curtain covered with mold spores and along the roof line. Of note the metal roof appears to be properly installed and intact on this wing of the building.

The center section is one story, the center section of the building by the front entrance/reception area building material has been left in place along the ground. As seen in the photos above the center section covered with tarps appears to be cedar shake under the tarps. Apart from the edge unable to ascertain the condition of the roof or whether old roof is still in place or has been removed and has been replaced. Please see video (img_300) on attached memory stick.

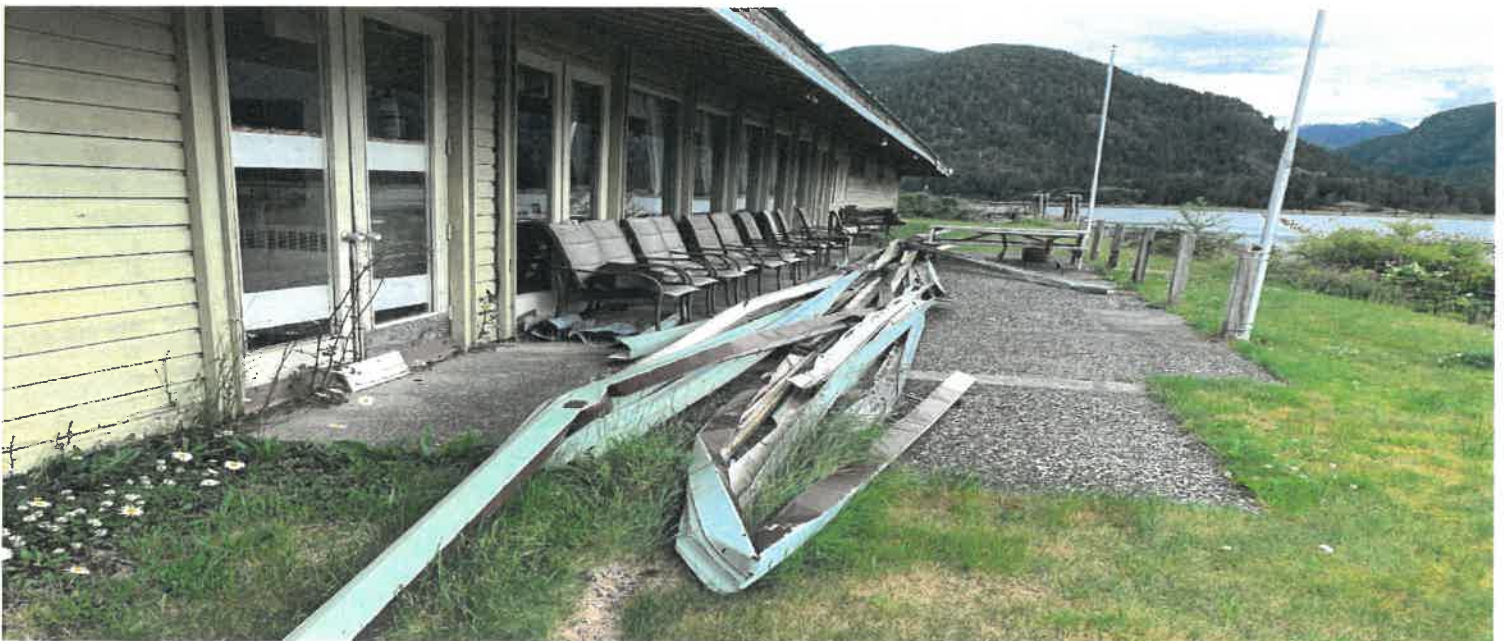
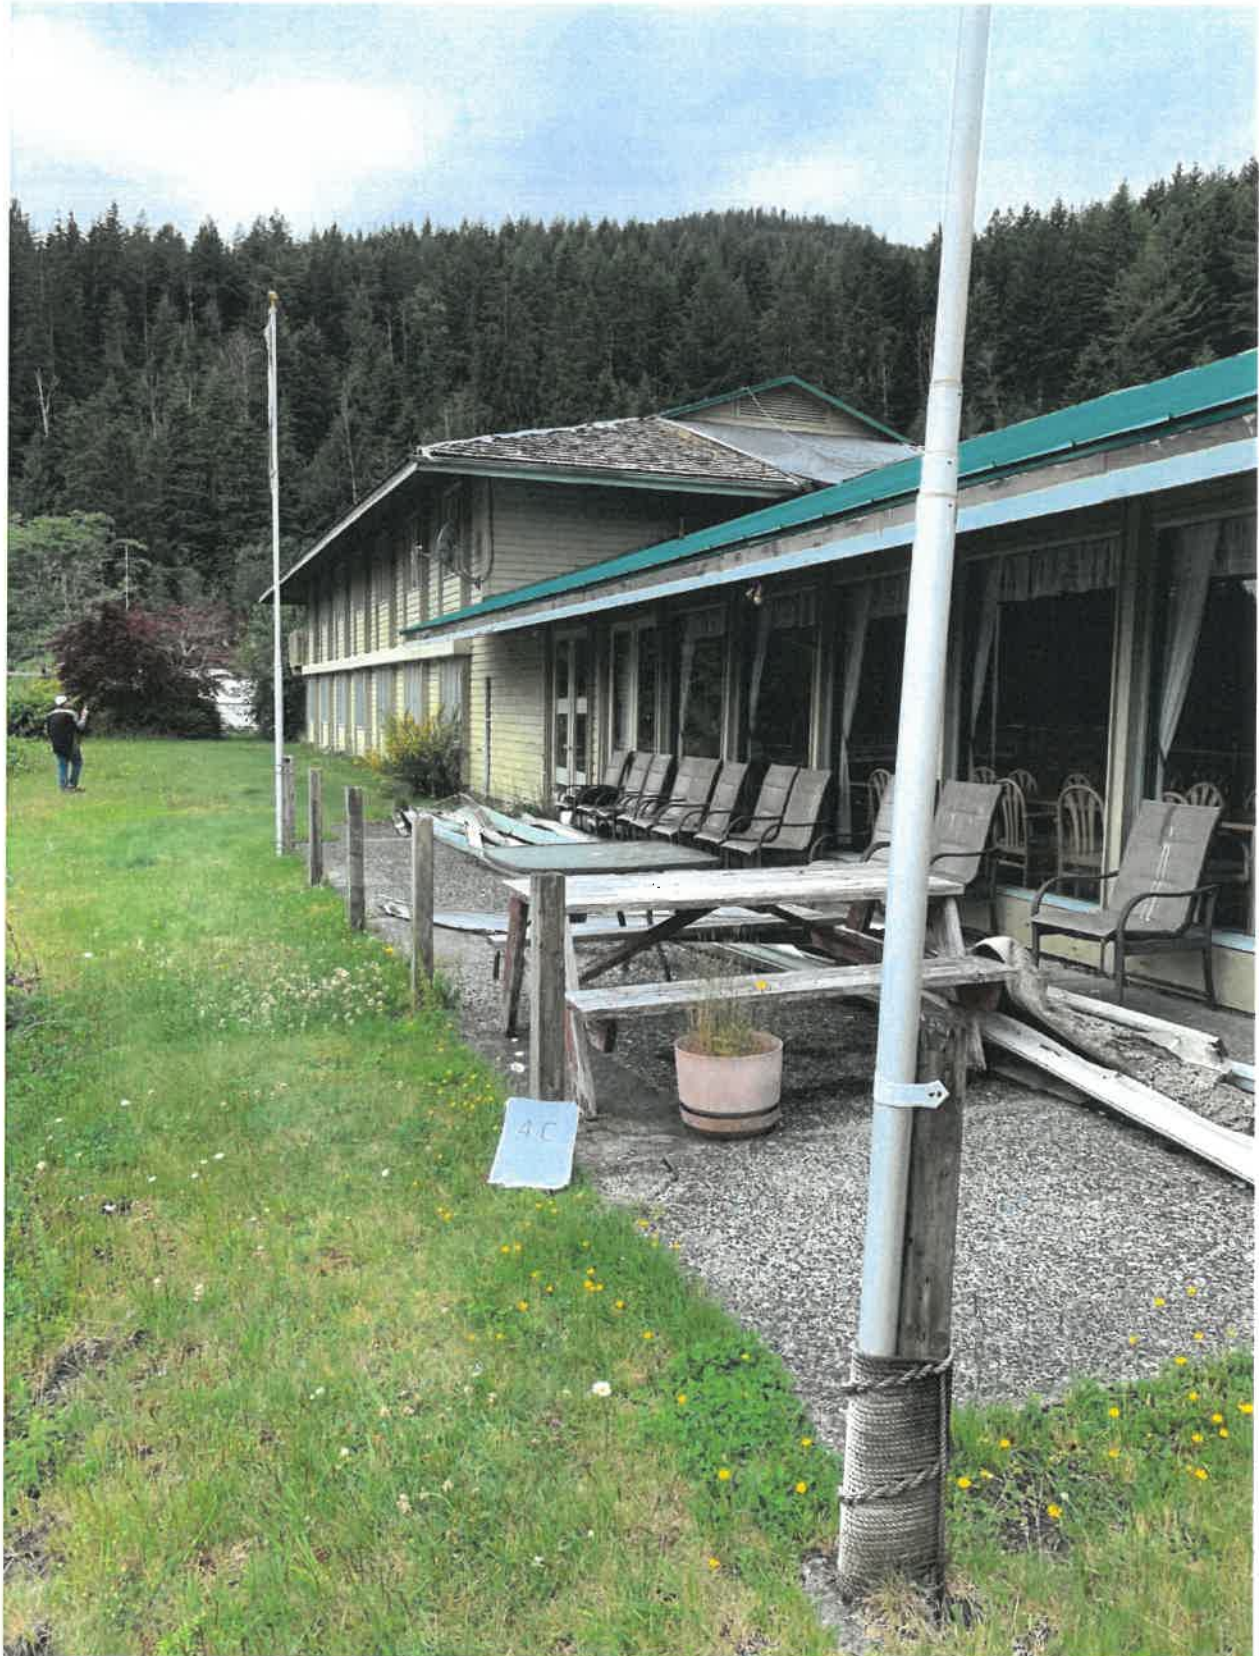
The C side of the building is the ocean side of the building. It is noted from this side there are tarps covering parts of the first floor and second floor. Part of the second-floor roof still cedar shake, it is assumed that cedar shake is also under the tarped area with the other section was replaced with metal. Due to the large overhangs, this building has fared better than buildings two and three. There was not much found on this side apart from a broken window, peeling /weathered paint and all the gutters and downspouts have been removed to place the metal roof on and never replaced. Mild deterioration noted on the middle wood band. At the C/D corner of the wall it is noted that the balcony is in poor condition

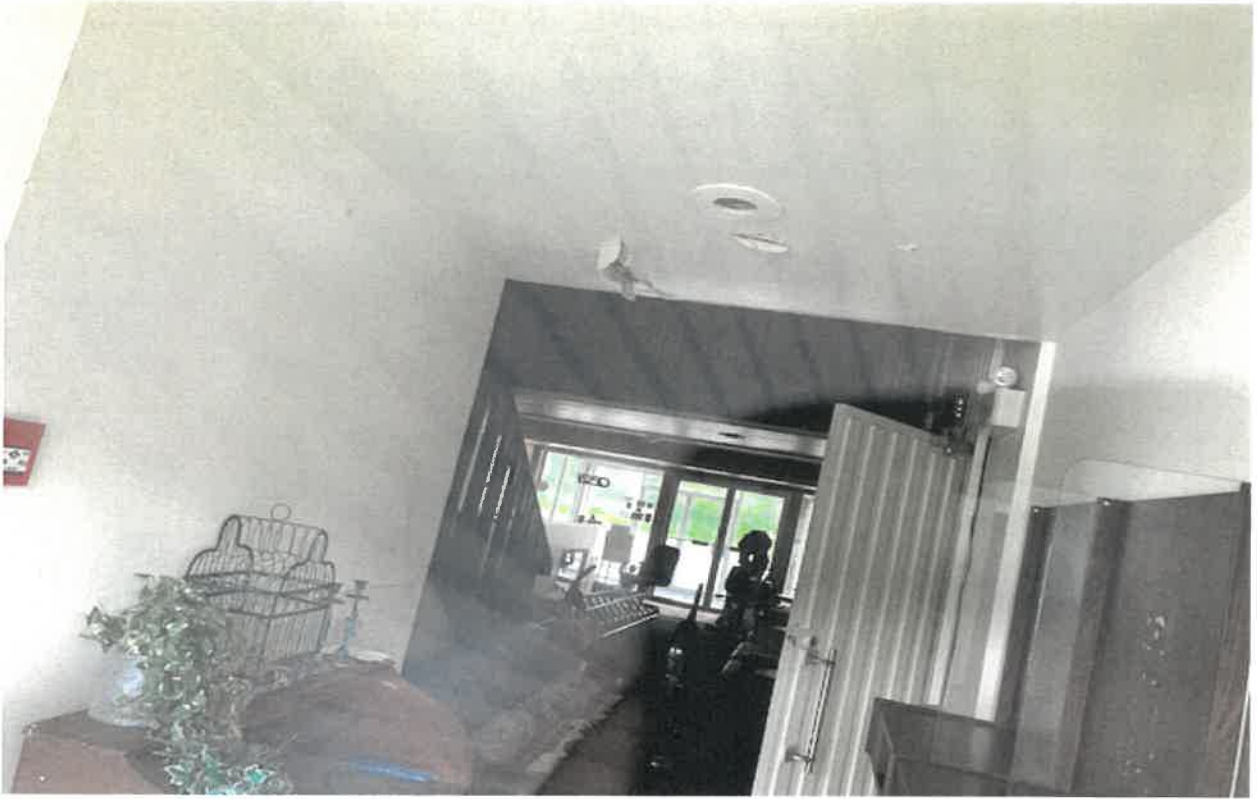
Note interior ceiling is cracked and falling. Unsure if this is related to water damage from tarps that are on the roof over this area

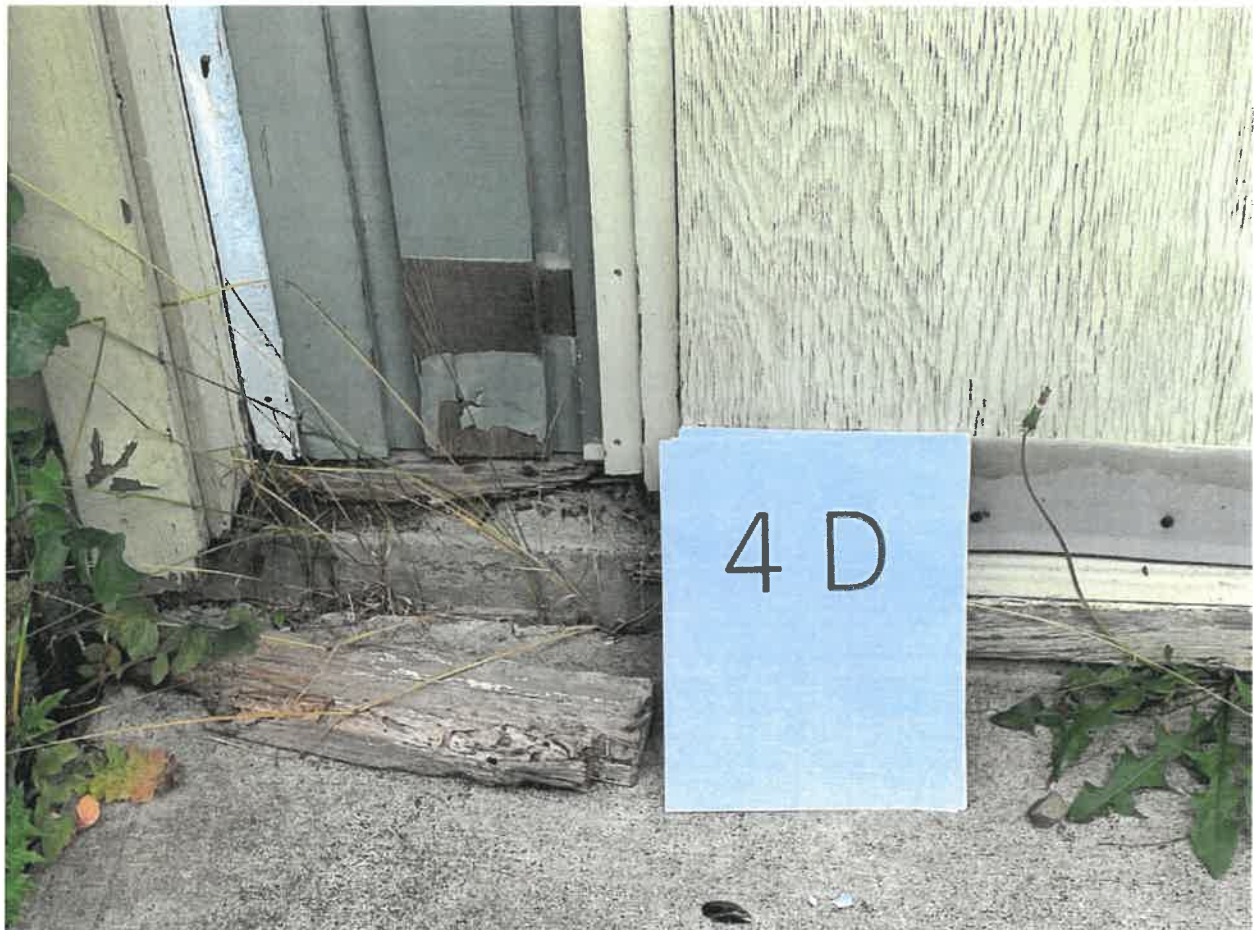
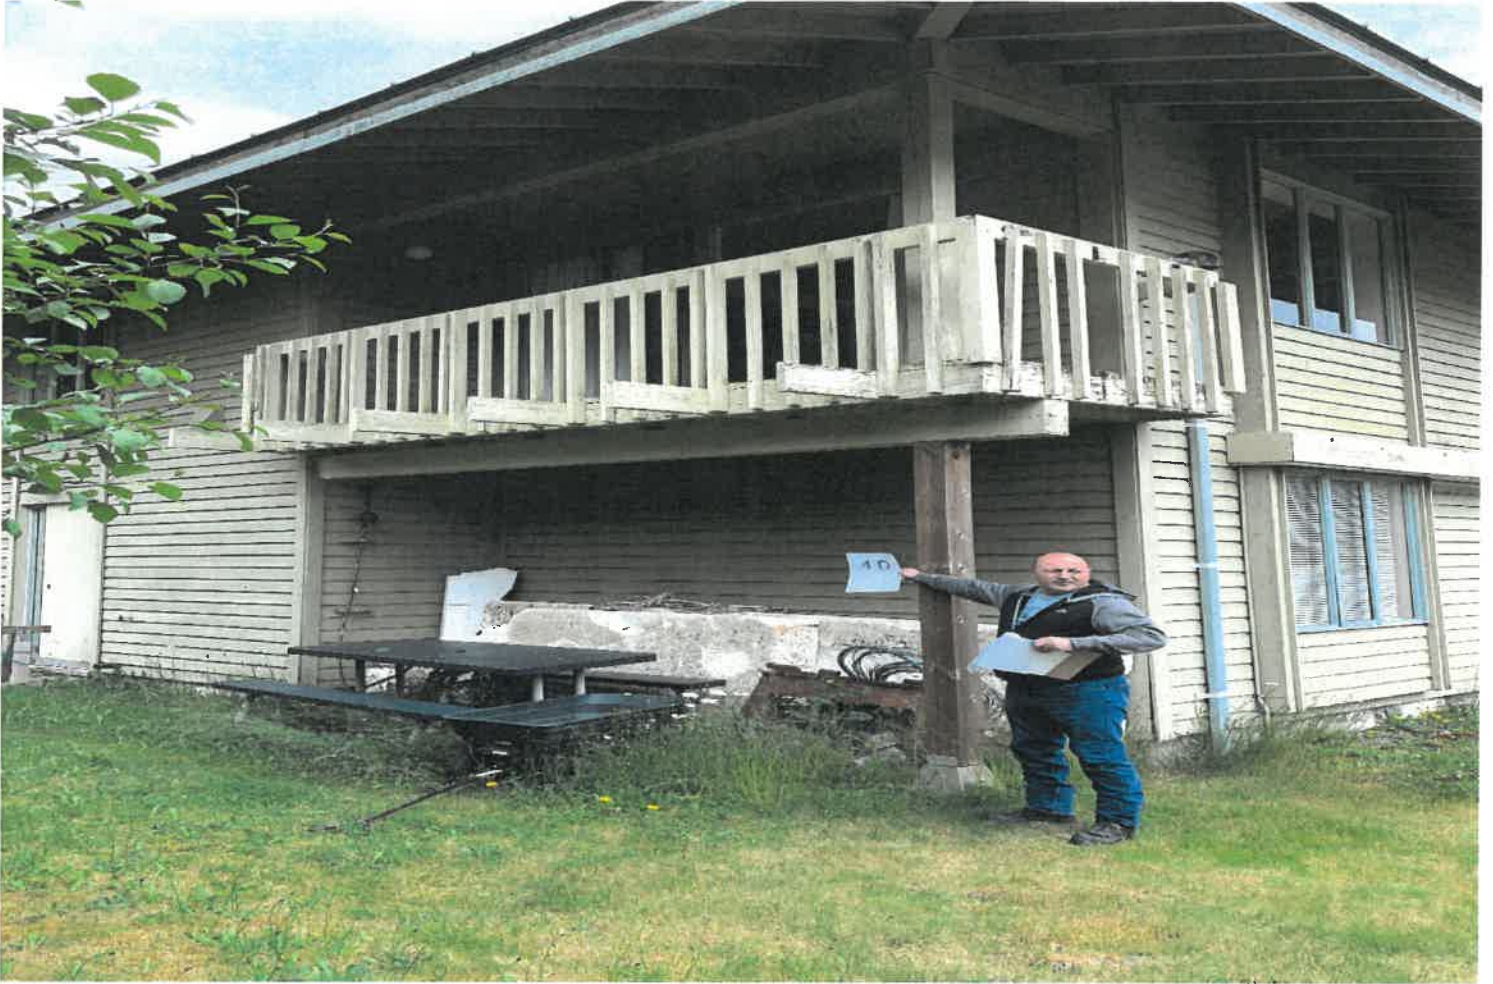
New metal roof completed on this side of the building (img_306). As noted from side C the deck pictured above is in poor condition, support post noted to have been replaced. Deterioration and rotting was observed along the bottom of the wall, by the exit door and by D/A corner.
