**Report to Council Re: Hearing by Council to reconsider its Remedial Action Requirement  
Order under Division 12 of Part 3 of the Community Charter pertaining to the buildings  
at the property located at the civic address 1400 South  
Maquinna Drive, Tahsis, BC (the "Property") and owned by 1031249 B.C.  
Ltd. (the "Owner")**

## Report to Council

Attachment 2      Inspection Report of 1400 S.  
Maquinna Drive  
January 20, 2022

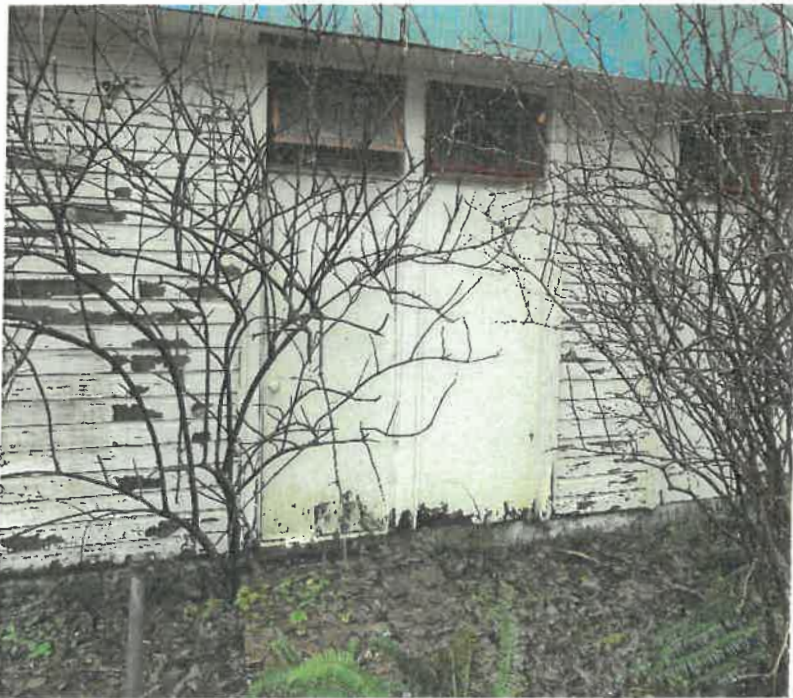
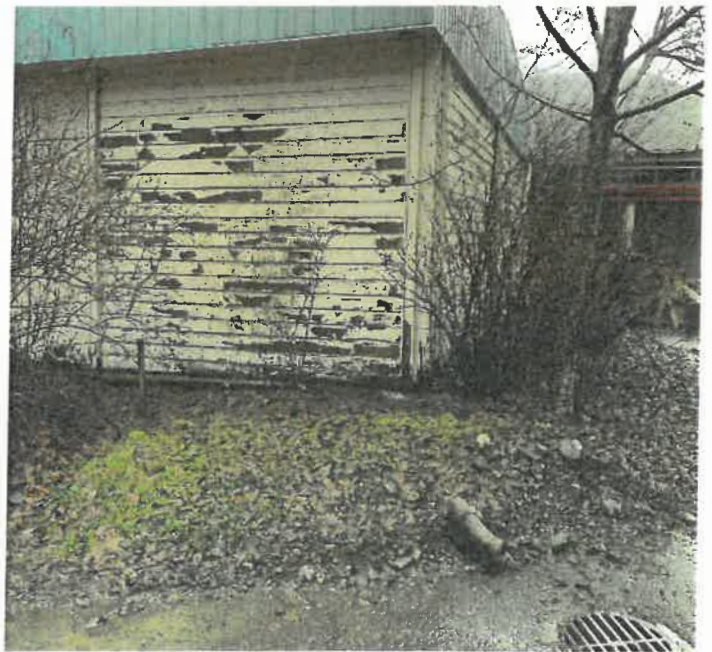
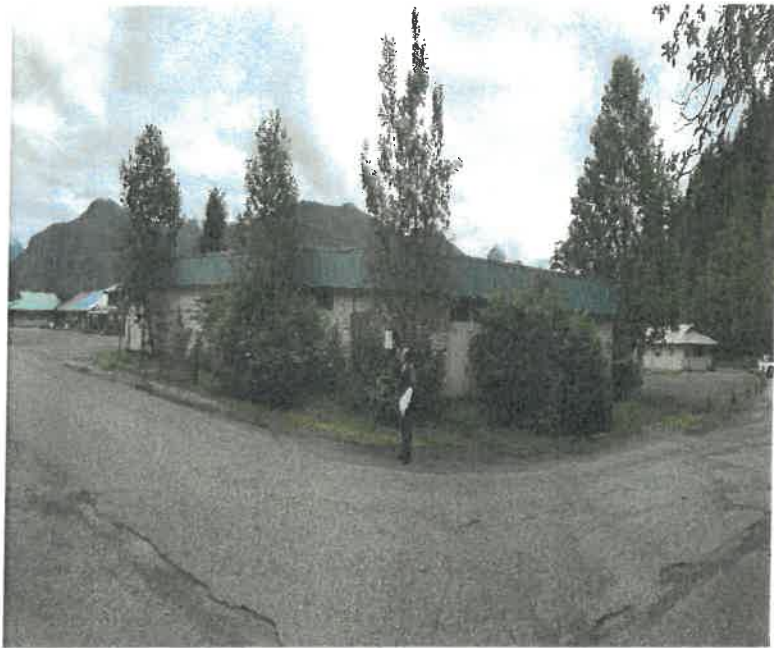
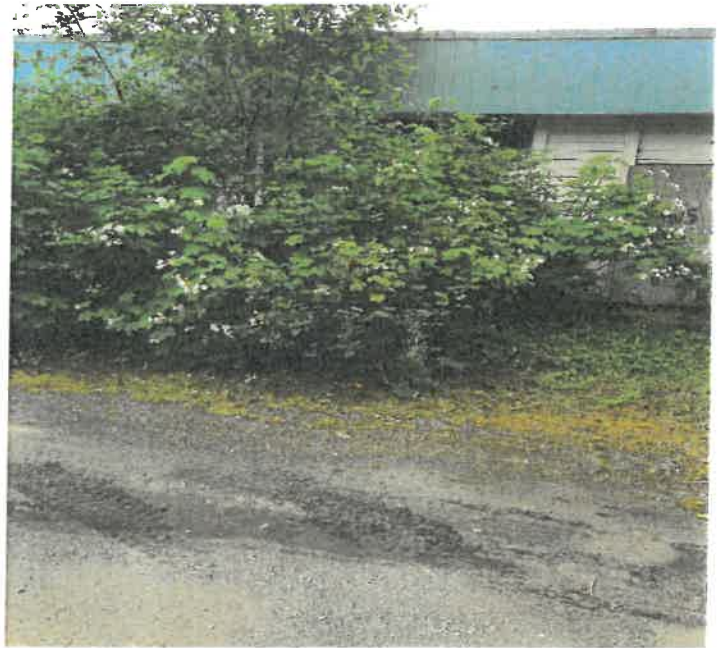
**BUILDING 2 SIDE A**

As seen in the photos above and below of Side A (Maquinna Drive,street side), there is no sign of any remediation done to the exterior of side A. The lack of vegetation shows the extent of dry rot at the base of the building 2 that was observed by inspectors and mentioned from the June 17,2021 inspection. Note the water pooling at the base of the building in the photo on the right.

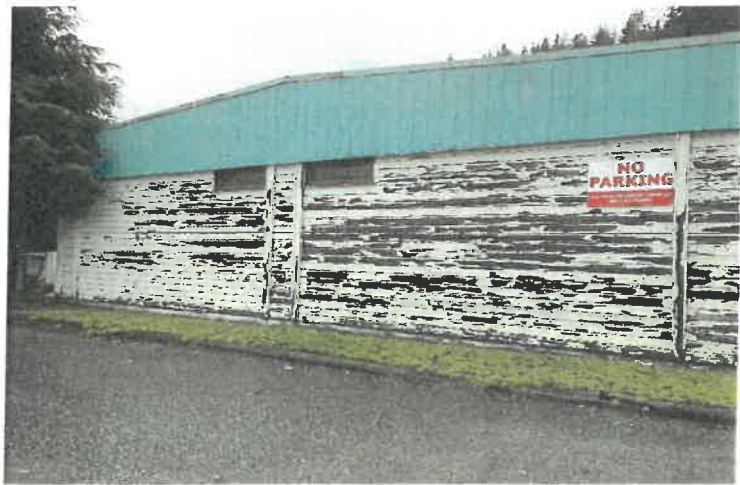
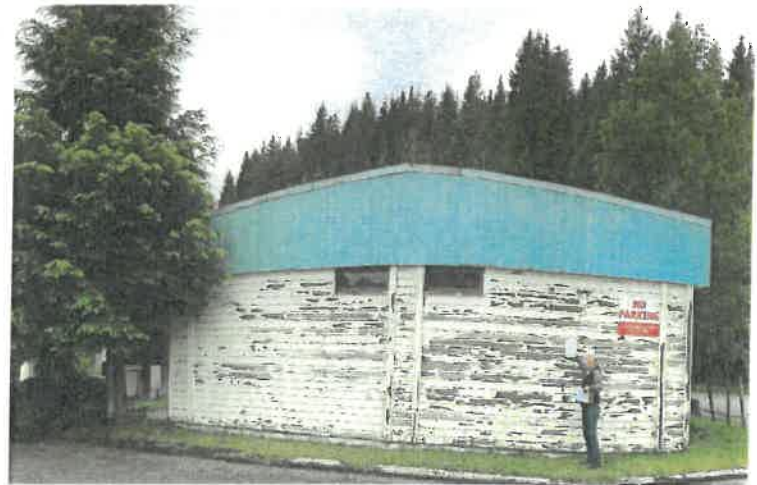
### **BUILDING 2 SIDE B**

With side B dry rot can be observed along the base of the building and the continued deterioration of the exterior wood where the paint has peeled away.

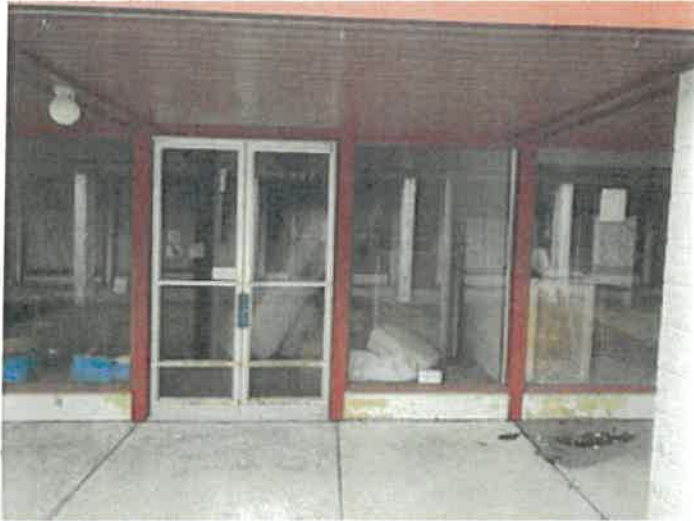
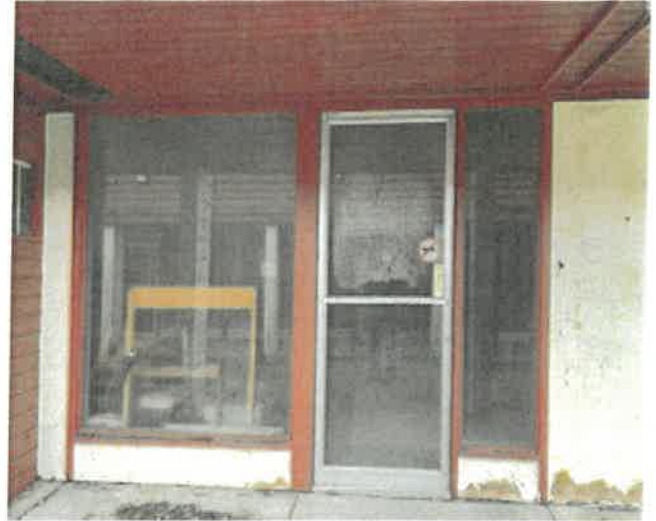
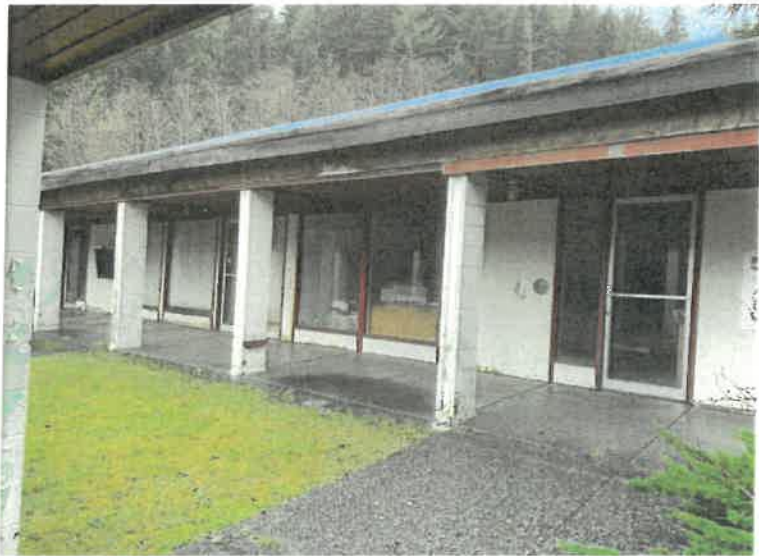
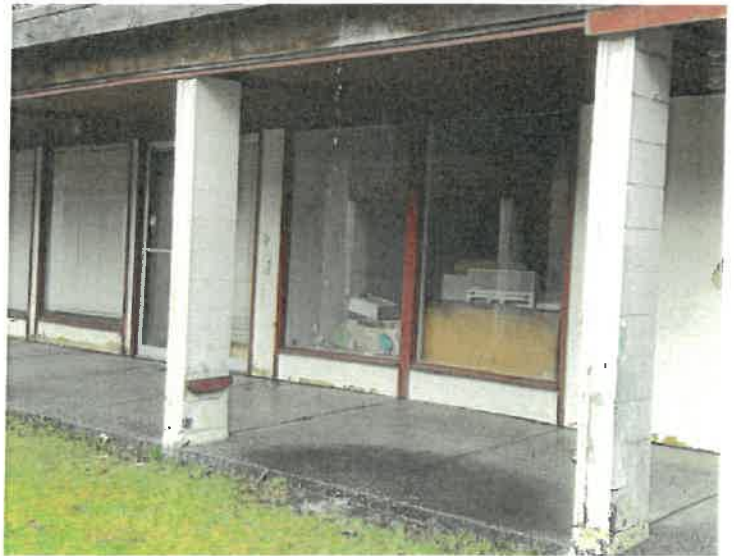
**BUILDING 2 SIDE C**

Photos taken above show the exterior of the building 2 side C there has been nothing been done. It was noted that there were some objects that were covered with tarps that were not present in the June 17, 2021, inspection. Roof appears to be in poor shape, indications of leaking visible and may have compromised the structure (a structural engineer will required evaluate to confirm this assumption).

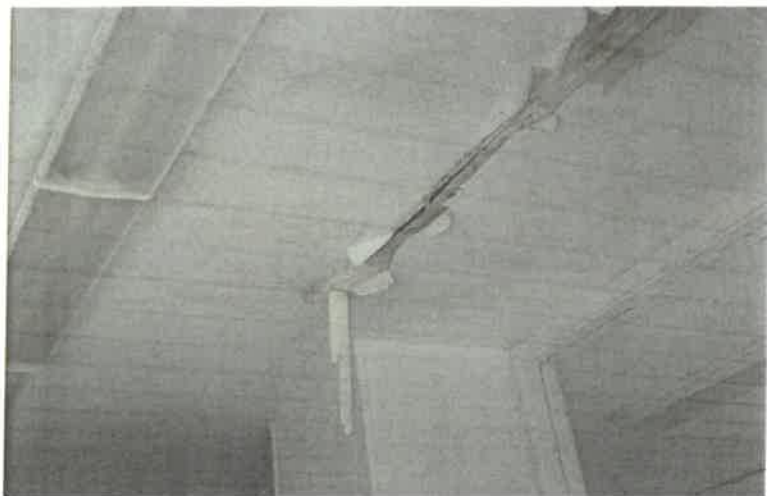
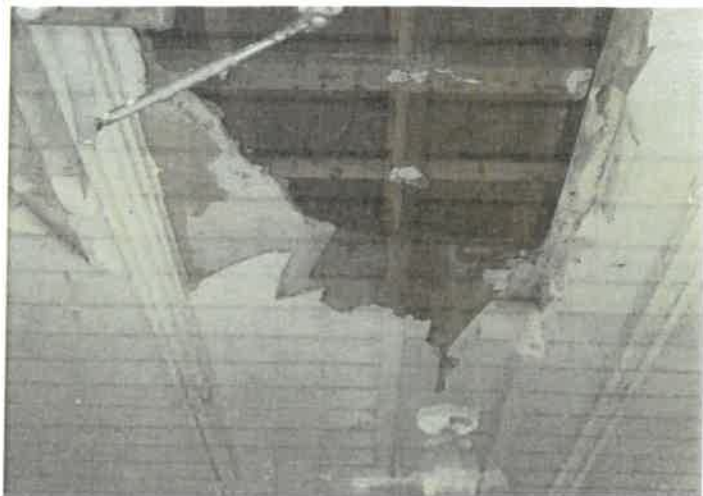
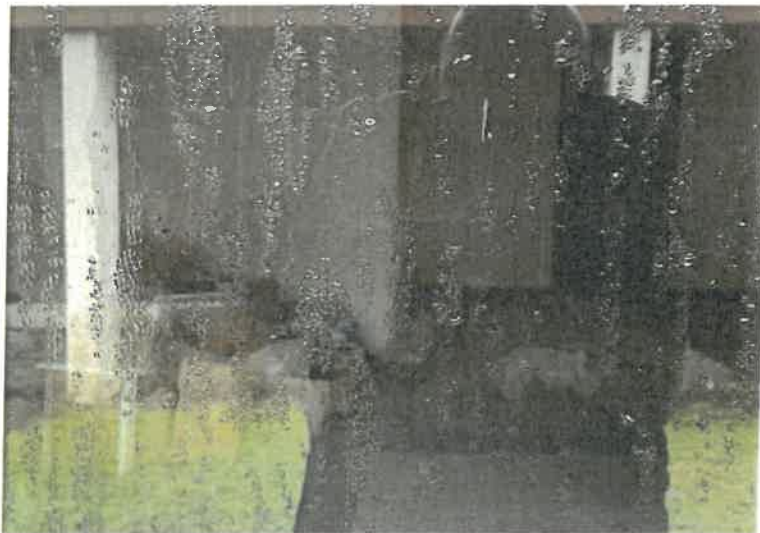
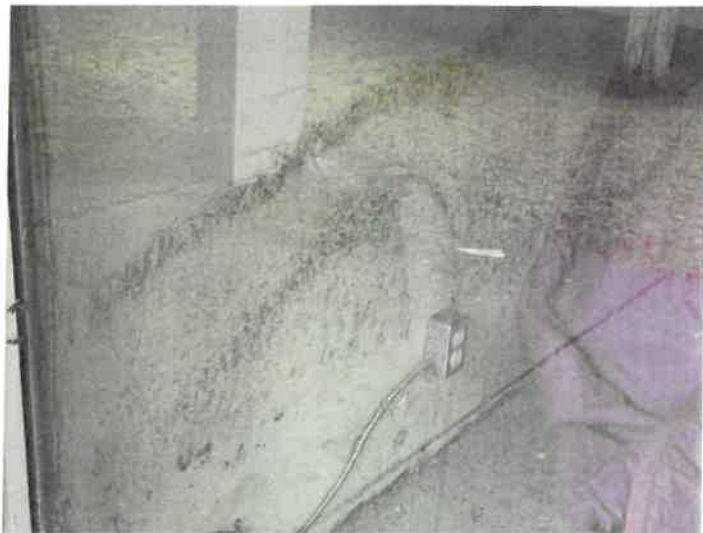
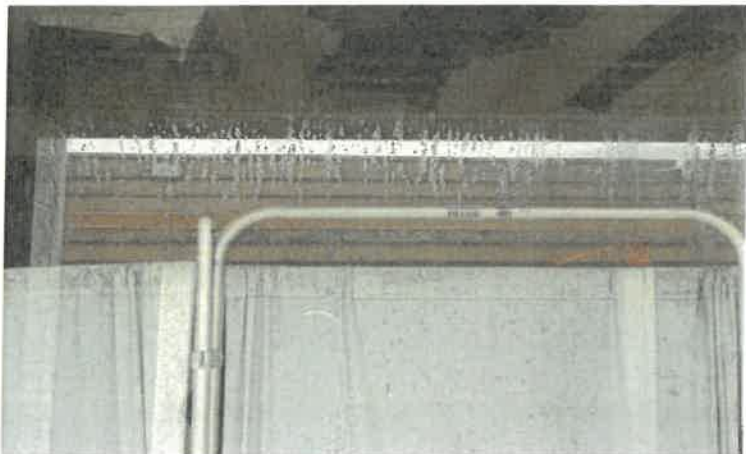
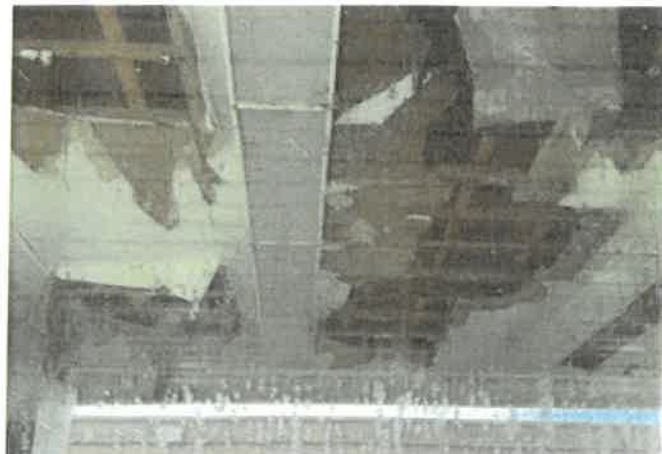
**BUILDING 2 SIDE C INTERIOR**

The photos below show the drywall from the roof that has fallen along with mold that is staining the windows and walls of the interior in all the units of Building 2.

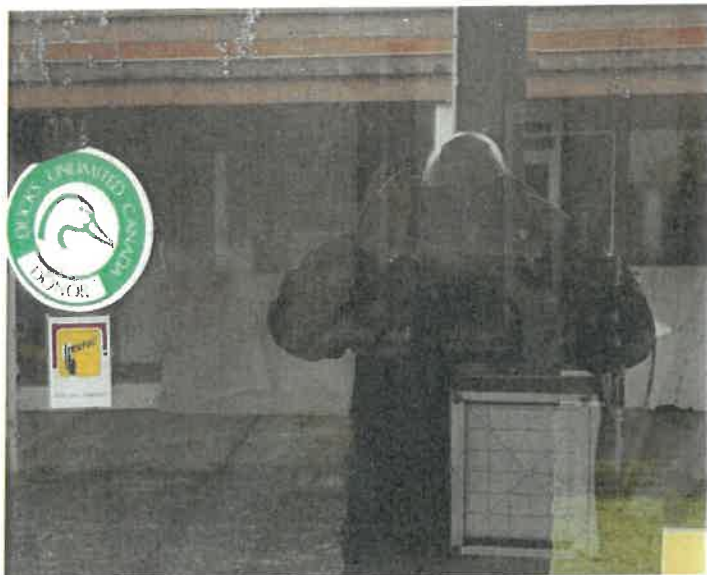
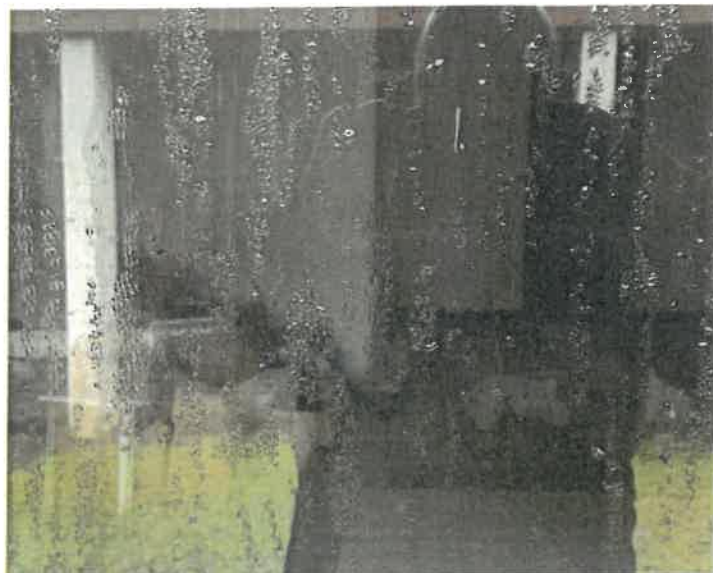
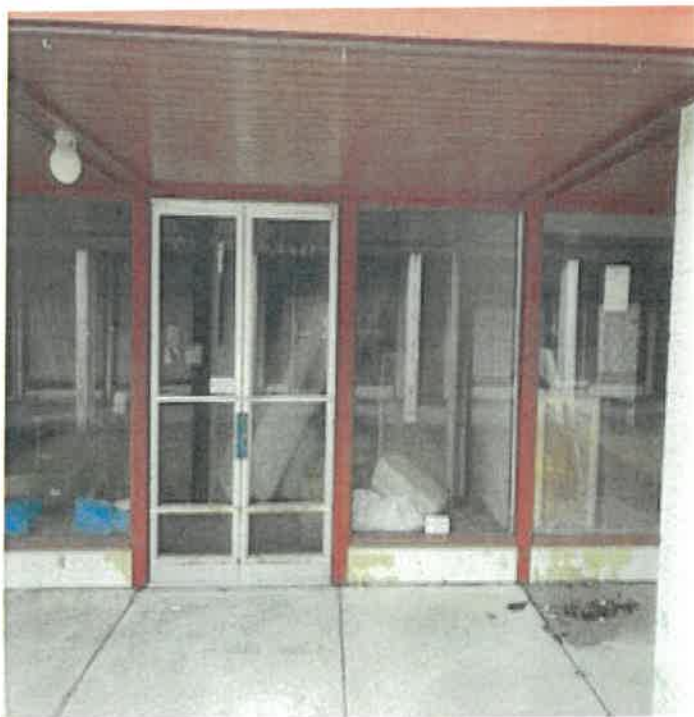
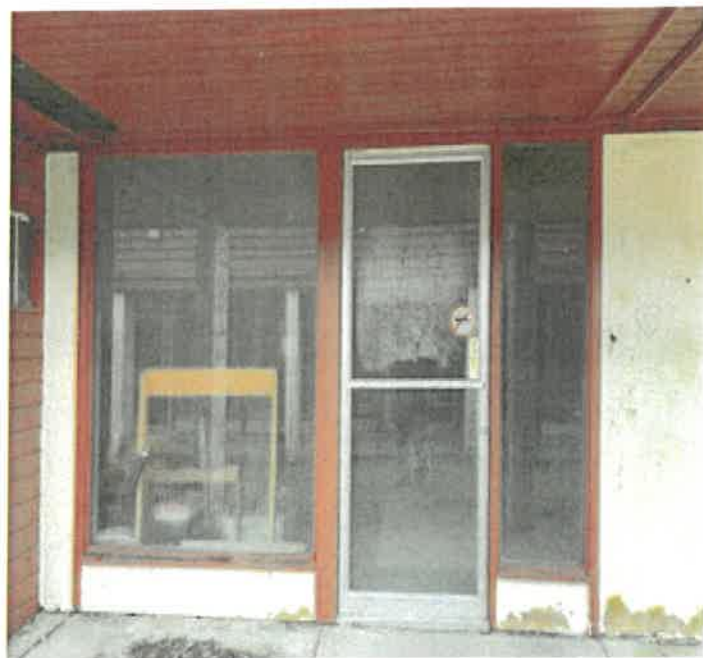
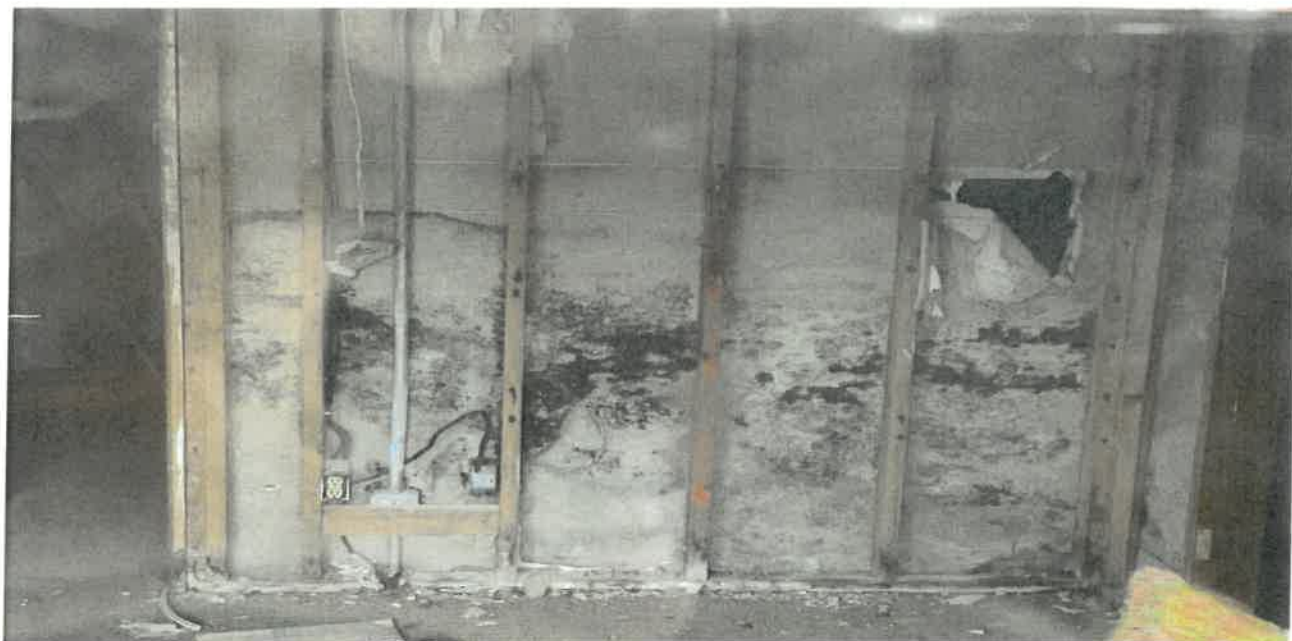
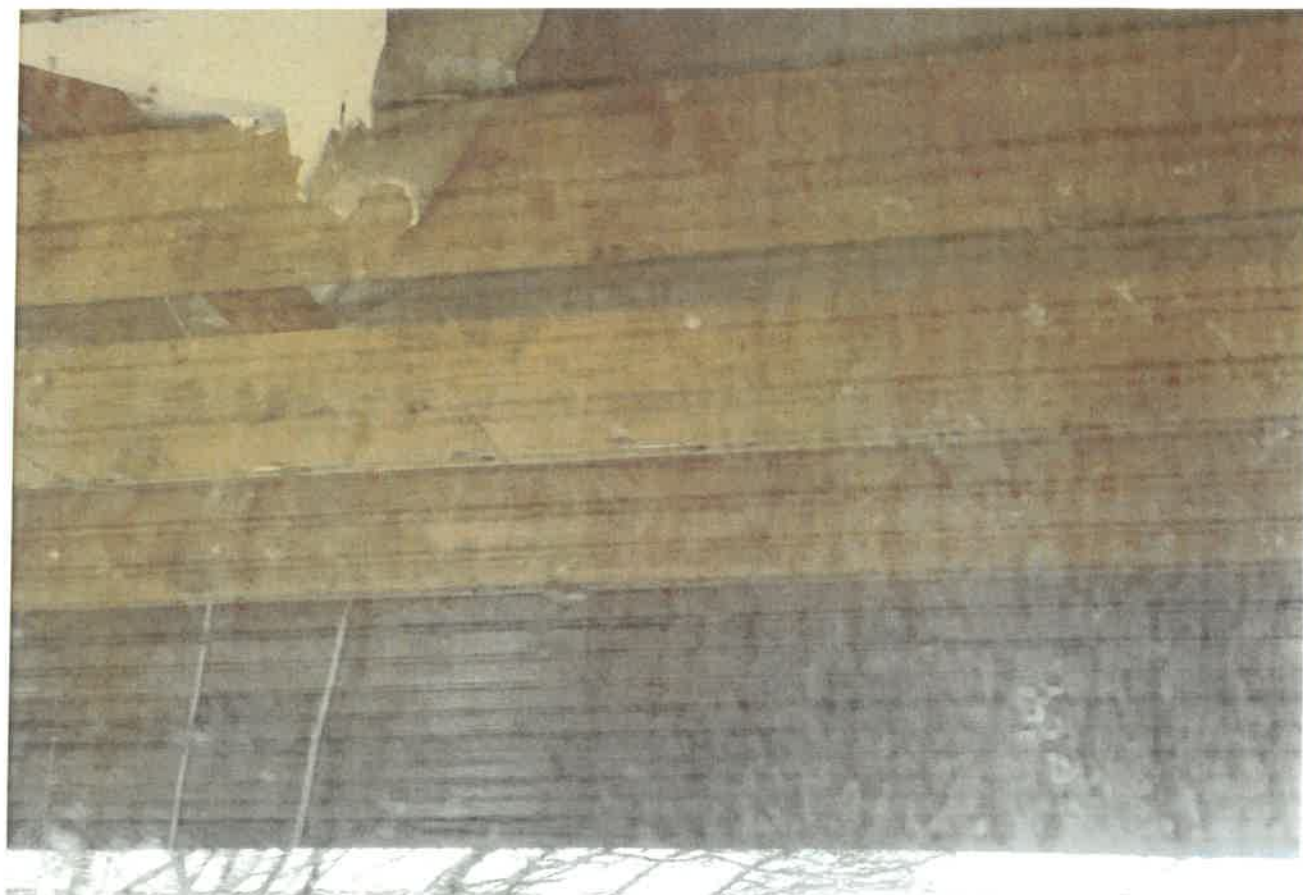
**BUILDING 2 SIDE C INTERIOR**

Of note that several other photos were taken of the interior to show dampness and water penetration on the floor of building 2. These photos did not turn out due to the reflections of window.

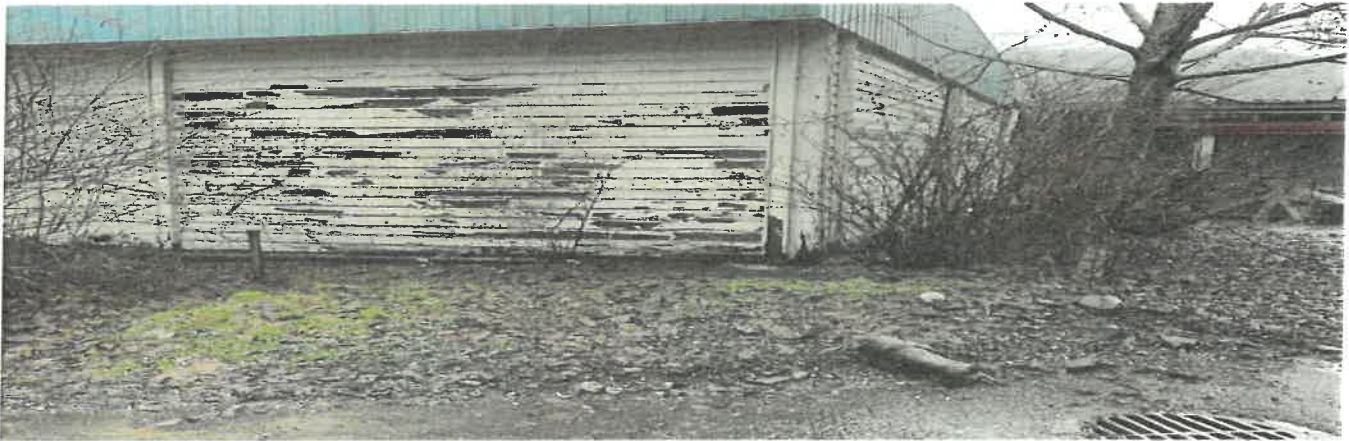
**BUILDING 2 SIDE D**

As with the previous report from June 17, 2021 where the video showed the side D of the building surrounded by vegetation, as seen in the photo below this side of the building still has vegetation, there has been no attempt to do improvements. Note again the pooling of water in the A/D corner. It was noted

that water was pooling on the surface by the corner of the building and not draining into the catch basin at the street.

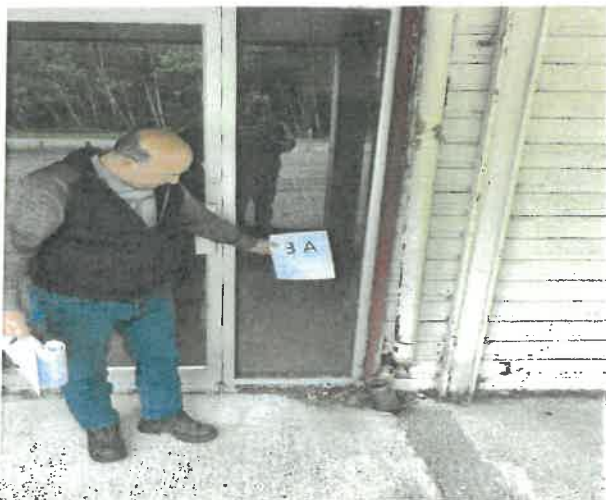
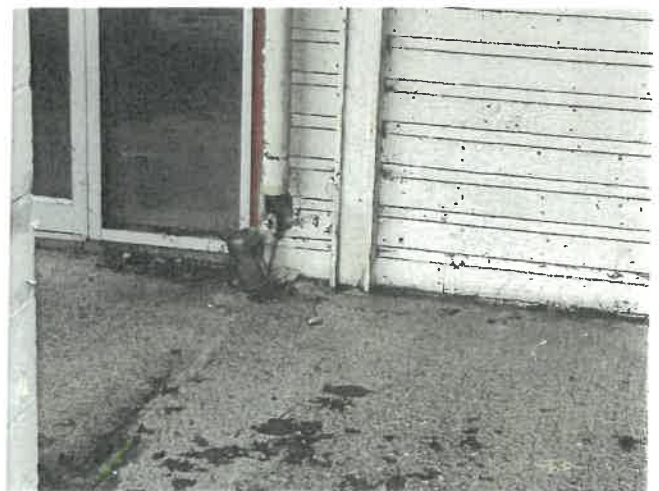
**BUILDING 3 SIDE A**

While the side A of the building is partially protected from the elements under the covered area. The plywood around the store front had numerous holes, rot along the wall in various areas peeling paint along with mold being seen on the windows. As seen in both the photos below from the June inspection and the January inspection the drainpipe. It was noted in the January 20, 2022, during the rain very little water was observed running out of the downspout for the front of the building from the roof as shown below.

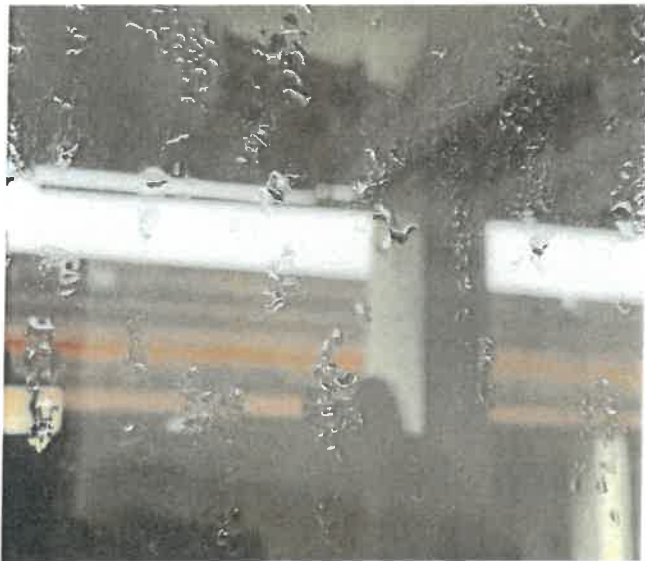
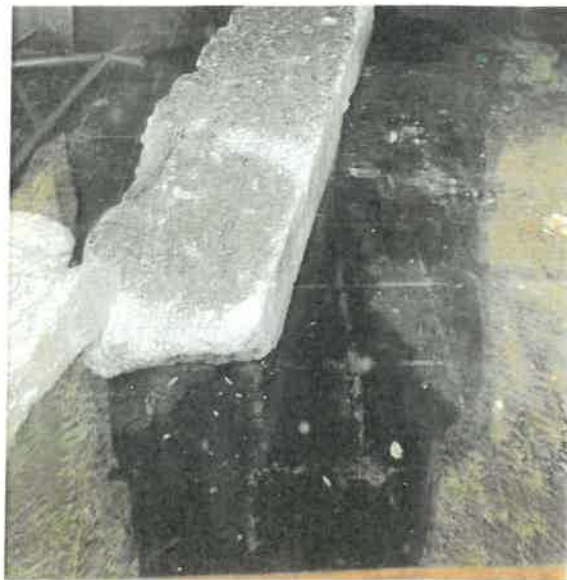
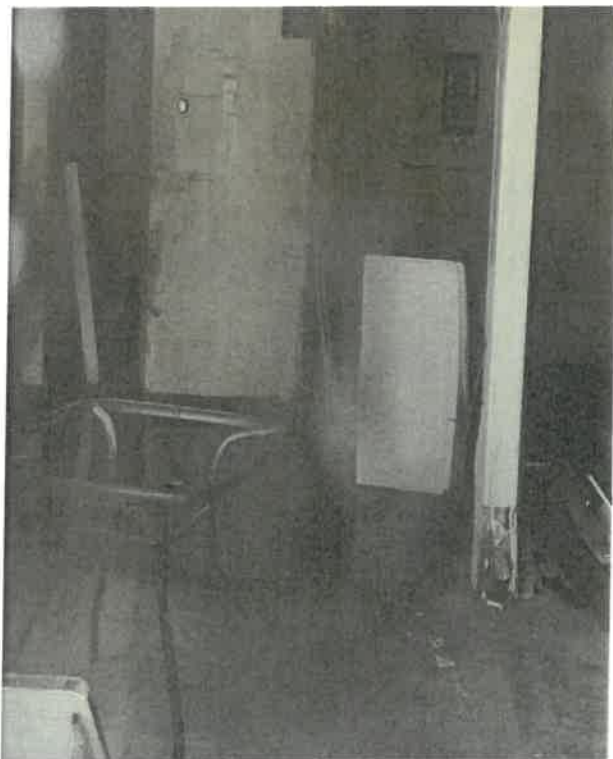
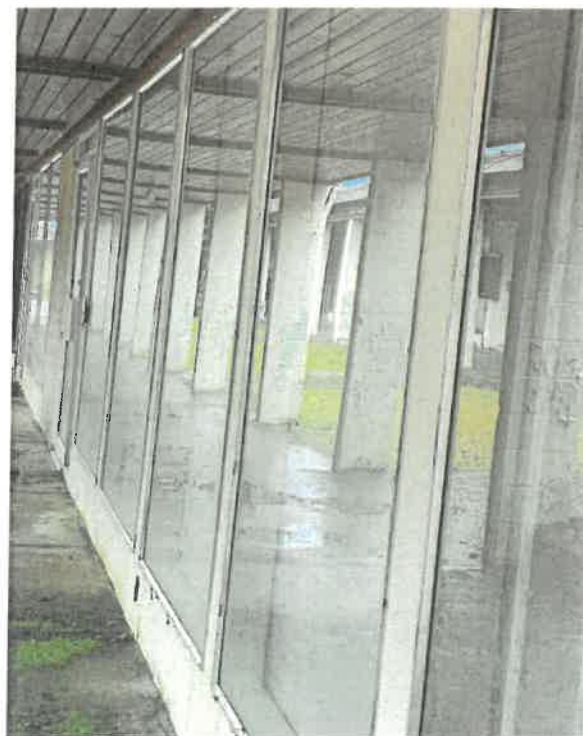
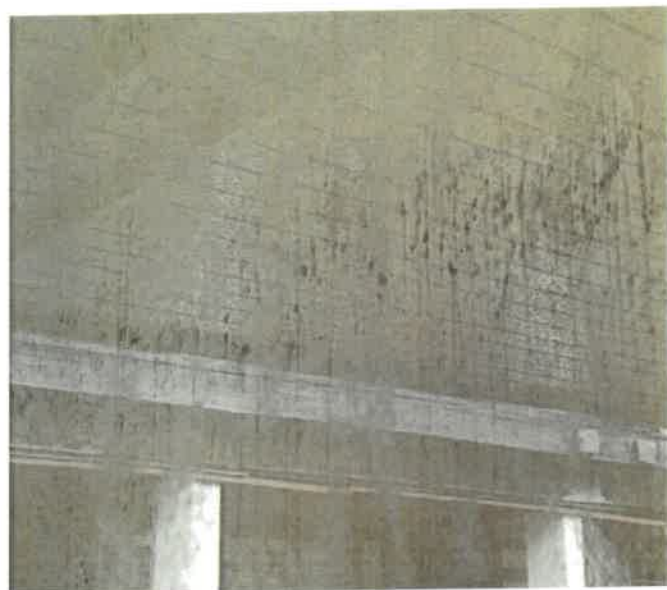
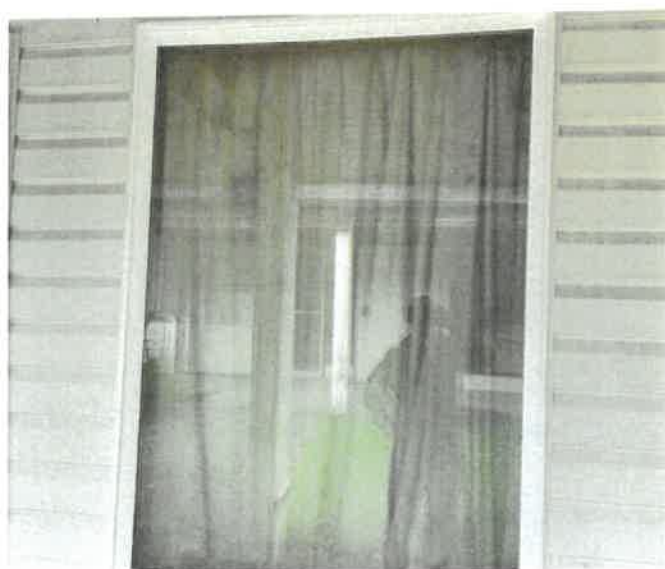
Tarps have been hung in the windows to prevent visibility into the building 3 Side A center section, this is the area where the roof has collapsed as will be seen in pictures from side\_C. Throughout side A it was observed by both building inspector and bylaw officer mold, water damage along with the drywall from ceiling that has fallen.

As with the pictures from Building 2, due to the reflections from the window the pictures do not properly depict the actual condition and moisture content that was observed by building inspector and bylaw officer of the interior of the structure.

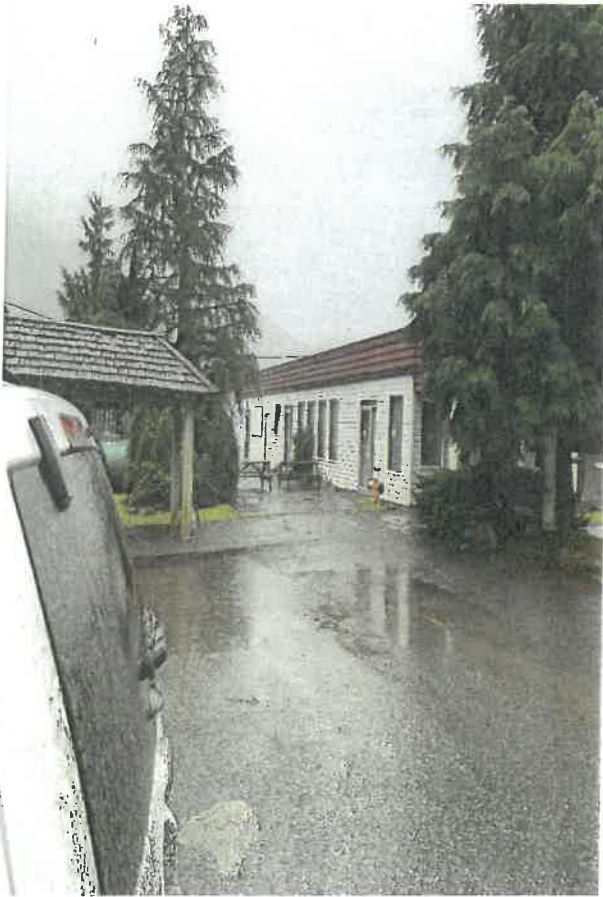
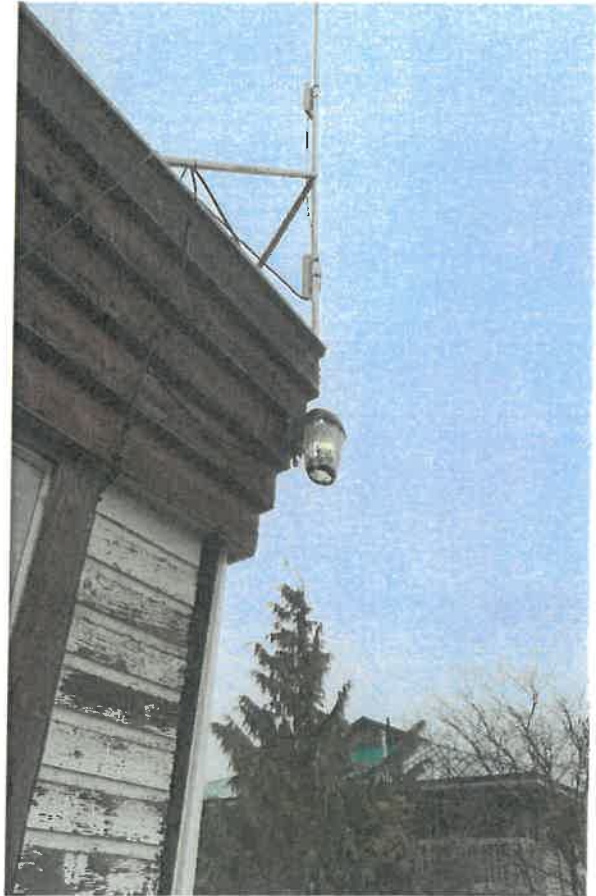
**BUILDING 3 SIDE B**

As with the rest of the building, due to drawn curtains it was unable to see into the structure. Nothing has been noted to be done except for the picnic tables placed at the by the B/C corner of the building to discourage access to rear of the building due the proximity to the water which was noted in the report from June 17, 2021. Of concern, an exterior light fixture was observed to be on (see photo above). This light was not noted in the prior inspection. Due to the deteriorating condition of the building and the exposure to water and moisture this poses a major hazard to life safety to anyone who enters this building.

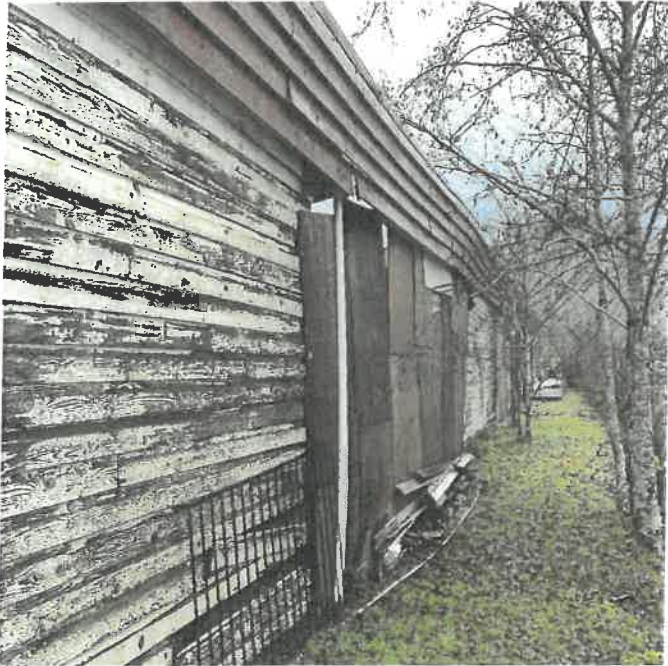
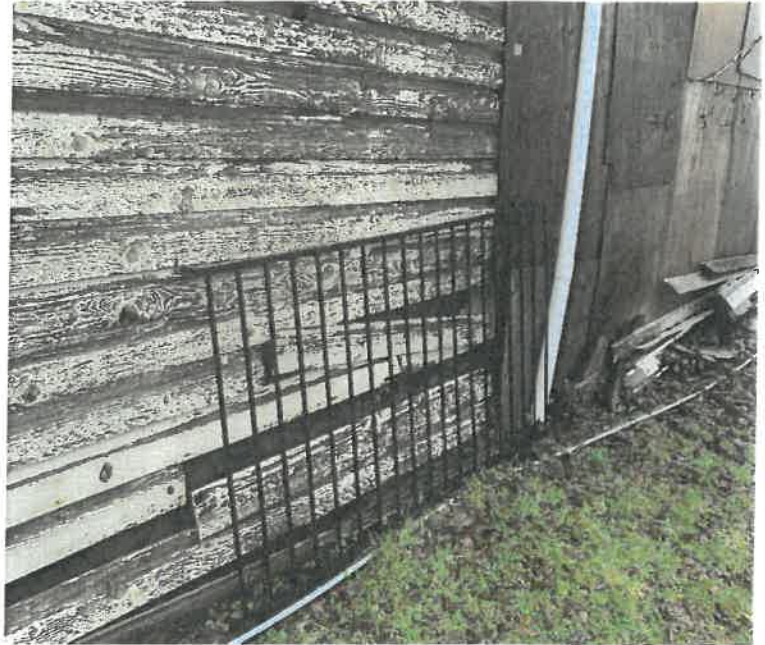
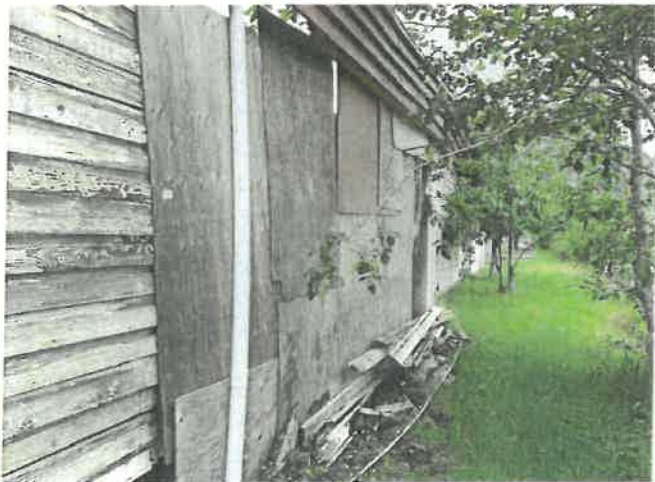
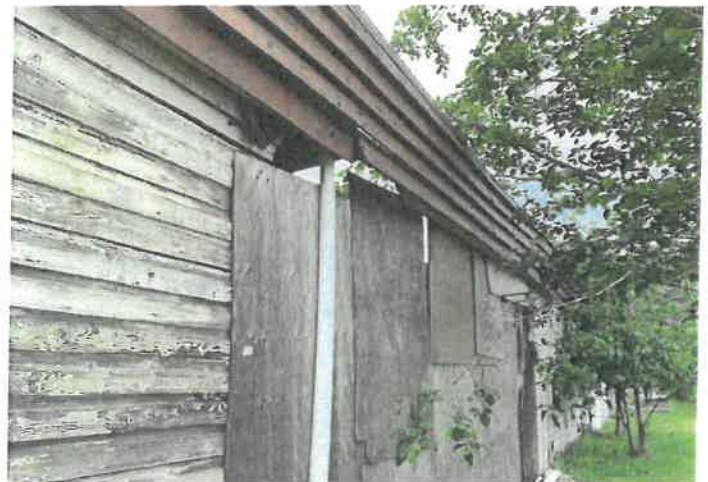
**BUILDING 3 SIDE C**

No changes were noted to the C side of Building 3. Access to the C side from the B side of the building was restricted due to fencing that had been placed as a deterrent as noted in the June 17, 2021, report. As noted in the June report, here the roof can be seen to have collapsed along with a section of wall that has been covered with plywood. It is unknown what is supporting the roof and wall as no framing or cross bracing can be noted from the exterior. It is unknown to the writer why the metal railing was placed up against the building, or of what use the metal railing could be used in the support of the wall.

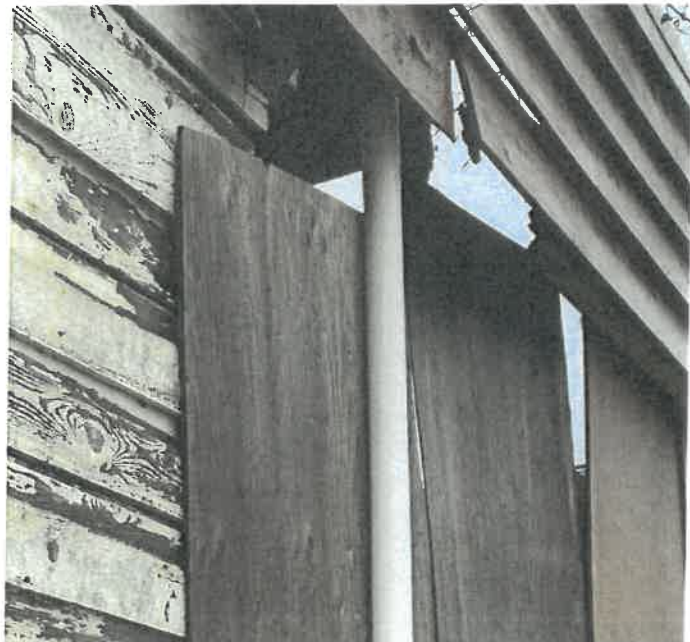
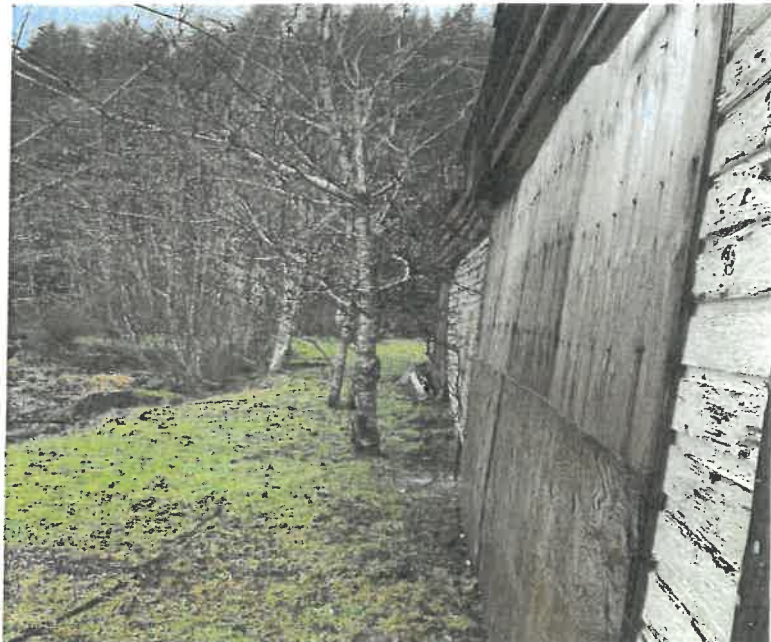
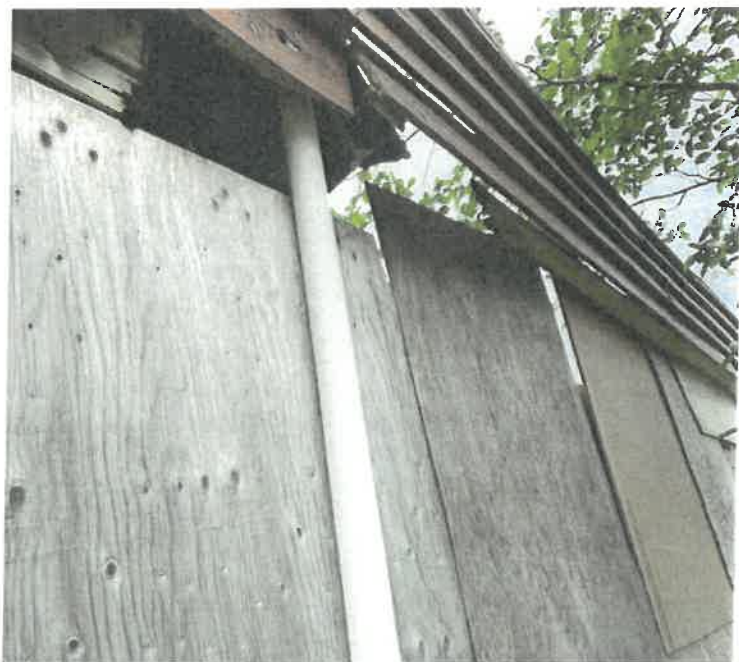
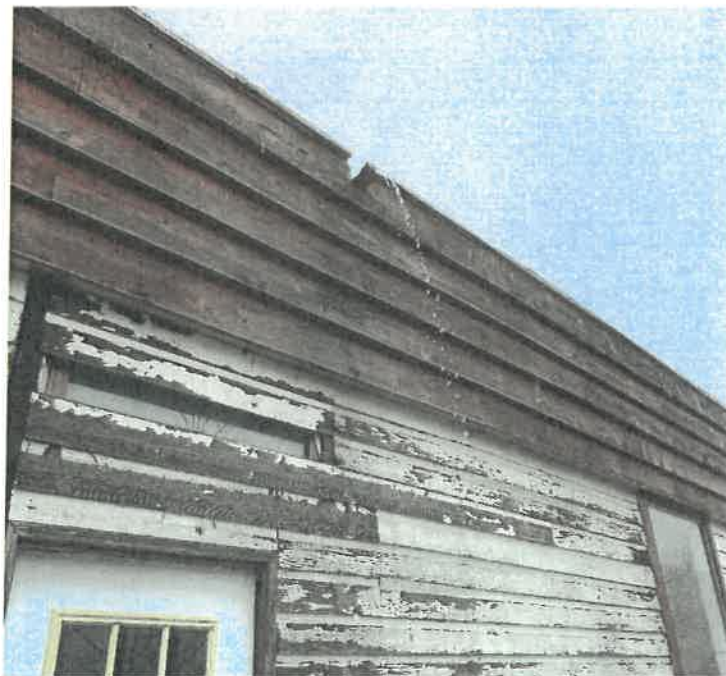
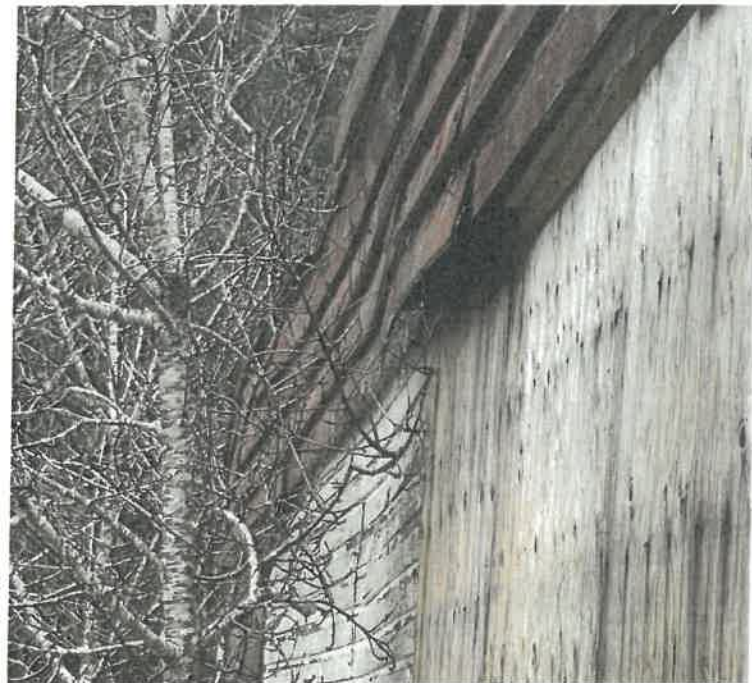
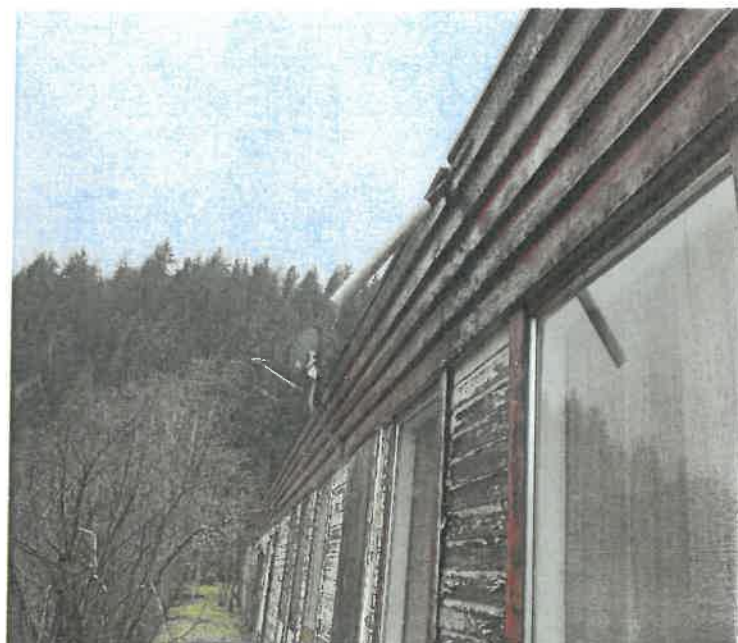
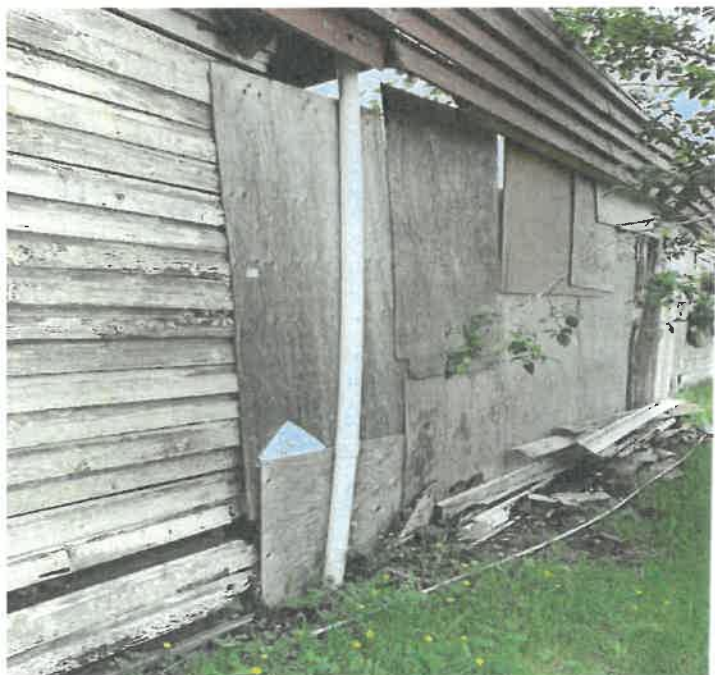
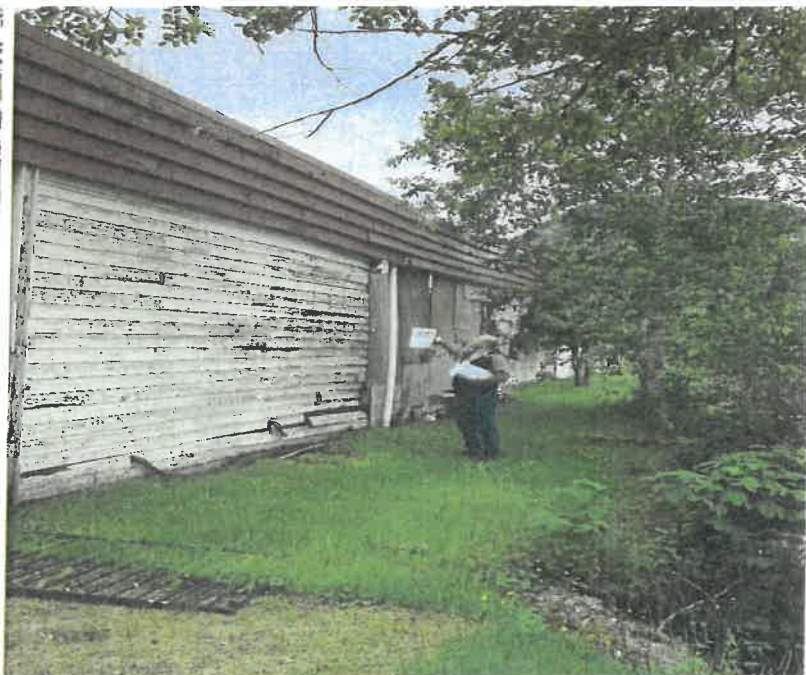
**BUILDING 3 SIDE C Continued**

The wall and roof continue to be warped and deteriorating, the visual images note that the roof is compromised and likely collapse in the future. This was noted in the June Report where it was advised by SRD staff that a Structural Engineer should be engaged as the condition of the building along with a Geotech Engineer should also be engaged to evaluate the location due to the potential undermining of the foreshore. As seen in the photos on the previous pages (page 12), makeshift devices have been made and installed in the roof to assist with water drainage from the roof.

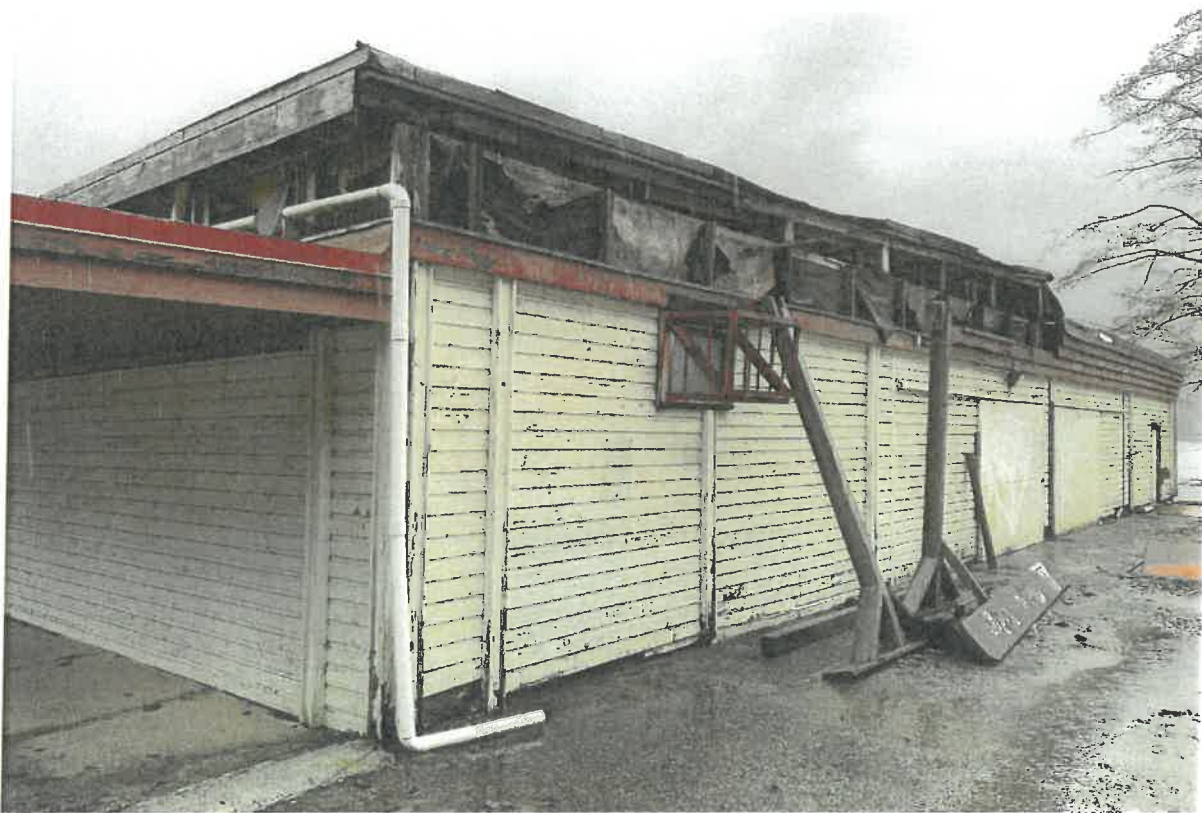
**BUILDING 3 SIDE D**

As noted in the report from June, the roof area on the D and A side are open and exposed to the elements. Of note the placement of the roof drain in the A/D corner. Due to the position of the pipe, water was observed flowing out of the pipe and following the natural grade of the ground, the ground water due to the natural grade was observed running along the entire building towards the back.
