**Report to Council Re: Hearing by Council to reconsider its Remedial Action Requirement  
Order under Division 12 of Part 3 of the Community Charter pertaining to the buildings  
at the property located at the civic address 1400 South  
Maquinna Drive, Tahsis, BC (the "Property") and owned by 1031249 B.C.  
Ltd. (the "Owner")**

## Report to Council

Attachment 2      Inspection Report of 1400 S.  
Maquinna Drive  
January 20, 2022

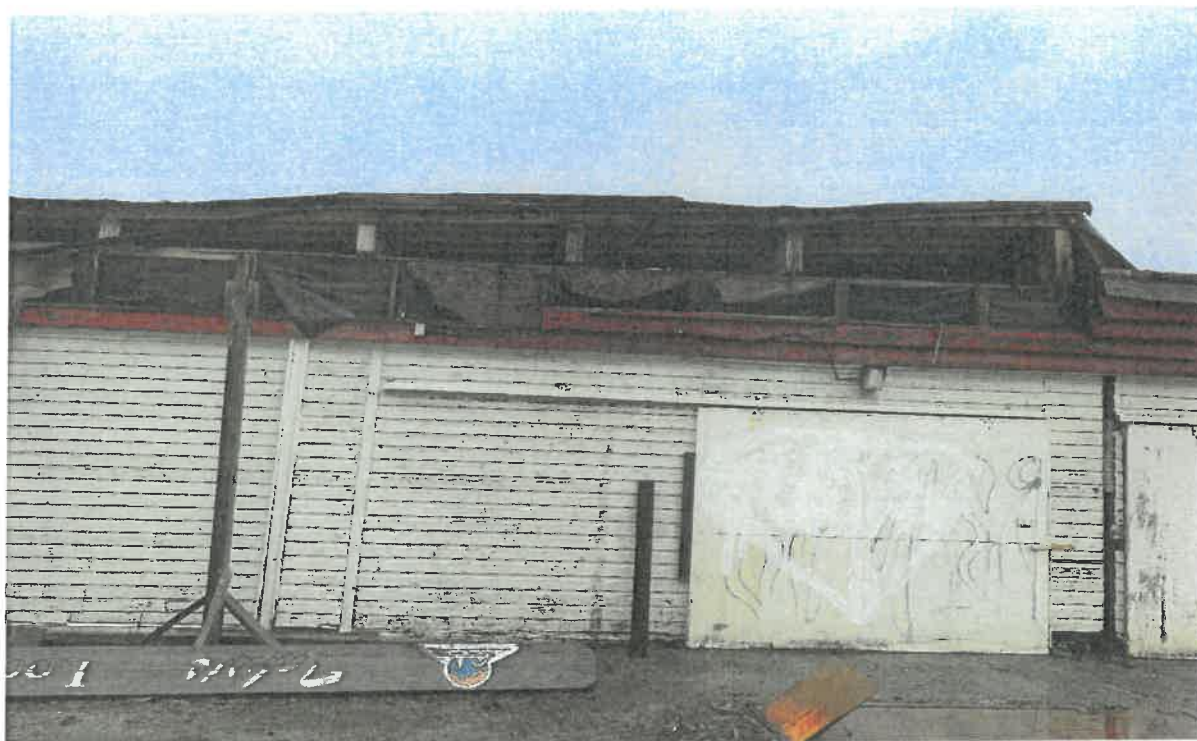
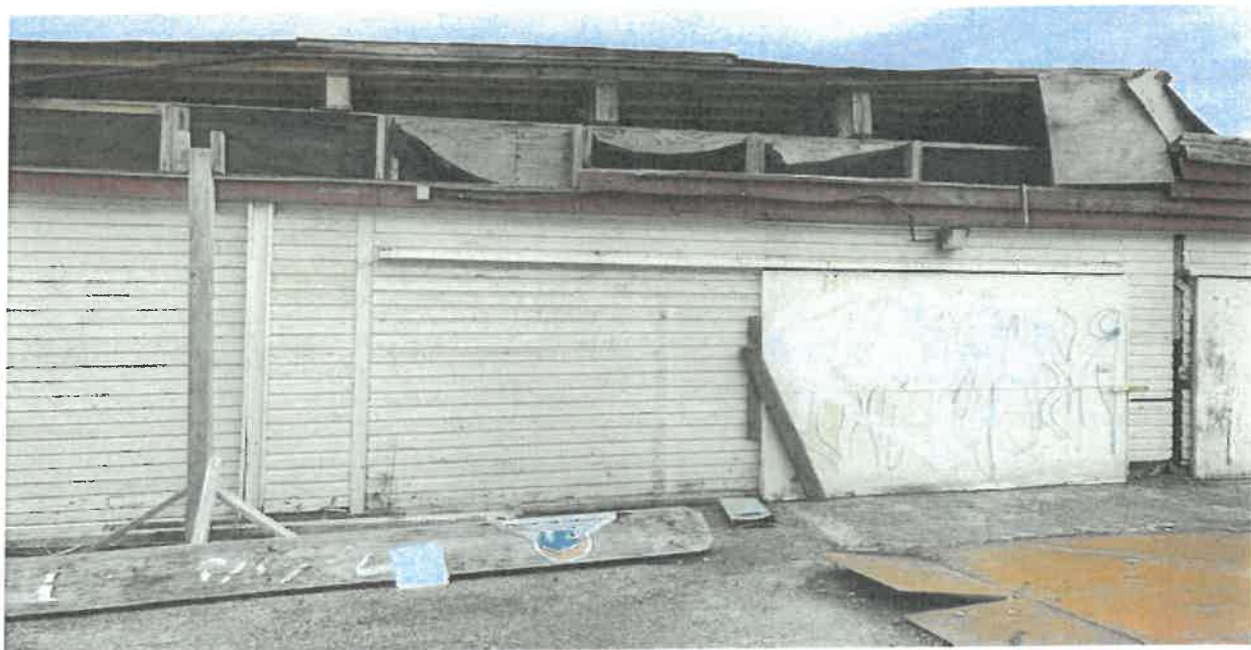
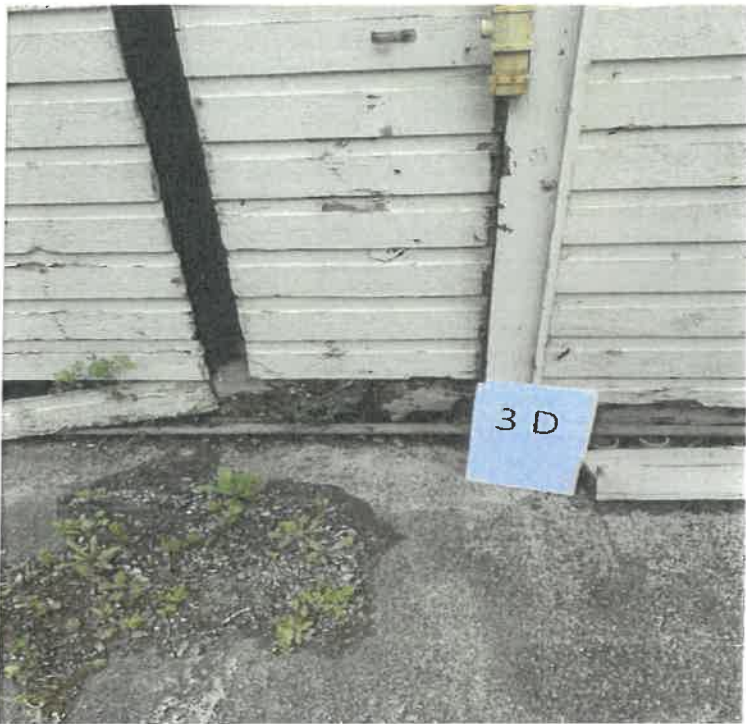
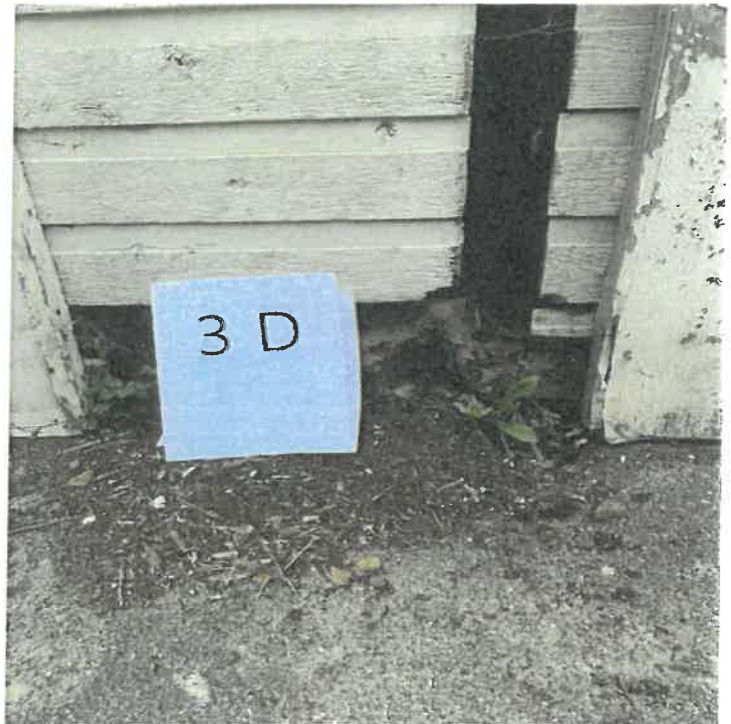
**BUILDING 3 SIDE D Continued**

This waterflow along the ground to the rear of the property is causing the rotting that has been observed and noted in both reports. SRD staff will recommend an Environmental Hygienist be engaged. A Hazardous Materials Assessment and Remediation of Buildings 2 and 3 will be required prior to any permits being issued for building 2 and 3.
