# VILLAGE OF TAHSIS

## Report to Council

### **TAHSIS FLOOD PROTECTION IMPROVEMENTS PROJECT PHASE 2**

## **Tahsis Flood Protection Project Phase 2 – Wall Construction Summary**

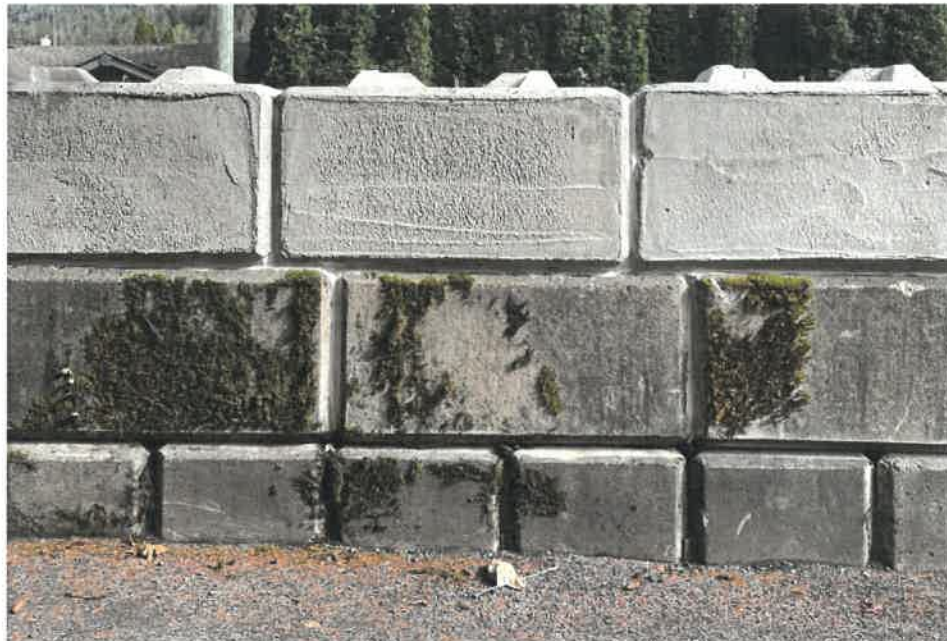
1. **Surface Caulking Sealant** – This is a durable polyurethane-based sealant that is applied to all surface joints on the river face of the wall. It is applied with a caulking gun and provides a flexible, weatherproof seal. This is the primary measure for sealing the wall. **Figure 1** below shows a section of the wall where the white caulking has been applied to the joints along the top two rows of blocks with the lower joints still to be sealed.

*Figure 1: Flood Wall with Surface Sealant Applied*

There may have been a misunderstanding from the public as to which side of the wall the sealant was being applied to. As the caulked surface sealant is intended for application along joints on the Tahsis River side of the wall, residents viewing from the Maquinna Drive side would not be able to see it applied.

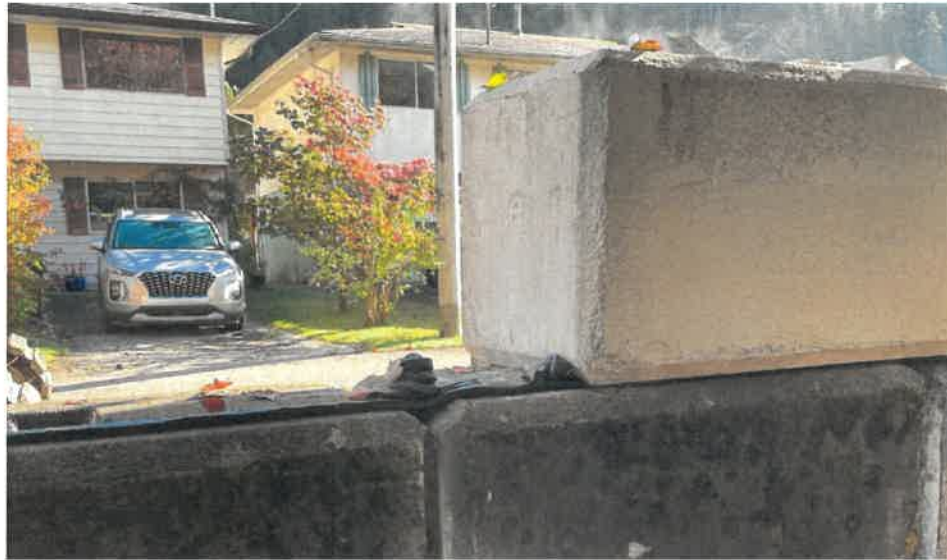
2. **Mastic Sealant** – This is a putty like material that comes in rolls and is placed between joints prior to blocks being set in place. This is a secondary measure for sealing the wall, and **Figure 2** below shows a row of black mastic being placed.

*Figure 2: Mastic Sealant Applied to Floodwall*

There were, however, concerns from residents that the mastic sealant was not being applied correctly as to ensure a watertight seal. As such, McElhanney has reviewed the wall design and sealant application methods with the contractor. Any areas of concern were identified in the field, and the contractor confirmed plans to apply more mastic product as required to ensure a proper seal.

Where tolerances between vertical joints were extremely tight and mastic could not be properly applied without negatively impacting wall fitment, the contractor was instructed to omit mastic. It should be noted again that the mastic is a secondary sealing measure with the caulking acting as the primary sealing measure.

There were locations identified along the wall where the existing wall deflected resulting in larger vertical joints with gaps greater than  $\frac{3}{4}$ " (19mm). It isn't practical for mastic to be filled between large gaps, so instead, the contractor agreed to fill any larger gaps with grout.
