REVISION 0

# 2019 CONDITION ASSESSMENT OF THE MUNICIPAL WHARF

The Village of Tahsis retained McElhanney Ltd. (McElhanney) to complete a detailed condition assessment of the Municipal Wharf facility located in Tahsis, B.C. The scope of work included the following:

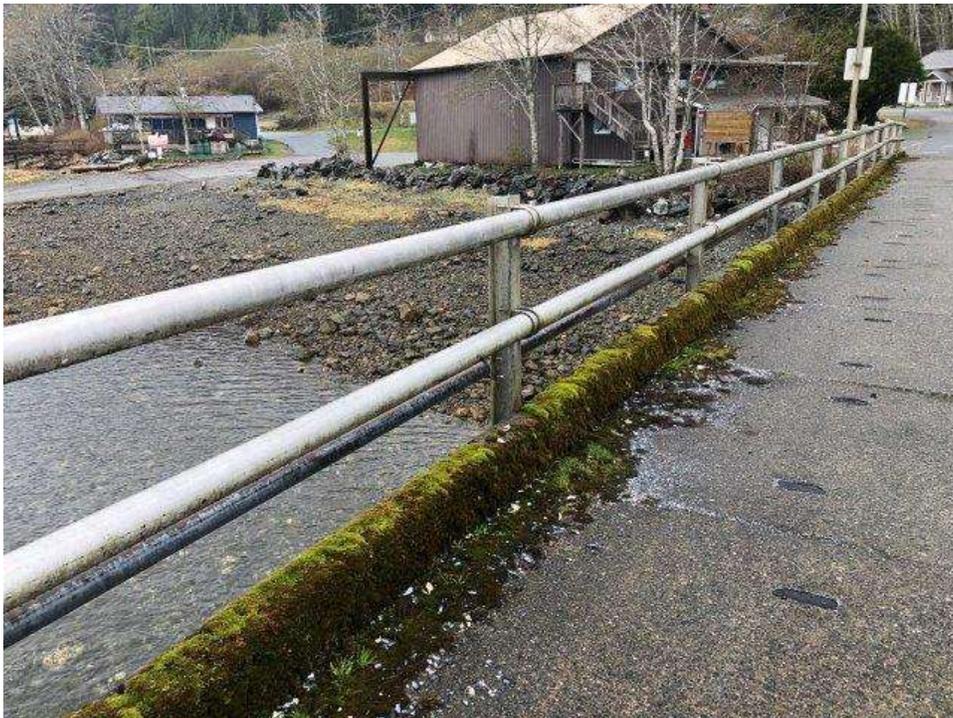
- The handrail and vehicle guardrail appear well secured. There is vegetation / moss growing on the concrete curb (Photo 8, Appendix B).
- The fire suppression utility service at the offshore end of the approach is not connected or in-service.

*Photo 8 – Approach Trestle Concrete Curb*

*Significant repairs are not recommended at this time, although continued monitoring should be carried out.*
