VILLAGE OF TAHSIS

Report to Council

Re: Hearing by Council to determine whether one or more buildings located at civic address 1400 S. Maquinna Drive should be declared a nuisance under Part 3, Division 12 of the *Community Charter* and whether to impose a remedial action on the property owner (the “**Hearing**”).

The follow observations were noted during exterior building inspection that was conducted on June 17, 2021, at 1400 South Maquinna Drive between the hours of 11:30 and 14:00hrs. The inspection was done by Strathcona Regional District Building Official Karl Neufeld and Strathcona Regional District Bylaw Compliance Officer Enzo Calla.

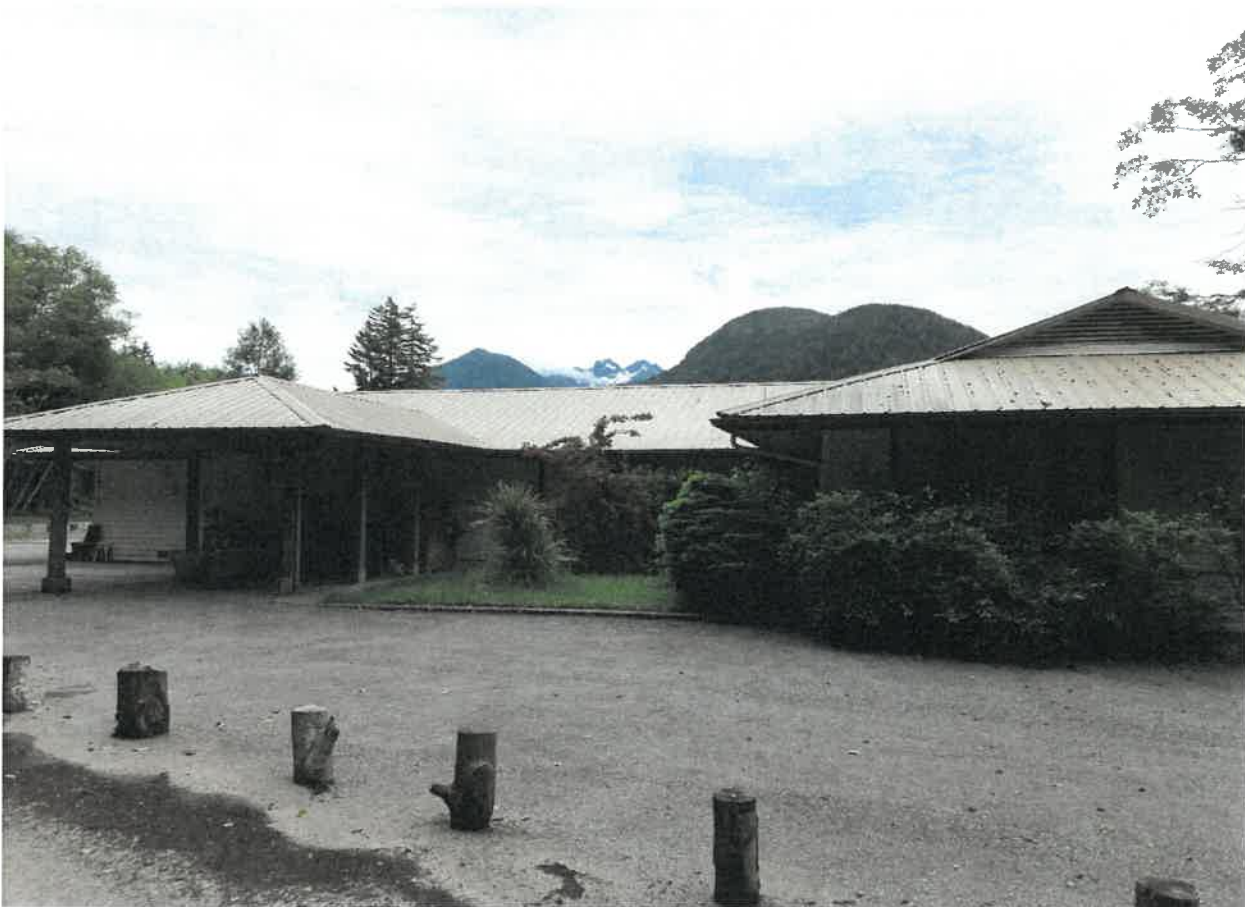
IMG_0271

BUILDING 1

The exterior inspection commenced with building 1 which is identified as the residential structure. A complete walk around the structure was done first to confirm that the area was passable and that there were no hidden dangers or fall hazards. During the initial walk around, it was noted that the building was in restively good repair. Starting with side A which had 2 doors and a carport or cover vehicle area;
